DALEY SCHOOL
LOWELL PUBLIC SCHOOLS
REPAIR/REPLACE ROOFS – ROOF SAMPLING

DALEY MIDDLE SCHOOL 150 Fleming Street

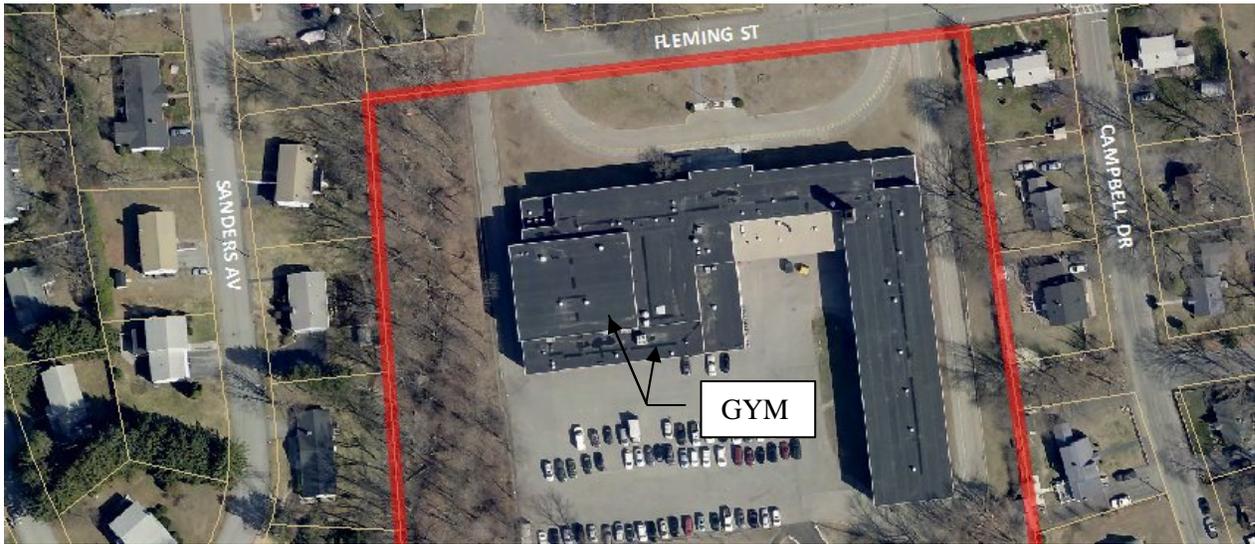
The gymnasium roof has two sections – an upper main roof and a lower roof over the locker rooms.

Both roofs are constructed of a rubber membrane and 3 inches of polyisocyanurate insulation on a concrete deck. The deck has minimal pitch. The insulation is tapered around the edges and drains to provide drainage.

- Insulation shall be tapered as shown on the drawings. Thickness shall be as specified: 4.5 inches average; 2 inches minimum, but not less than R-25 average over the whole roof.
- Asbestos was found in sealant where the lower roof meets the vertical wall; see asbestos report by Axiom Partners and EMSL Analytical, Inc.
