**STRUCTURES INSPECTION FIELD REPORT**

**ROUTINE & SPECIAL MEMBER INSPECTION**

B.I.N.  
**2BQ**

BR. DEPT. NO.  
**L-15-031**

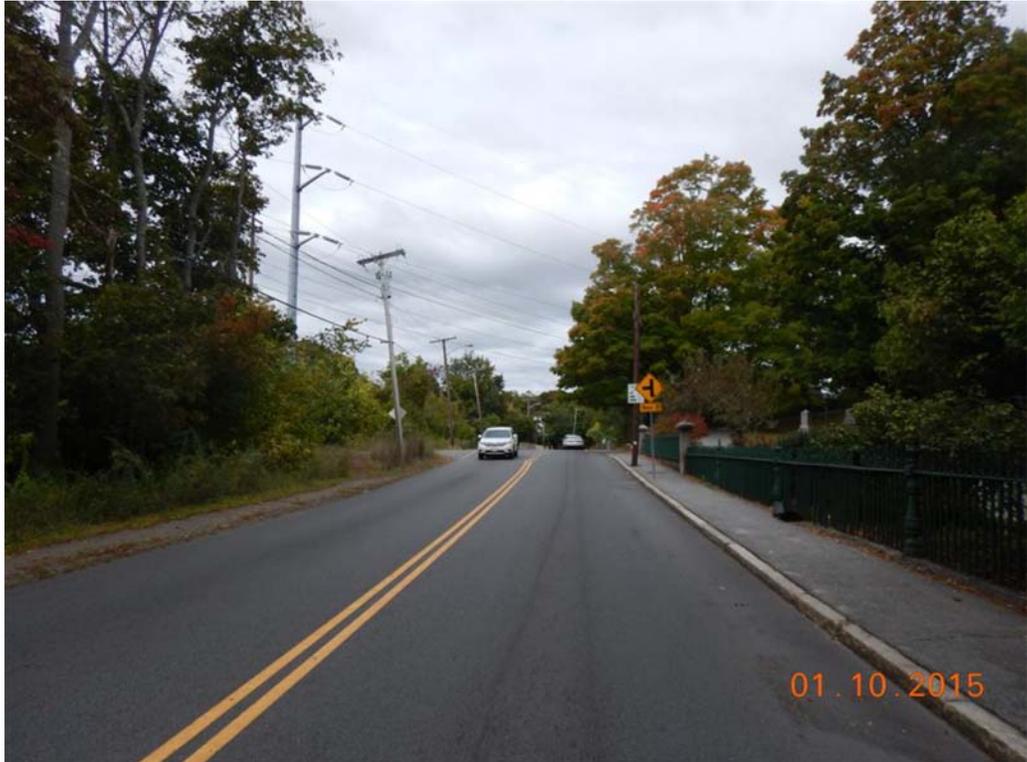
- Due to the deck condition rating of 3, underside access by snooper truck was not performed, and was instead performed by staging from a pontoon boat for spans B, C and D, and by wading/ladder for spans A, E and F, where the water depth was too shallow to permit boat use.
- The east approach posting sign is partially obscured by a street sign (Moore Street), **see Photo 1**.
- The east approach advance sign was not observed.

**Photo 1: Partially obscured east approach posting sign**

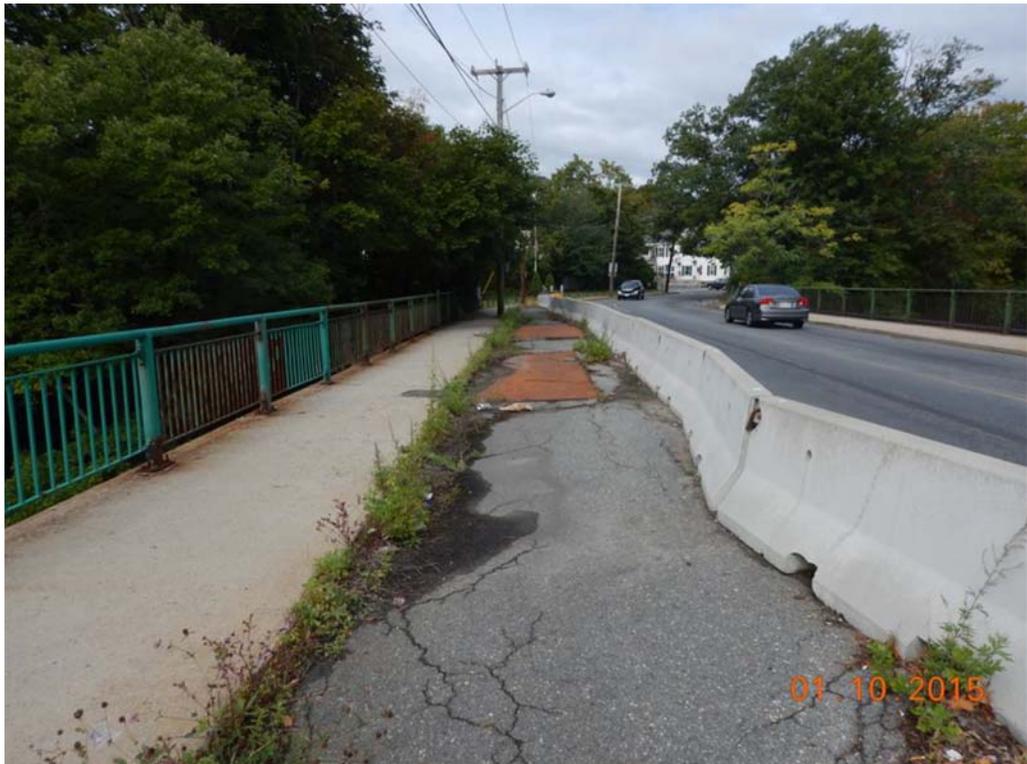
- The wearing surface between the barriers and the south curb is displaced adjacent to the south curb, exhibits up to 1/2" wide cracks, and exhibits heaving at the pier locations up to 2", **see Photo 2**.
- There is significant vegetation growth along the south curb.

**Photo 2: Typical south pavement condition**

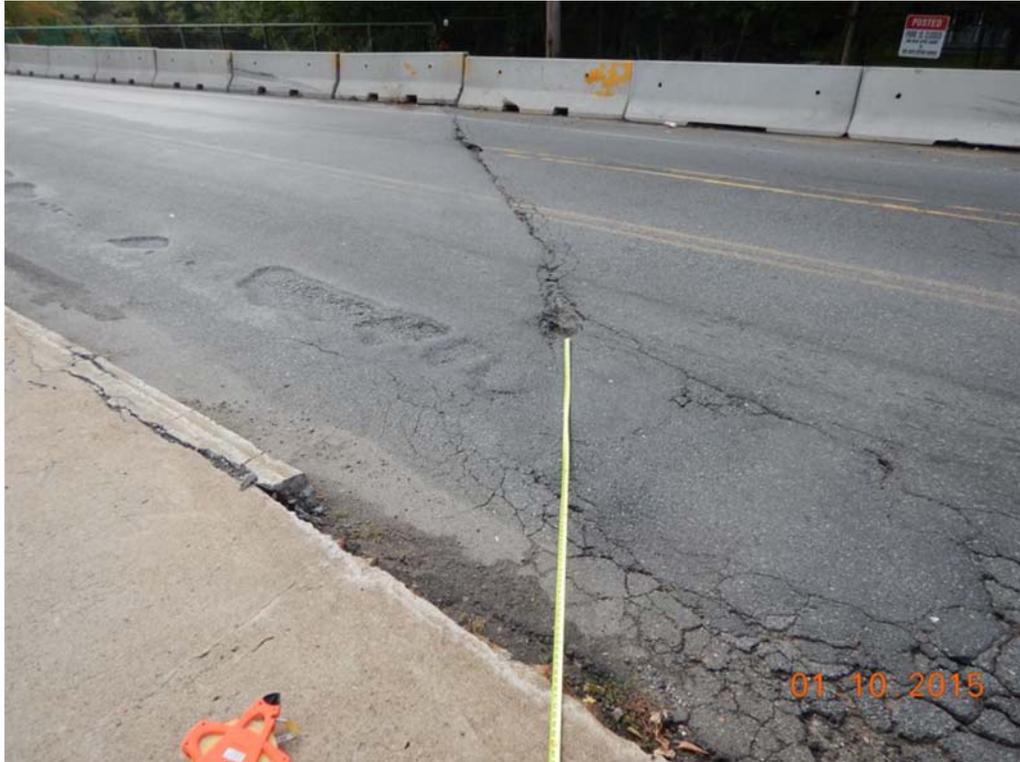
**Photo 3:** Multiple wearing surface potholes up to 1" deep, approx. 4 feet off north curb

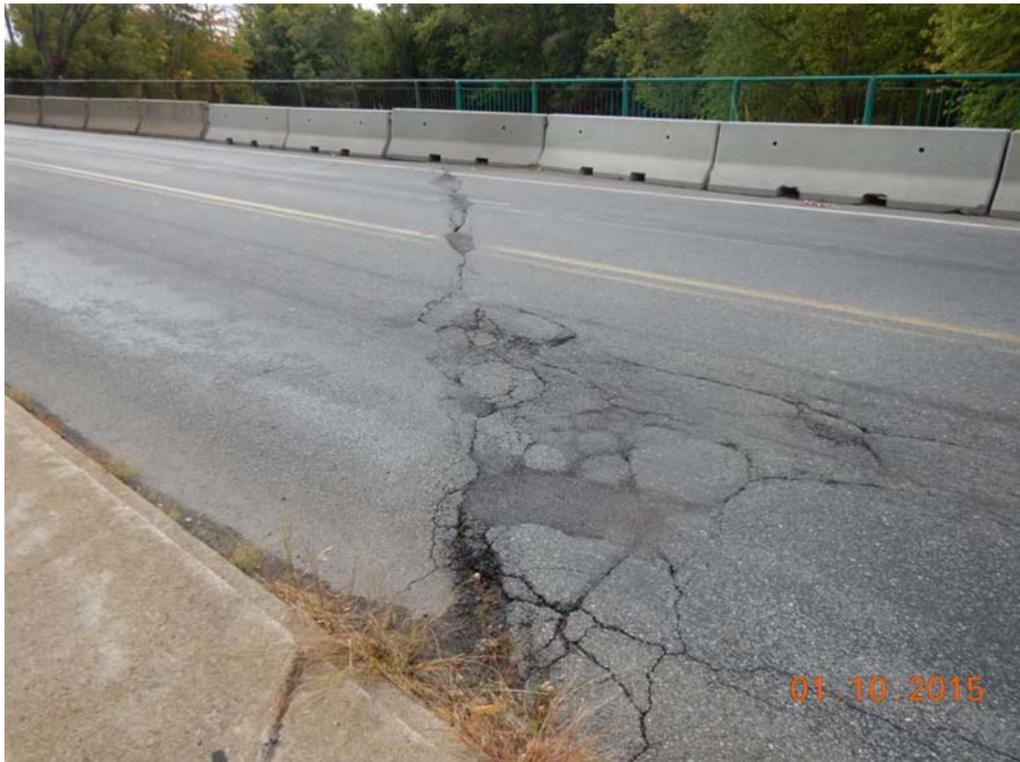
- A 6" +/- wide section of cracked wearing surface with failed patches up to 2' extends the full roadway width, **see Photo 4.**

**Photo 4:** Deteriorated wearing surface and previous repairs, Pier 3

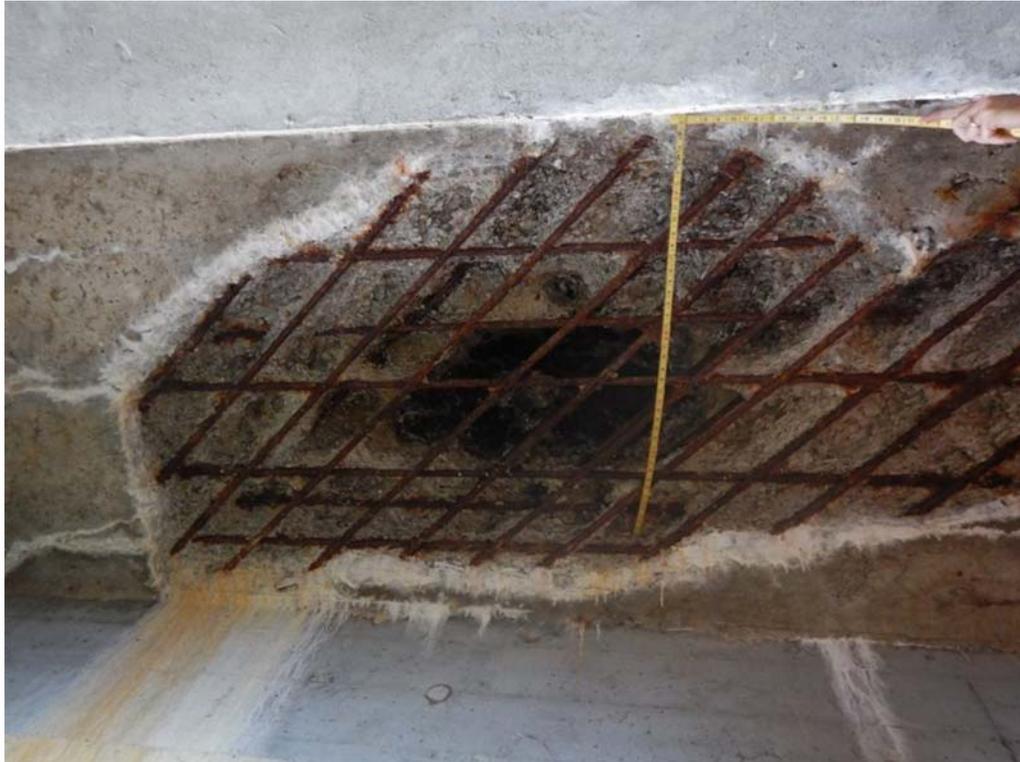
- Span C, Bay 3 - There is a full depth spall 8' x 4' with 24 exposed bars, 10% to 25% section loss (20 bars), 100% section loss (4 bars), **see Photo 5.**
- Span C, Beam 3 at Pier 2 - Typical efflorescence buildup at the deck/beam web interface, **see Photo 6.**
- Span E, Bay 2 at Pier 4 - There is a full depth spall 14' x 4' with 48 exposed bars, 25% to 100% section loss, **see Photo 7.**
- Span E, Bay 4 - The deck is delaminated the full length between Pier 4 and Pier 5, within 30" north of Beam 4, **see Photo 8.**
- Span E, Bay 8 - There is pattern cracking within 8' of Pier 5, deck is damp and cracks exhibit efflorescence, **see Photo 9.**

**Photo 5:** Span C, Bay 3 - Full depth spall

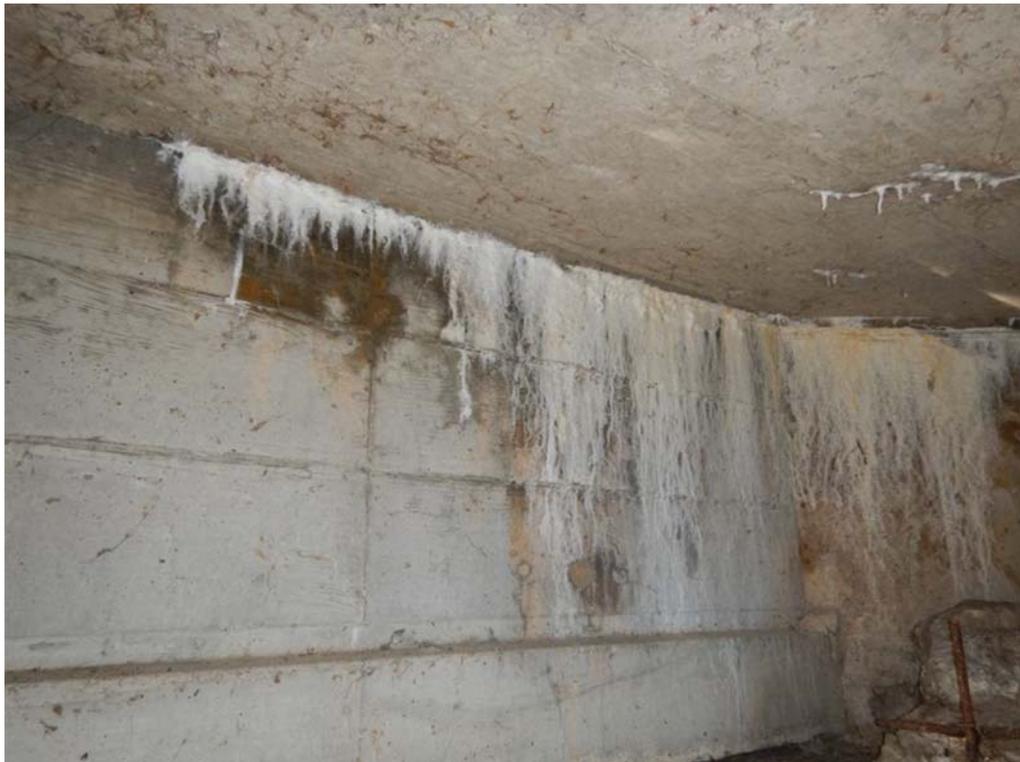
**Photo 6:** Span C, Beam 3, Pier 2 - typical efflorescence buildup at deck/beam interface

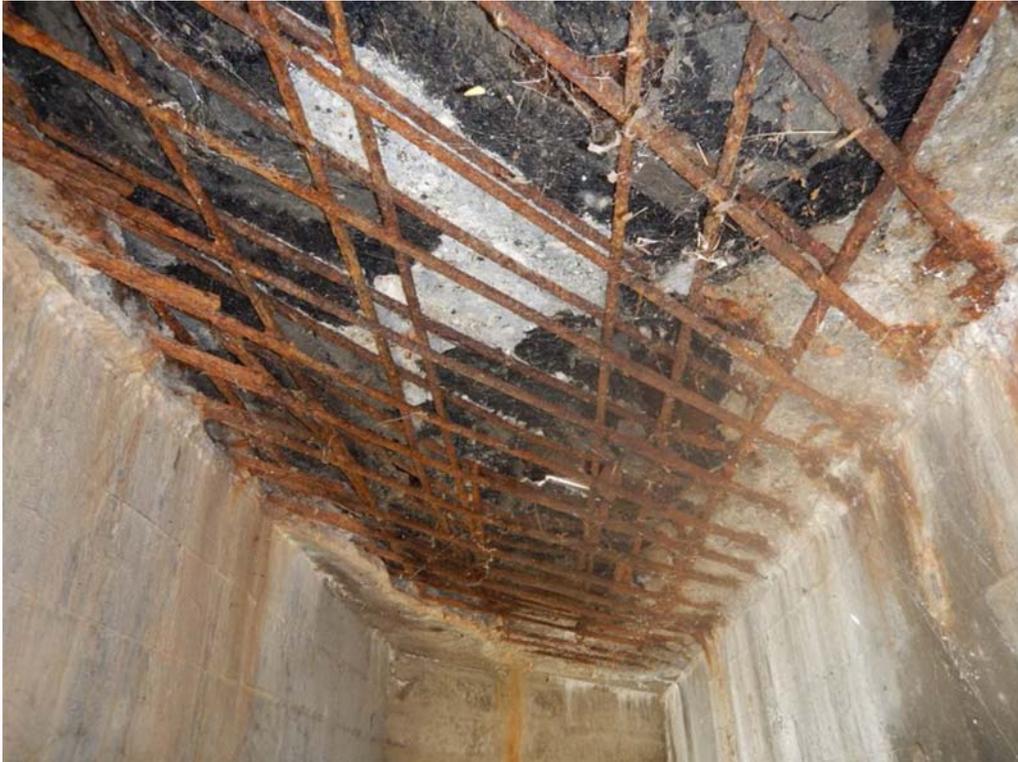
**Photo 7: Span E, Bay 2, Pier 4 - Full depth deck spall**

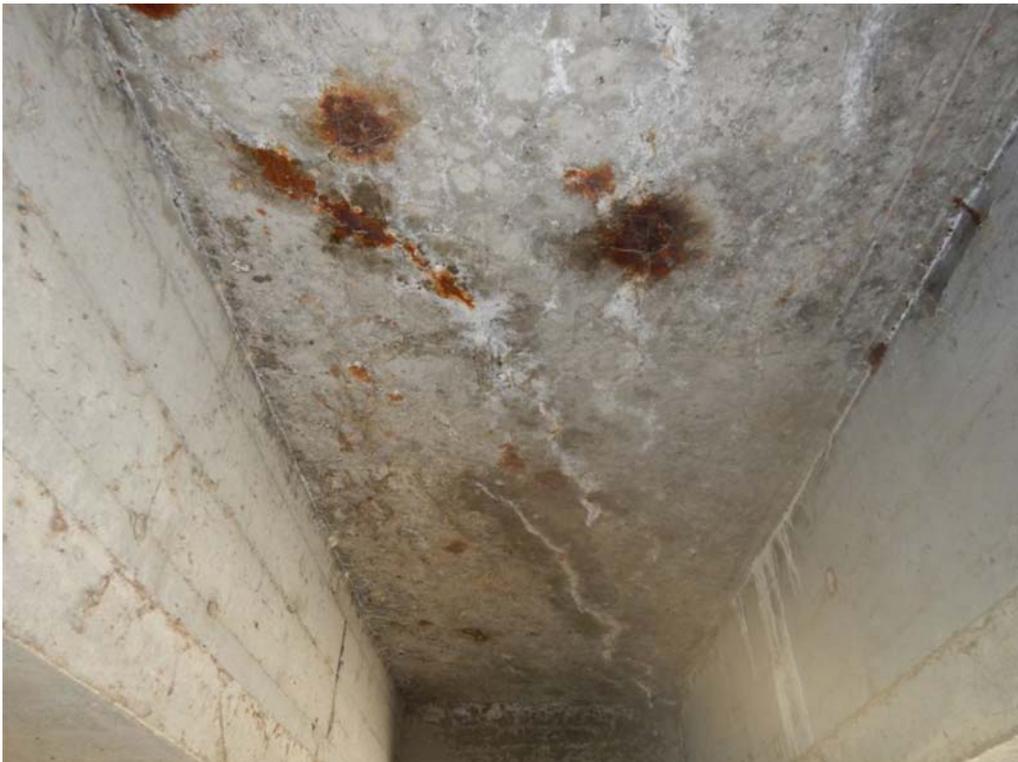
**Photo 8: Span E, Bay 4 - Full length deck delamination between Piers 4 and 5**

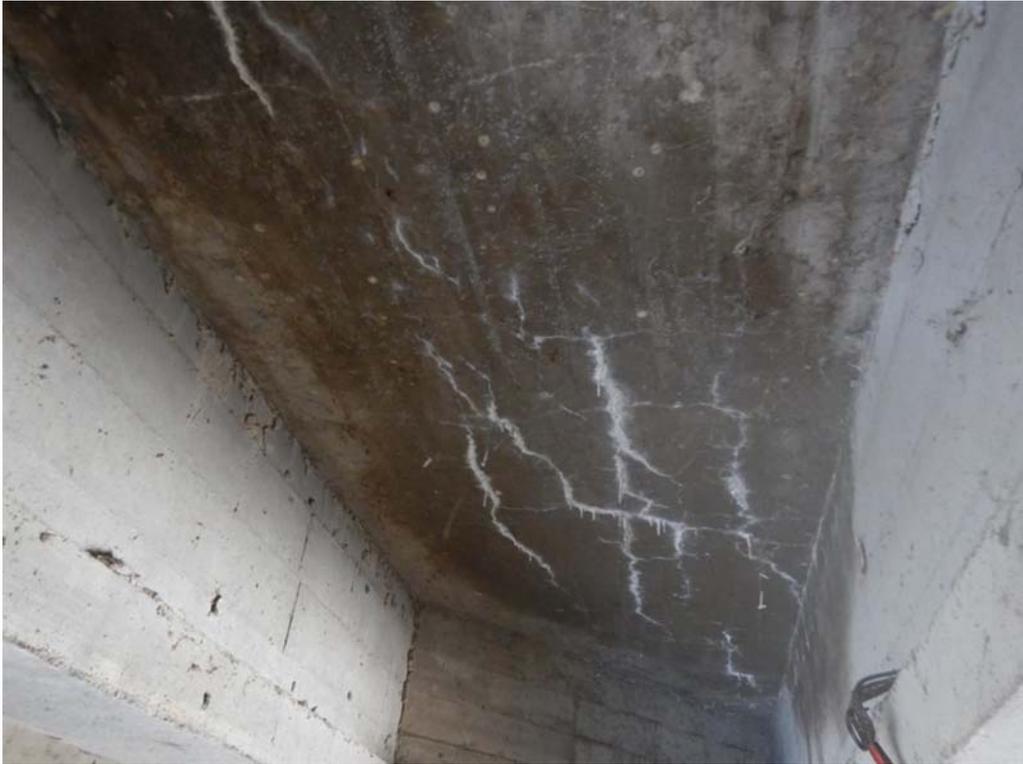
**Photo 9: Span E, Bay 8 - map cracking**

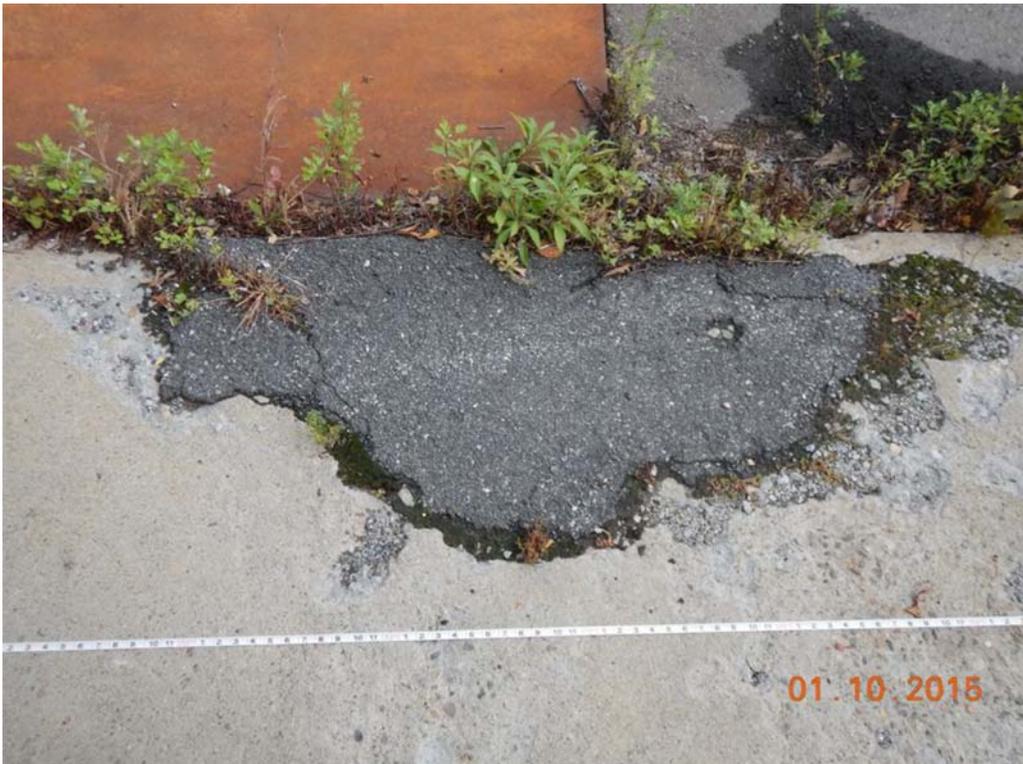
- Over Pier 1 - Bituminous concrete patch along the curb section adjacent to the roadway, **see Photo 10.**
- Over the East Abutment - Spall adjacent to the roadway with typical cracking along the curb section, **see Photo 11.**

**Photo 10: Pier 1 - Bituminous concrete surface patch at south sidewalk**

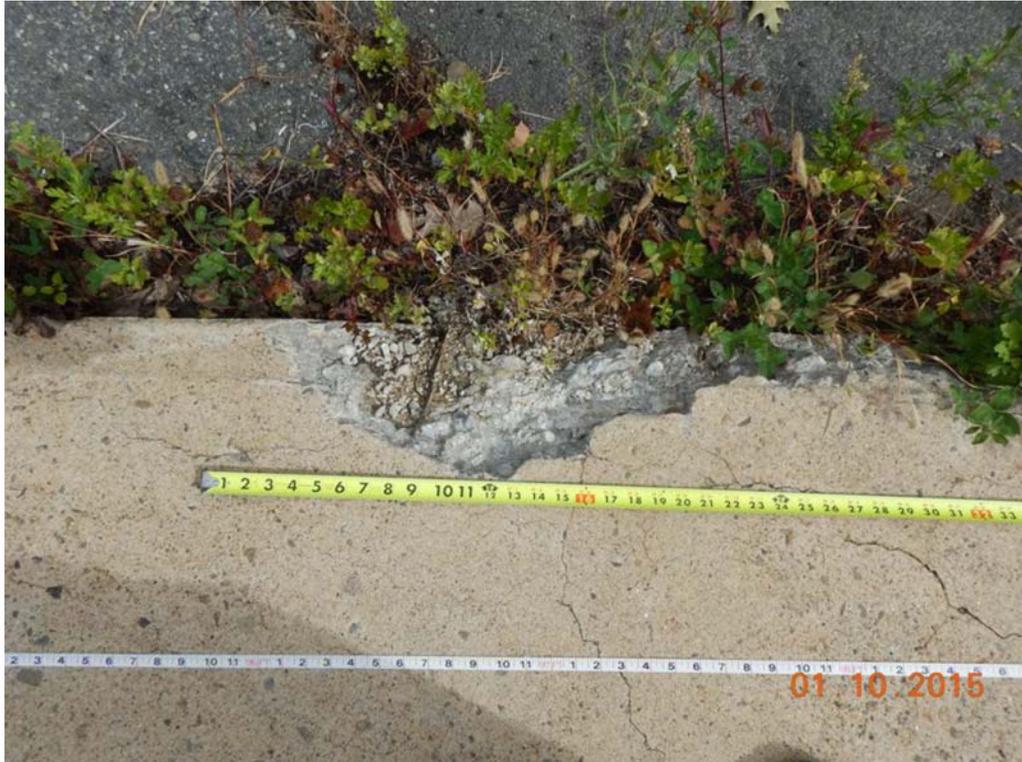
**Photo 11: Over East Abutment - curb spall and cracking**

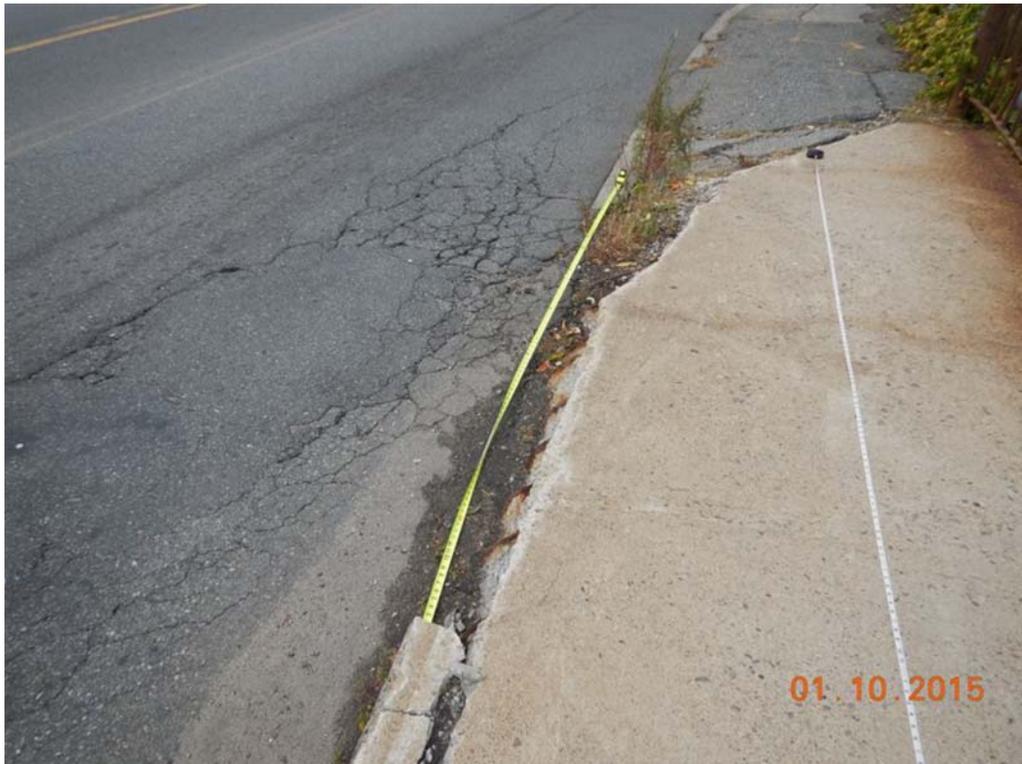
- Over the West Abutment - 8' spall adjacent to the roadway spall with 11 exposed bars up to 10% section loss, **see Photo 12.**

**Photo 12: Over West Abutment - 8 foot spall in sidewalk curb section, 11 exposed bars**

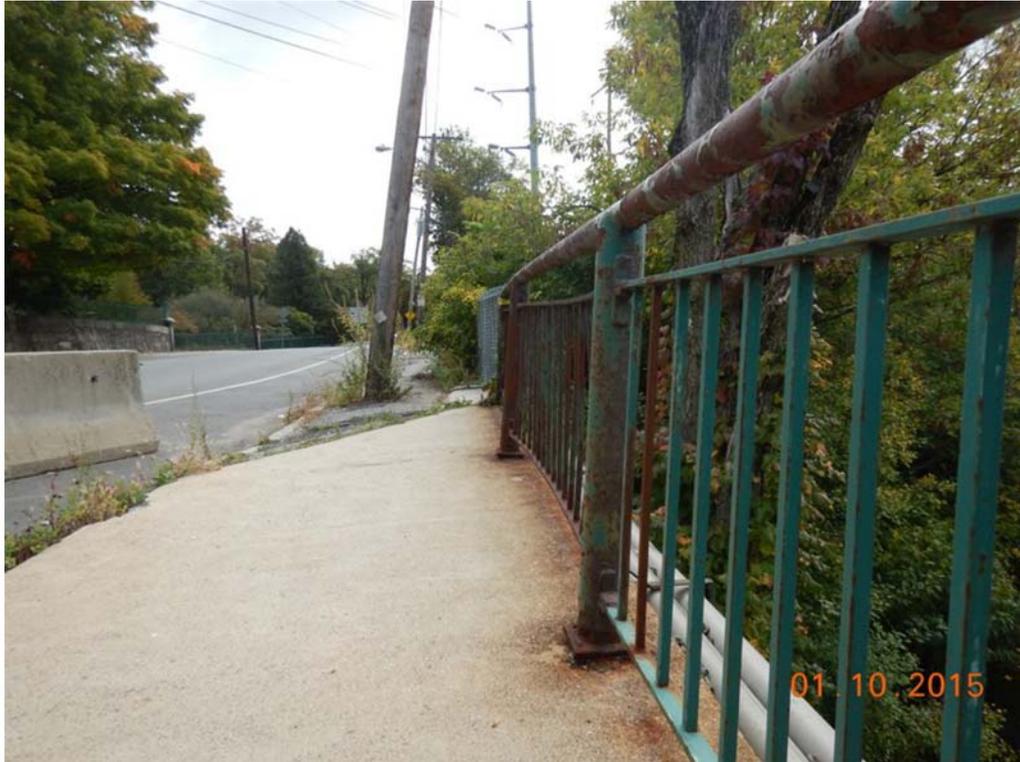
- First two panels adjacent to the East Abutment have limited capacity due to corroded connections, **see Photo 13.**
- 5% of the pickets exhibit impact damage at discrete locations along the railing, **see Photo 14.**
- Second post west of Pier 3 has failed, **see Photo 15.**

**Photo 13:** Southeast sidewalk at east abutment - damage railing panels and corroded post connections to sidewalk (2 sections)

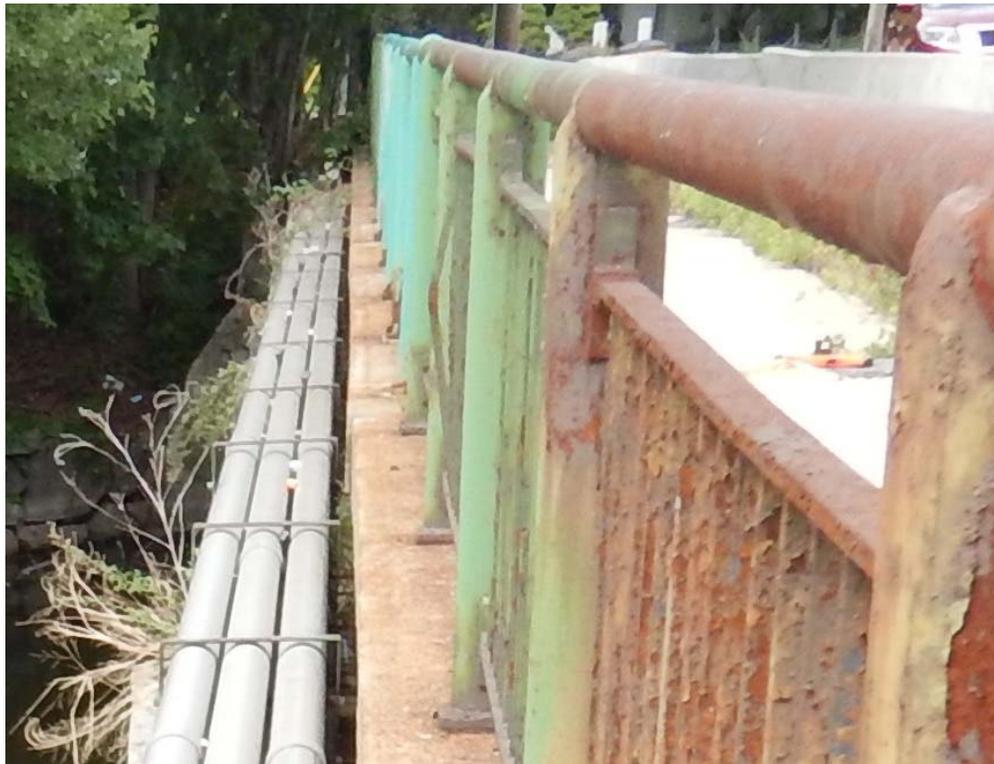
**Photo 14:** Typical picket impact damage

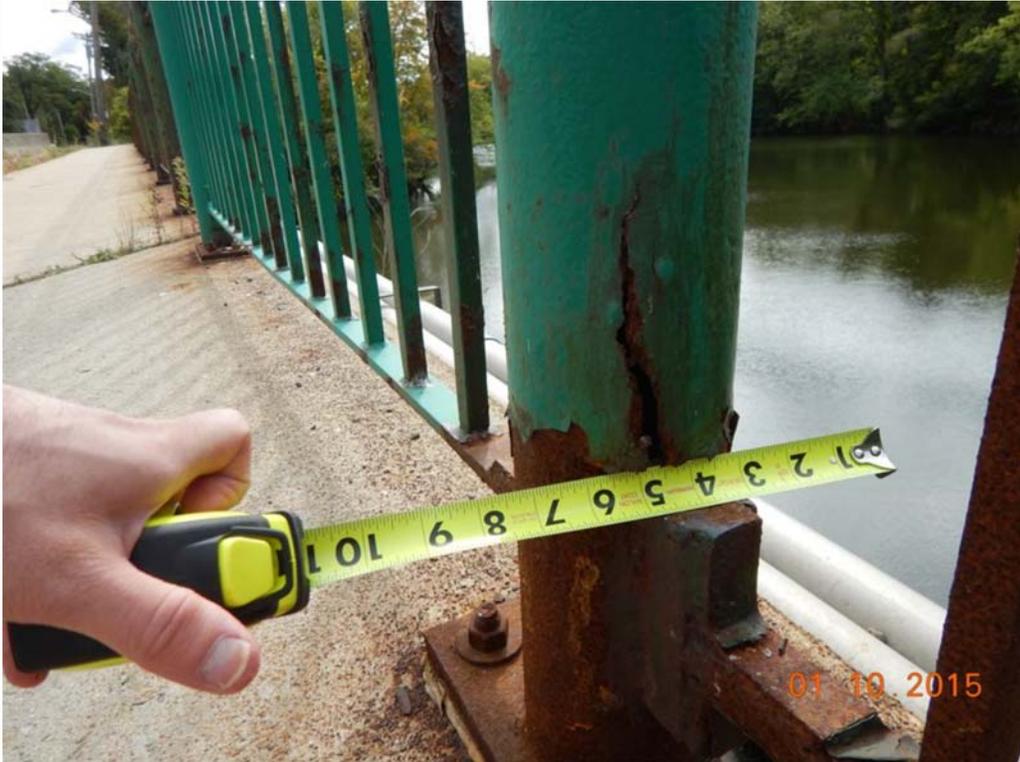
**Photo 15: Second post west of pier 3 - failed due to corrosion/section loss and split**

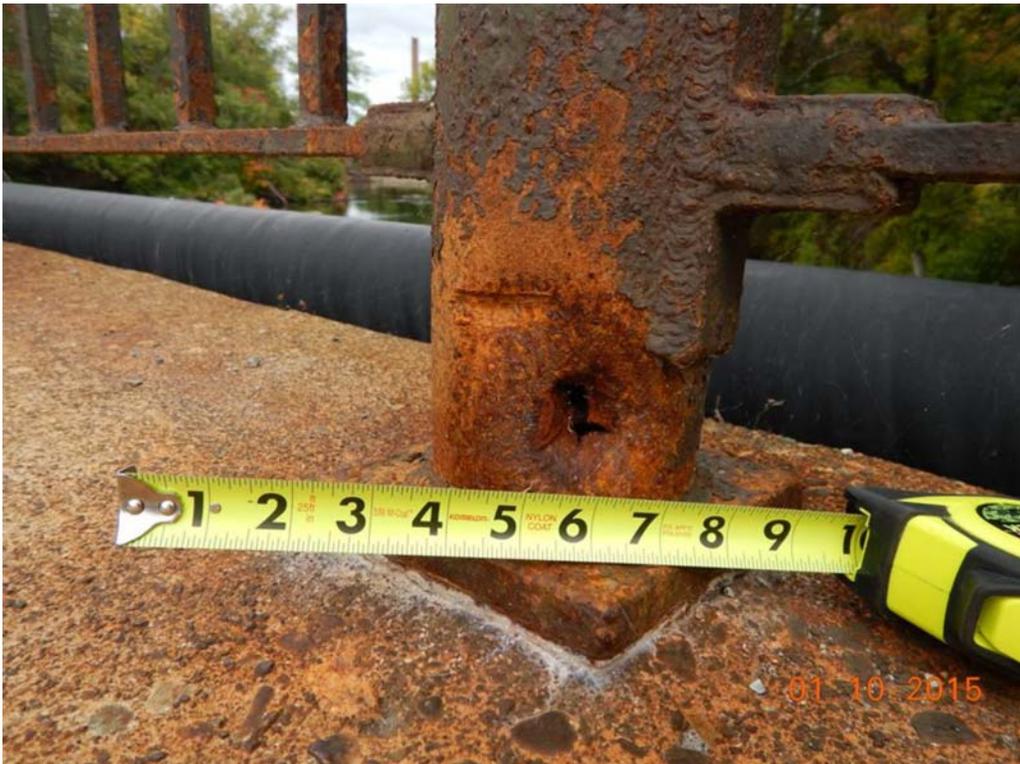
- Second post east of Pier 3 has failed, **see Photo 16.**

**Photo 16: Second north railing post east of pier 3 - failed due to corrosion/section loss**

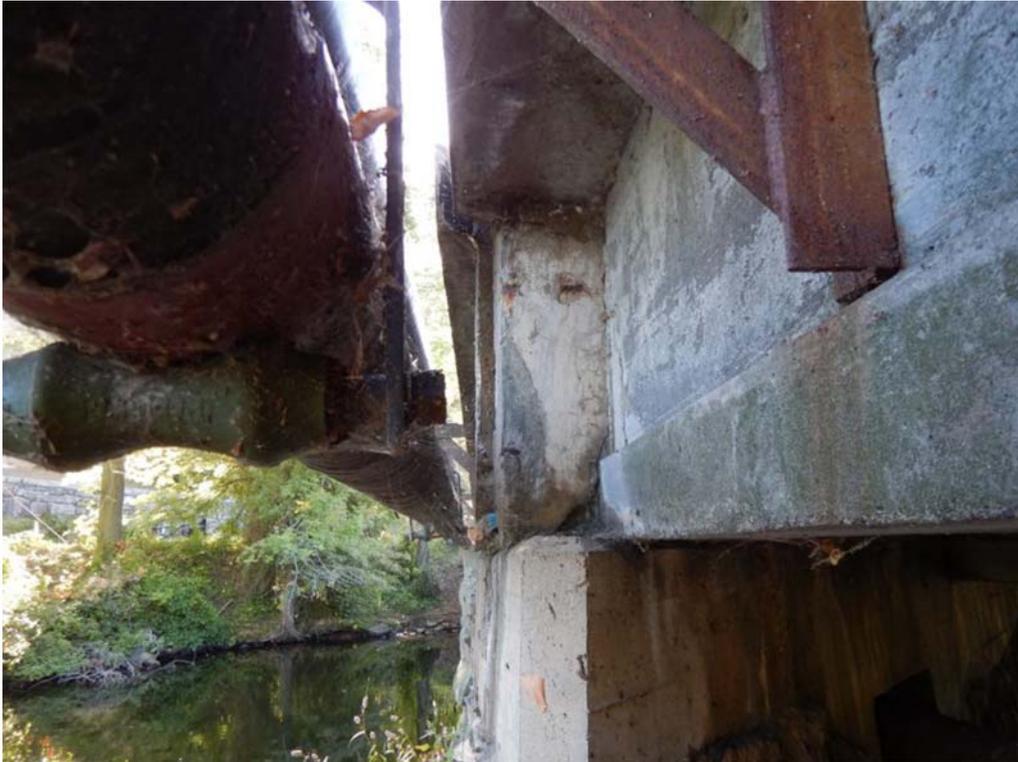
- The utility hangers and utility pipes have minor to moderate corrosion, **see Photo 17.**

Photo 17: Typical lower utility corrosion

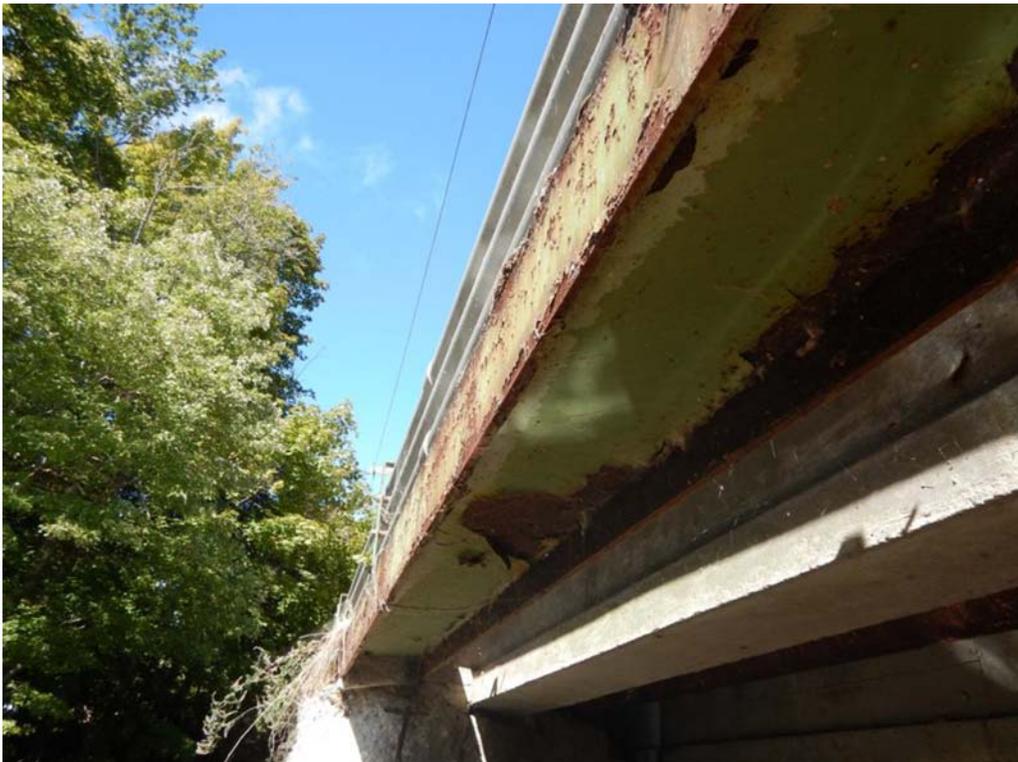
- The utility support has minor to moderate paint loss, **see Photo 18.**
- The plastic conduit at the West Abutment is broken open with a portion exposing interior utilities, **see Photo 19.**
- The utility pipe in Bay 1 at Pier 3 is severely corroded with 100% section loss, **see Photo 20.**

Photo 18: Typical south utility support paint loss

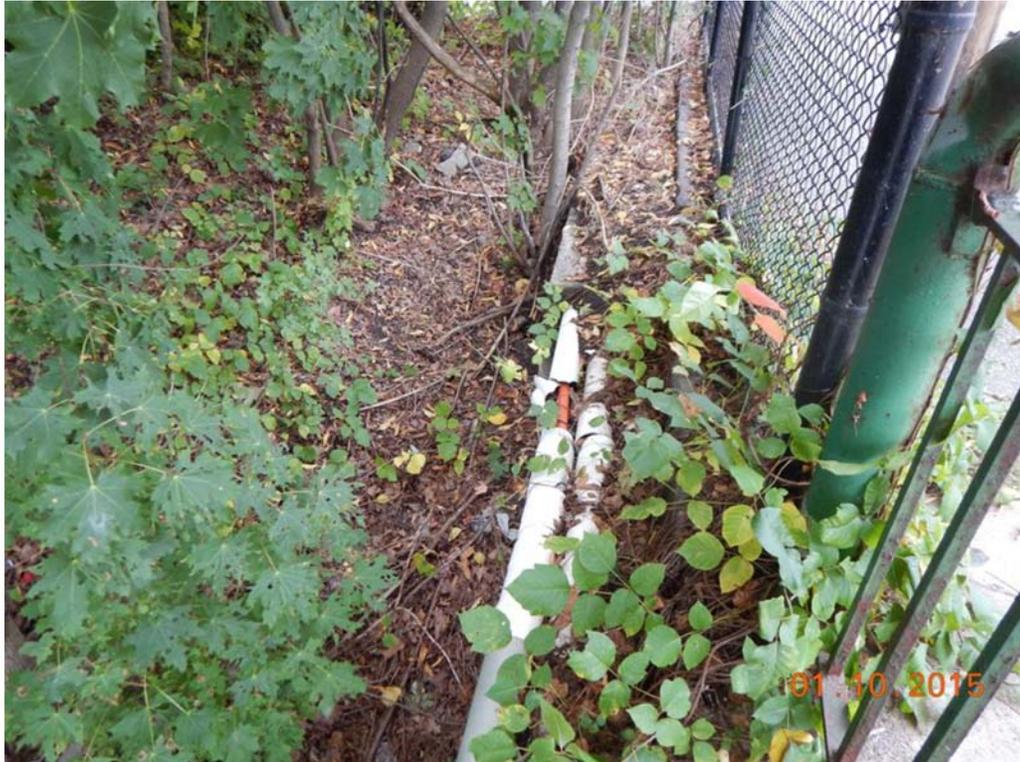
**Photo 19: South sidewalk at west abutment - Damaged plastic conduit**

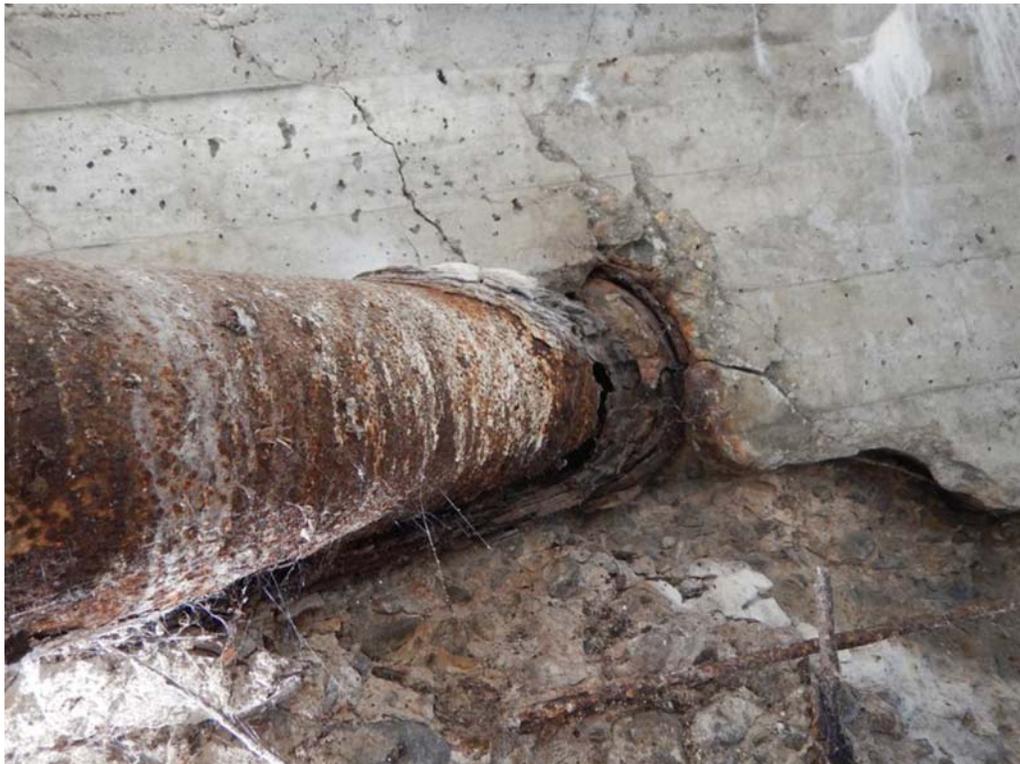
**Photo 20: Bay 1, Pier 3, south fascia - failed utility pipe due to corrosion/section loss**

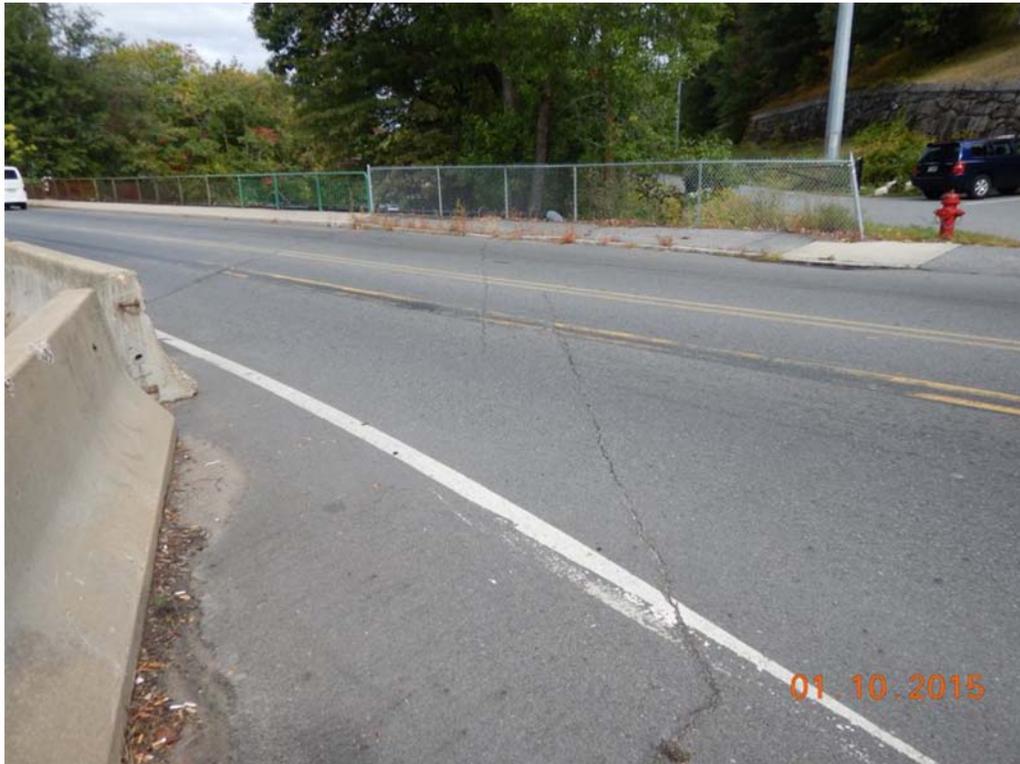
- East Approach - There are two 1/4" transverse cracks approximately 18" apart located approximately 18' east of the East Abutment, **see Photo 21.**
- West Approach - Approximately 30 sf of bituminous patching and approximately 25 sf of cracked/broken pavement adjacent to the north curb/abutment, **see Photo 22.**

**Photo 21: East Approach - Cracks approx. 18 feet from abutment**

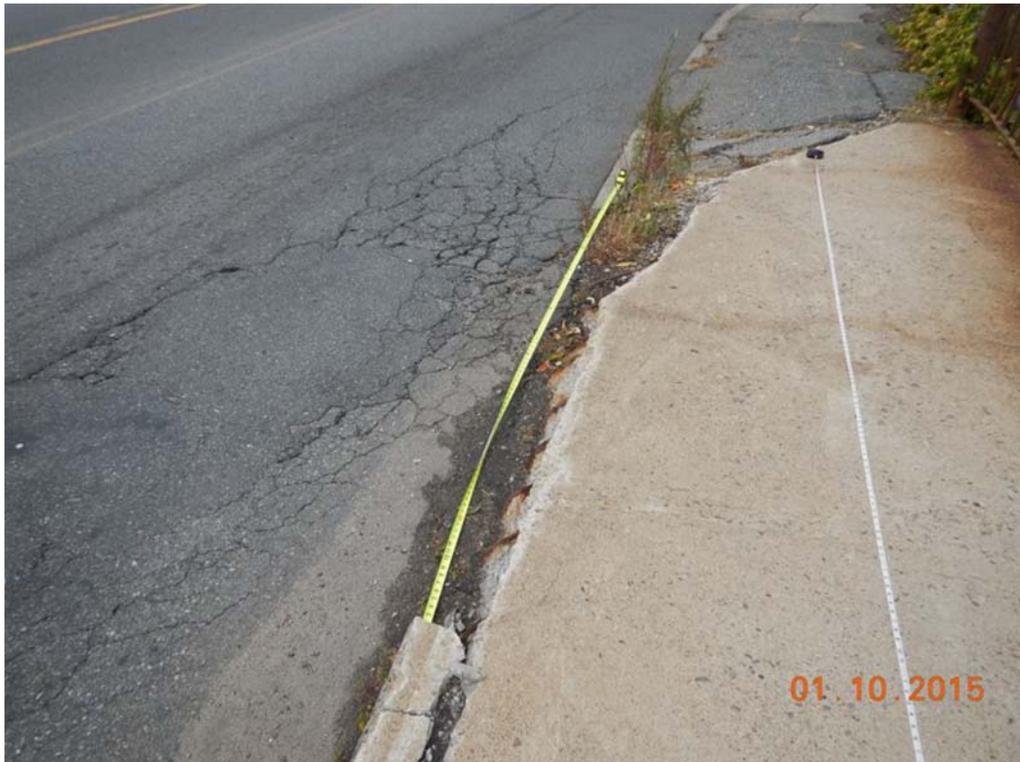
**Photo 22: West approach adjacent to north sidewalk - cracked wearing surface and patch repair**

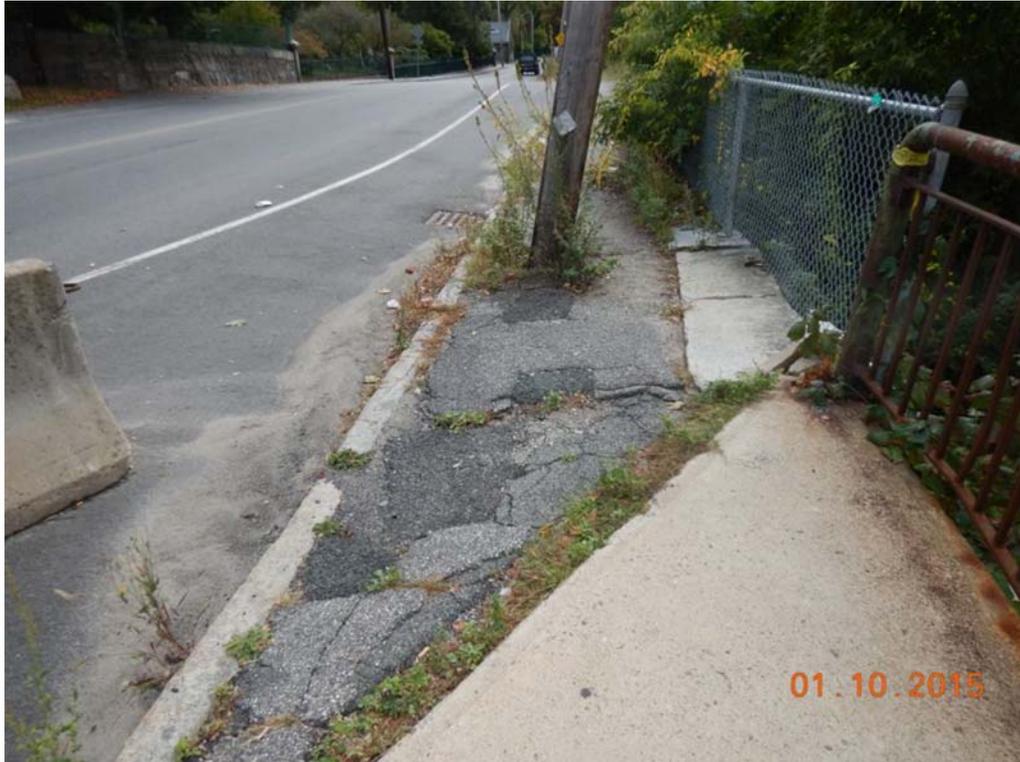
**Photo 23:** Southeast sidewalk approach - cracked/patched wearing surface and vegetation growth

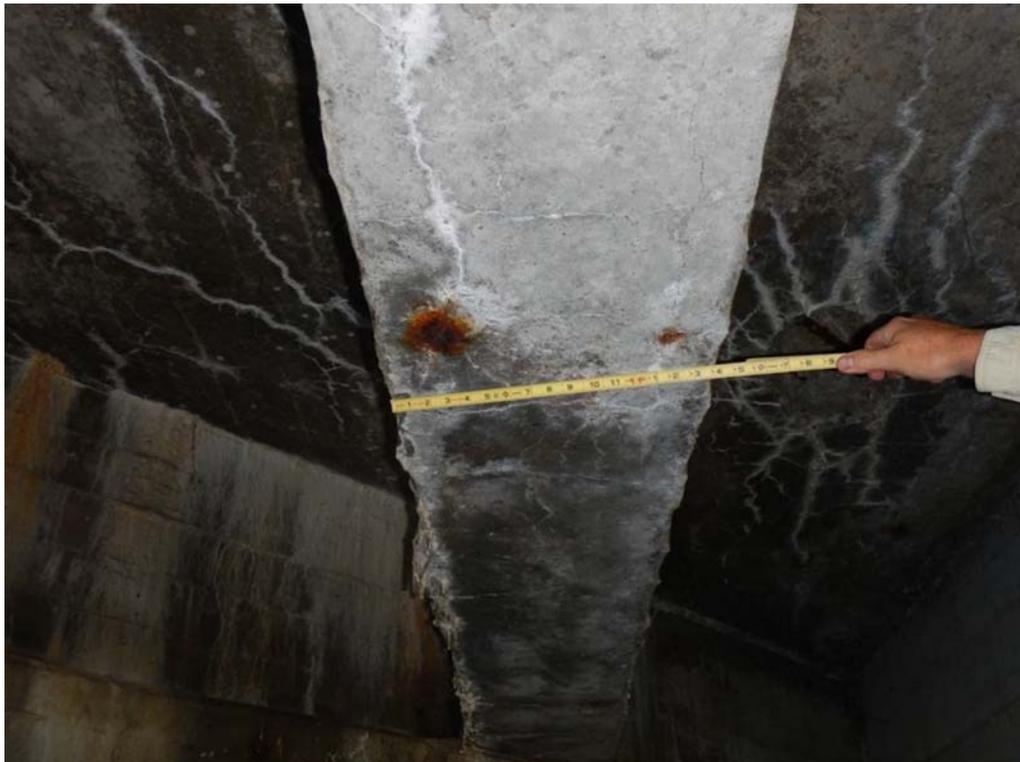
**Photo 24:** Span C, Beam 9 - typical bottom flange cracks with rust and efflorescence

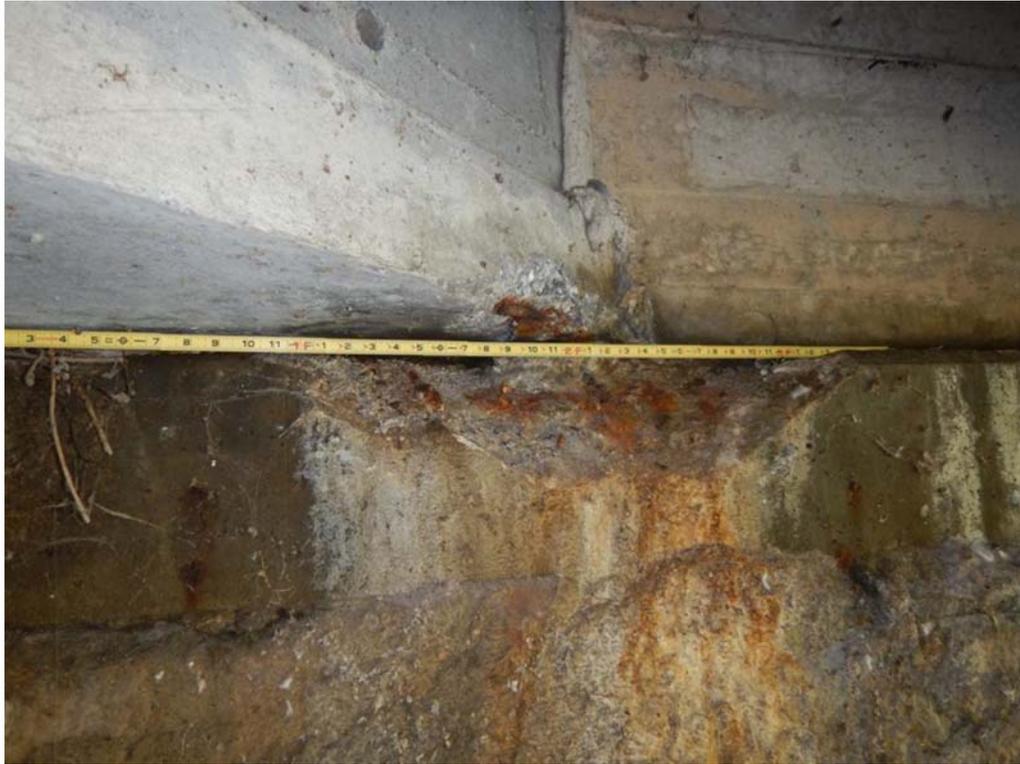
Photo 25: Span C, Beam 5, Pier 3 - bottom flange spall

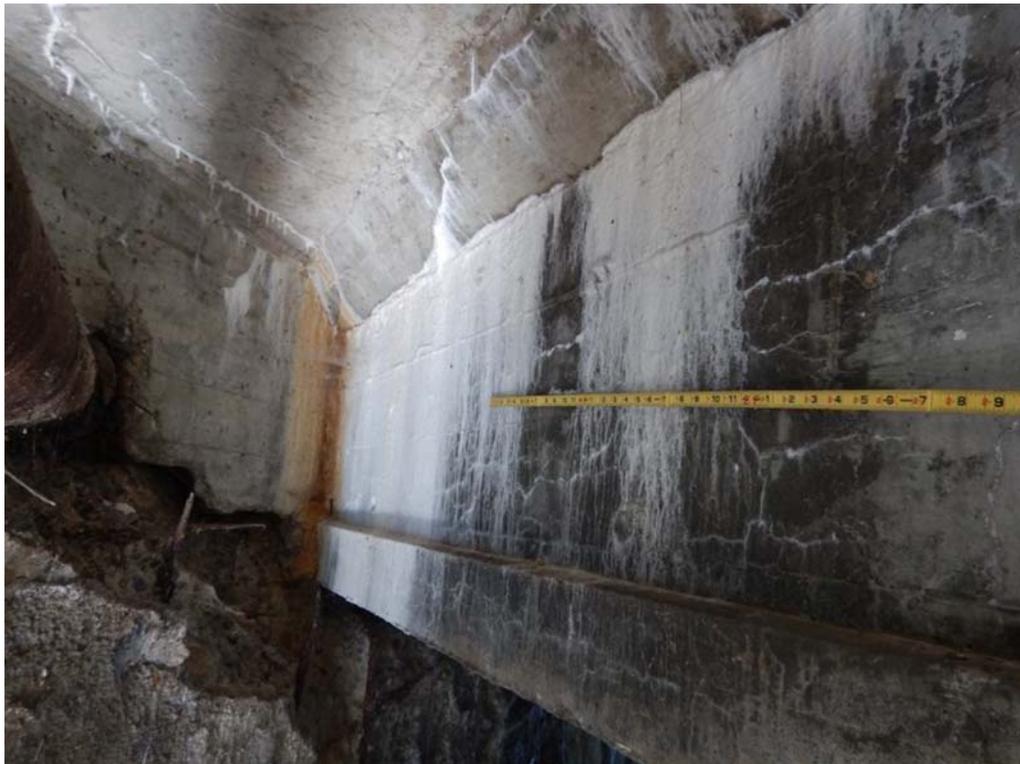
Photo 26: Span D, Beam 2, Pier 3 - Typical longitudinal beam haunch crack

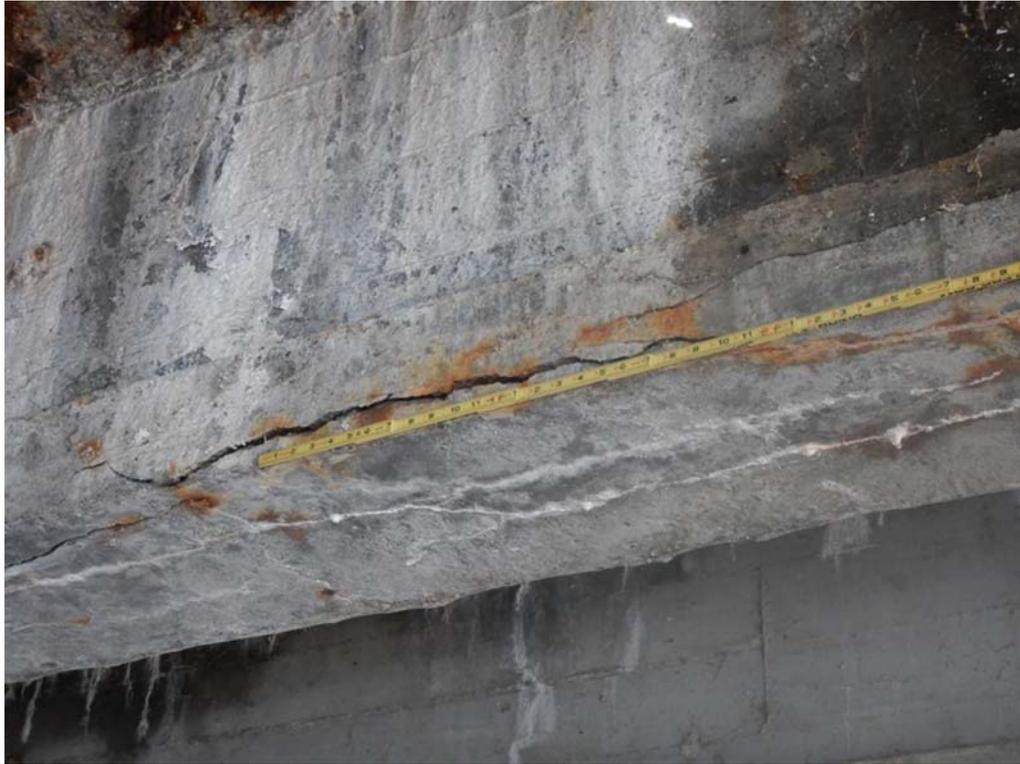
Photo 27: Span E, Beam 3 - 15 foot bottom flange delamination

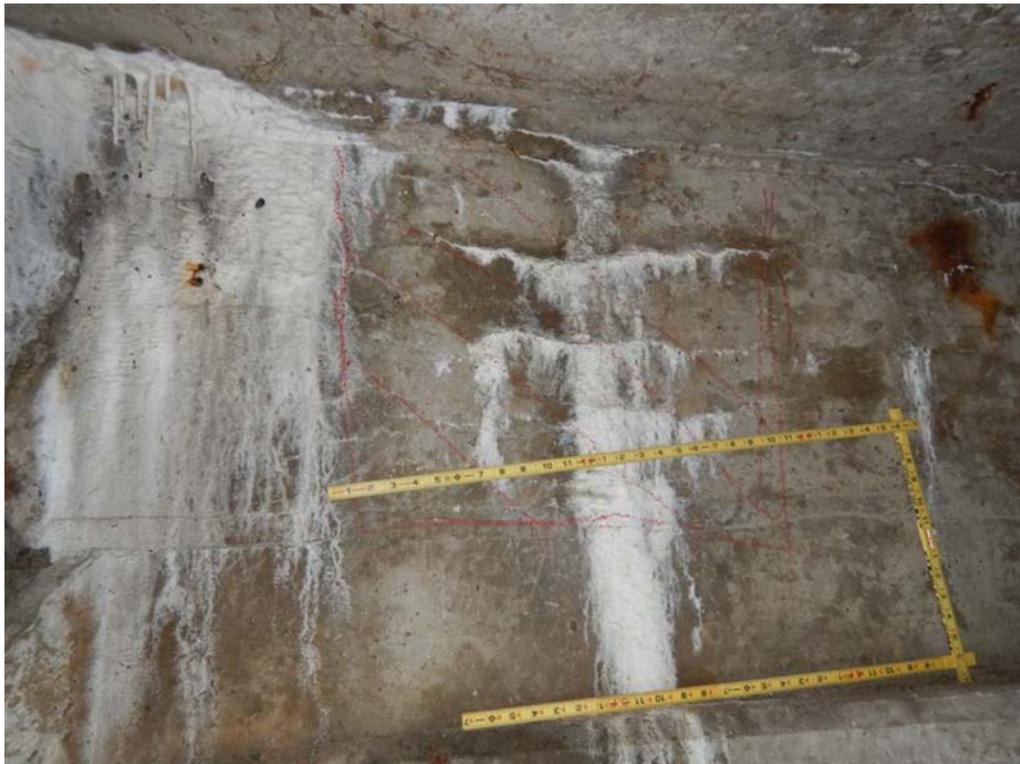
- Span D, Bay 3 at Pier 3 - Typical delamination with horizontal cracks and efflorescence buildup, **see Photo 28.**
- Span D, Bay 5 at Pier 3 - Spall, **see Photo 29.**
- Span F, Bay 7 at Beam 8 - Typical efflorescence buildup at beam interface, **see Photo 30.**

Photo 28: Span D, Bay 3, Pier 3 - Typical diaphragm delamination
