**STRUCTURES INSPECTION FIELD REPORT**

**ROUTINE & SPECIAL MEMBER INSPECTION**

B.I.N.  
**2BQ**

BR. DEPT. NO.  
**L-15-031**

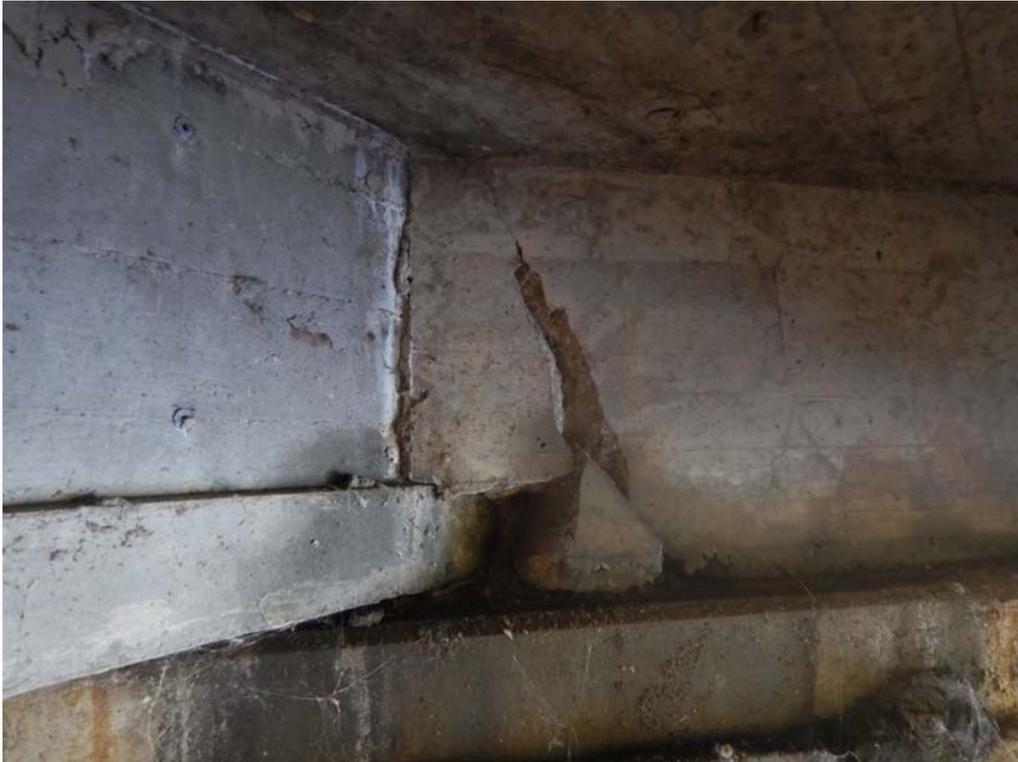
Photo 29: Span D, Bay 5, Pier 3 - Diaphragm spall

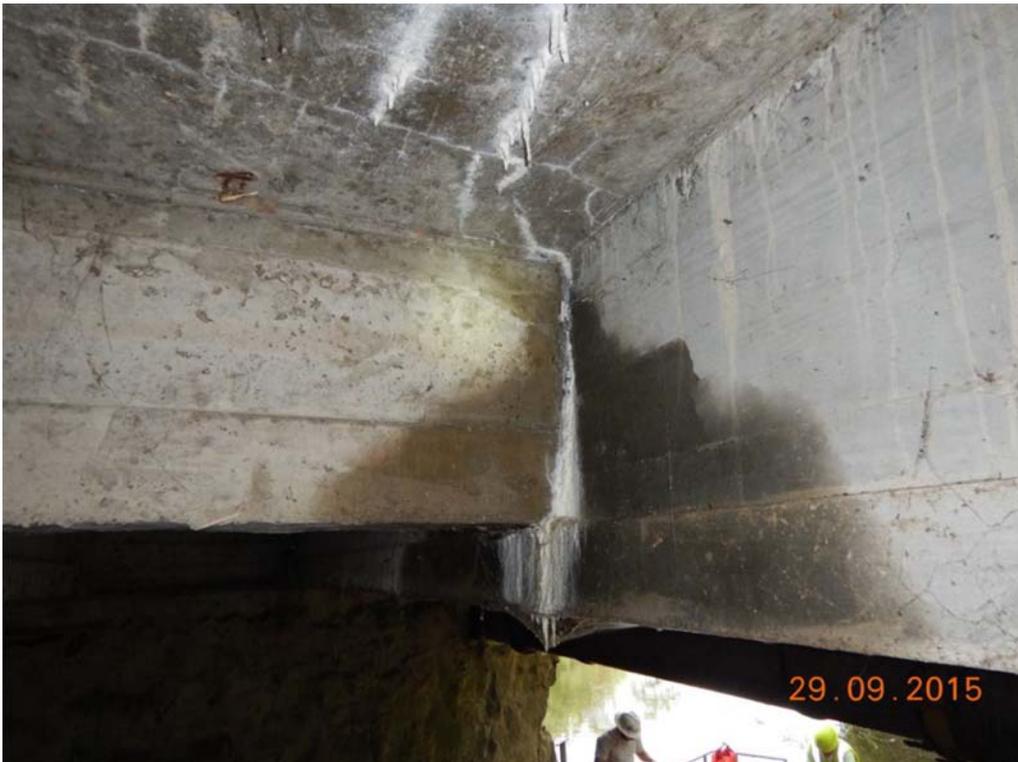
Photo 30: Span F, Bay 7, Beam 8 - Typical efflorescence at beam/diaphragm interface

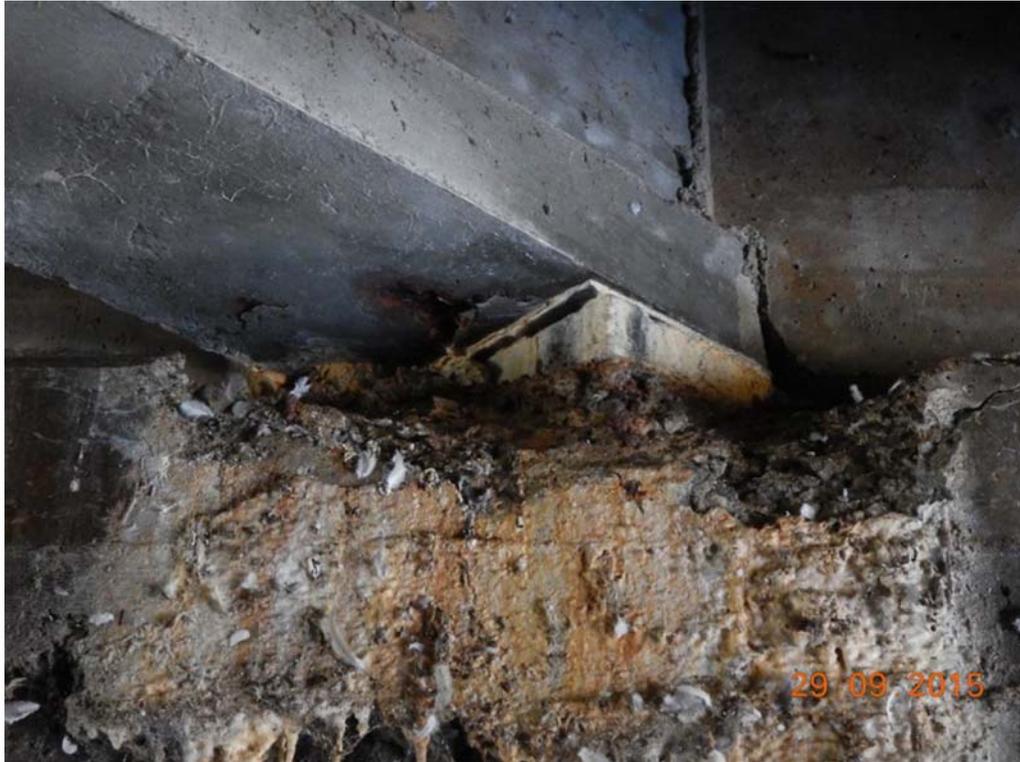
Photo 31: West Abutment, Beam 4 - spall/efflorescence

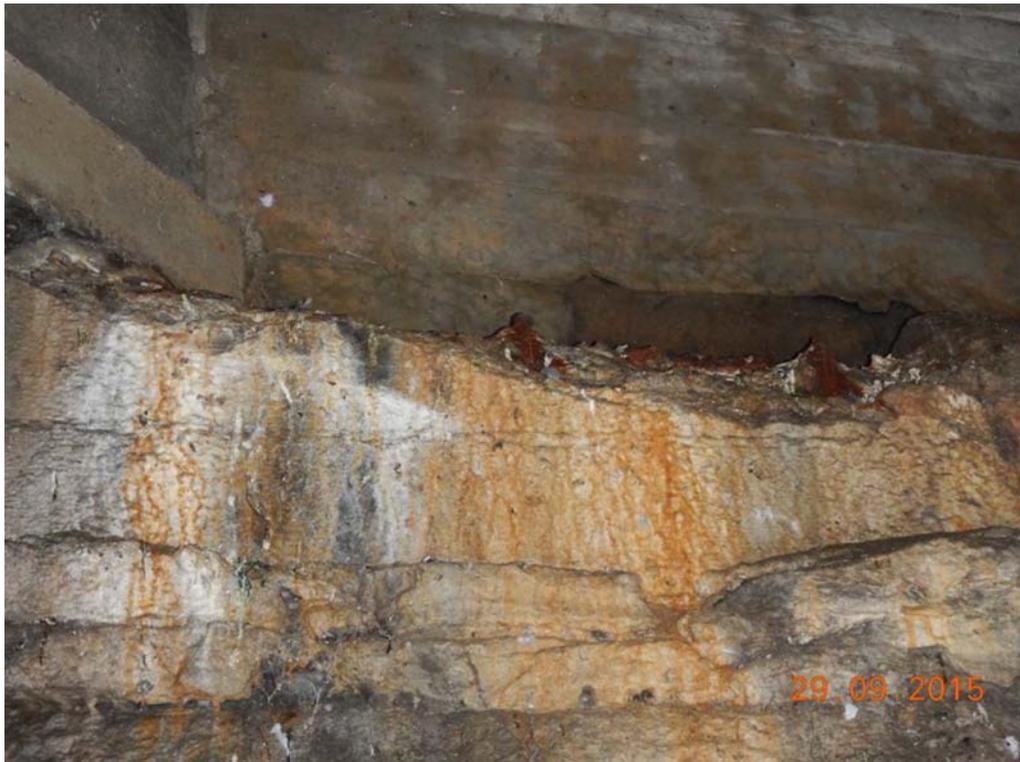
Photo 32: West Abutment, Bay 5 - spall with 2 exposed bars

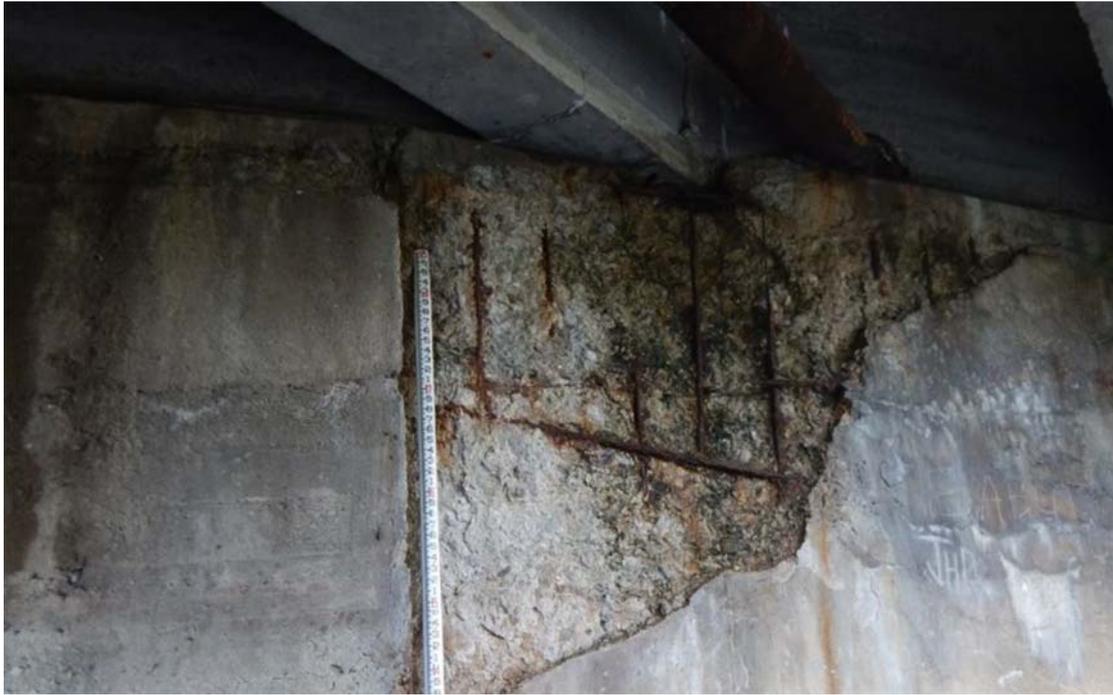
Photo 33: East Abutment, Beam 2 - spall with 9 exposed bars

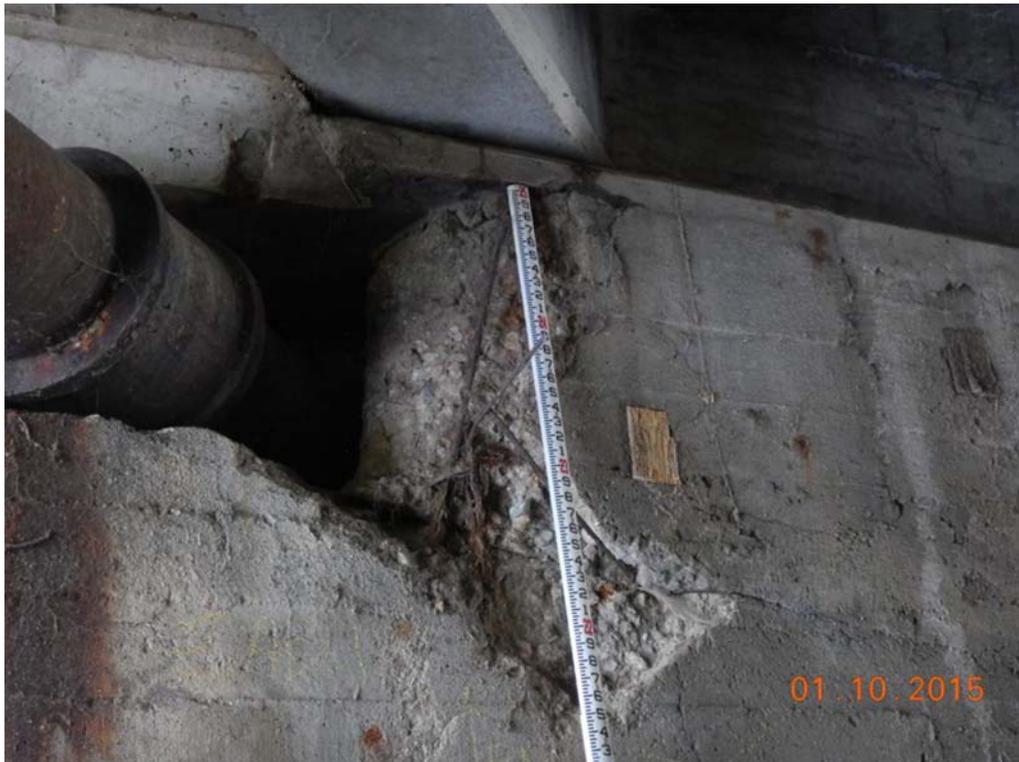
Photo 34: East Abutment, Beam 9 - spall with 3 exposed bars

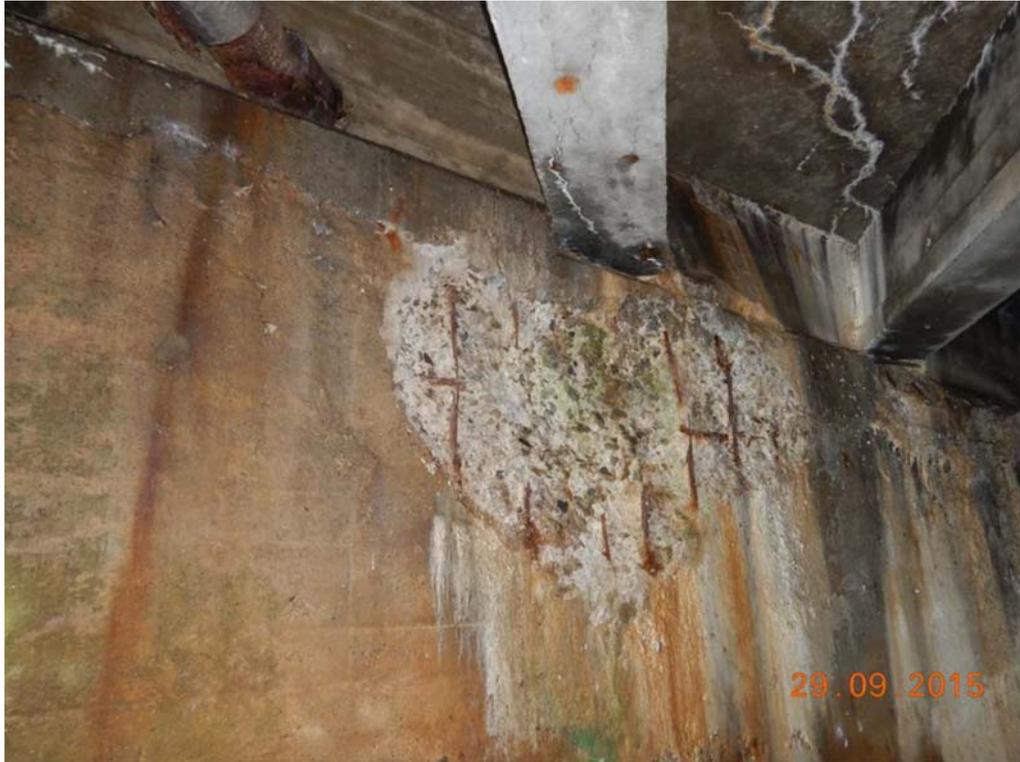
Photo 35: West Abutment, Beam 2 - spall with 9 exposed bars

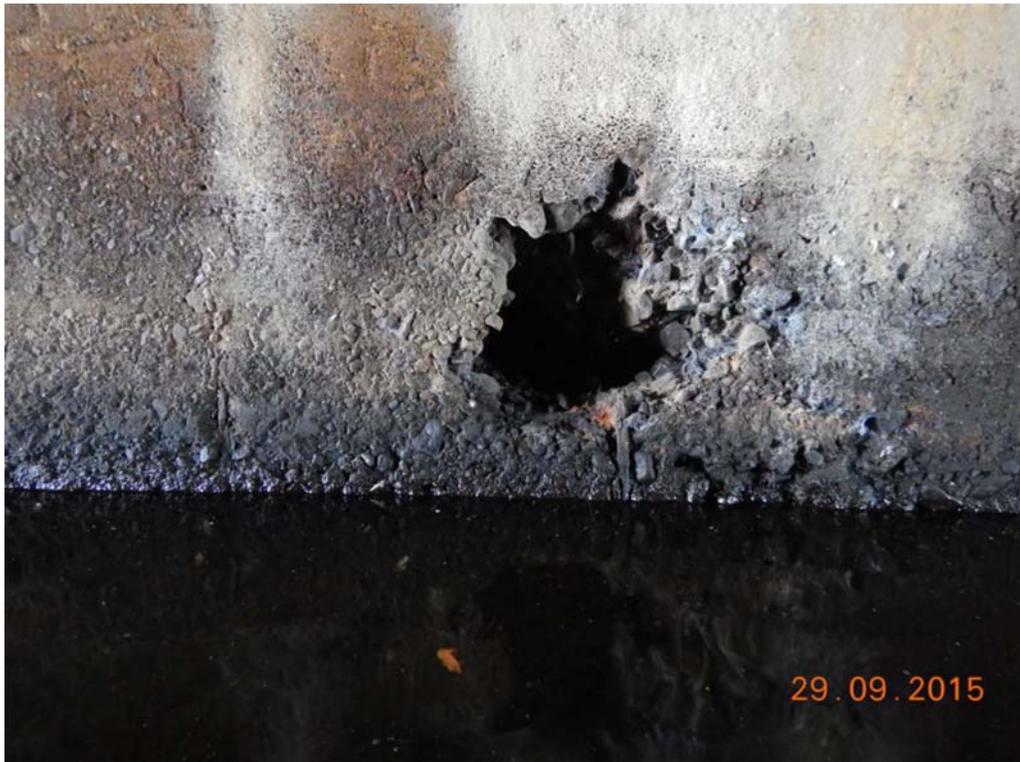
Photo 36: West Abutment, Beam 3 - void at waterline

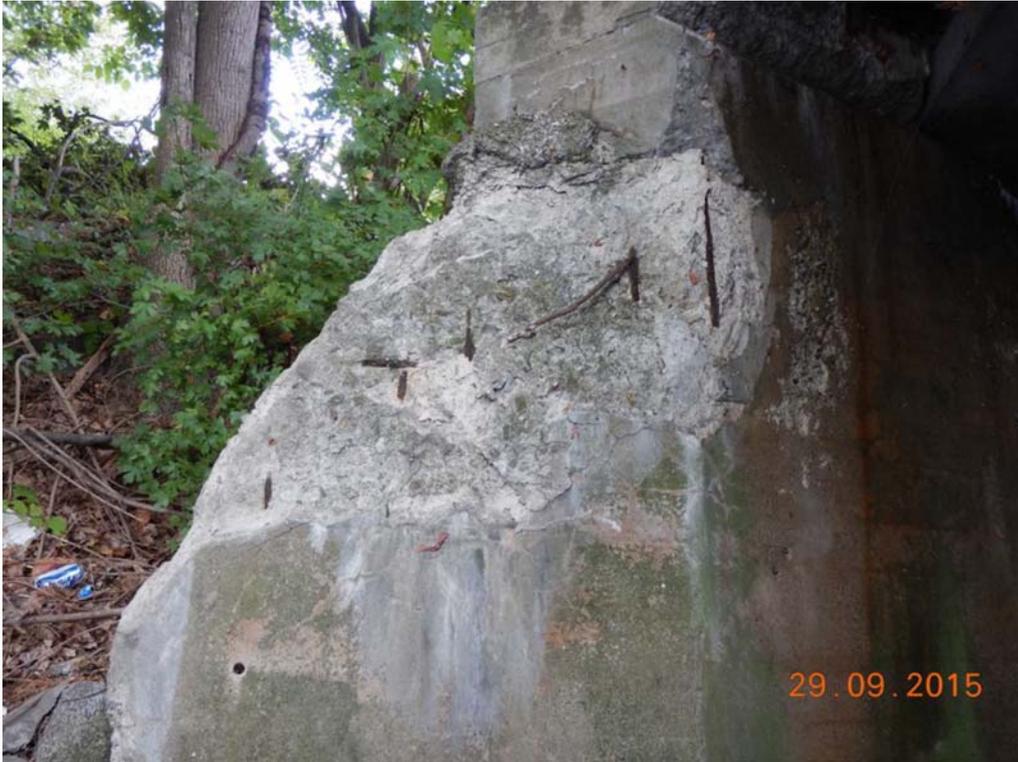
Photo 37: Southwest wingwall - spall with 7 exposed bars

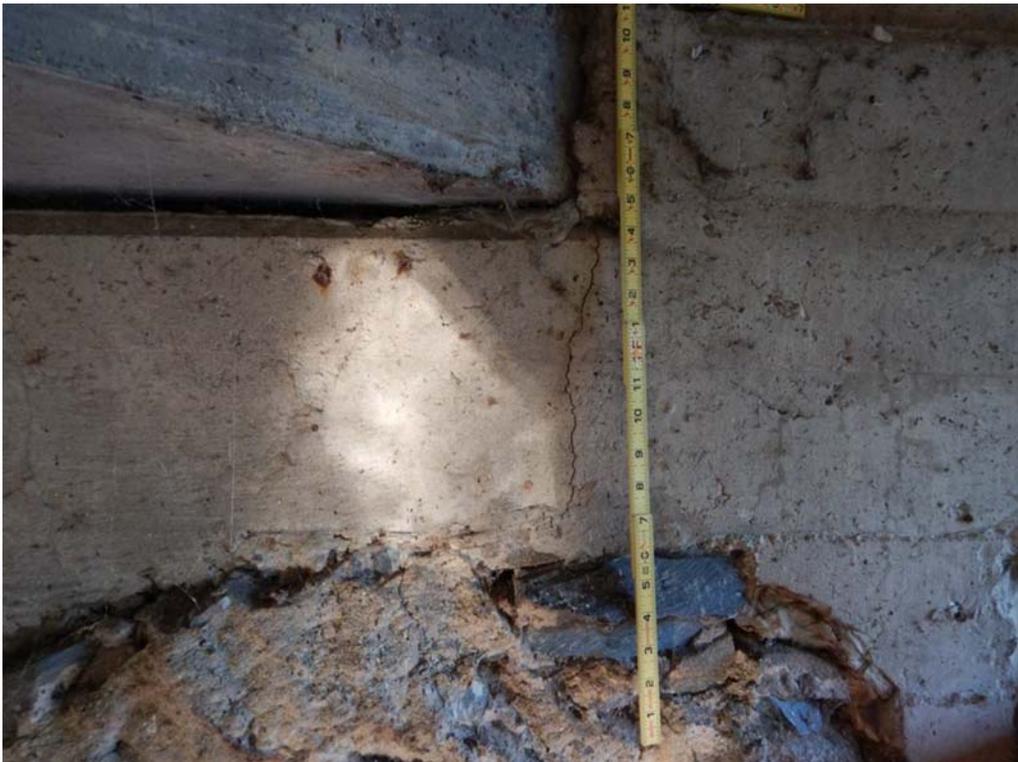
Photo 38: Pier 2, east face, Bay 9 - vertical crack in concrete cap

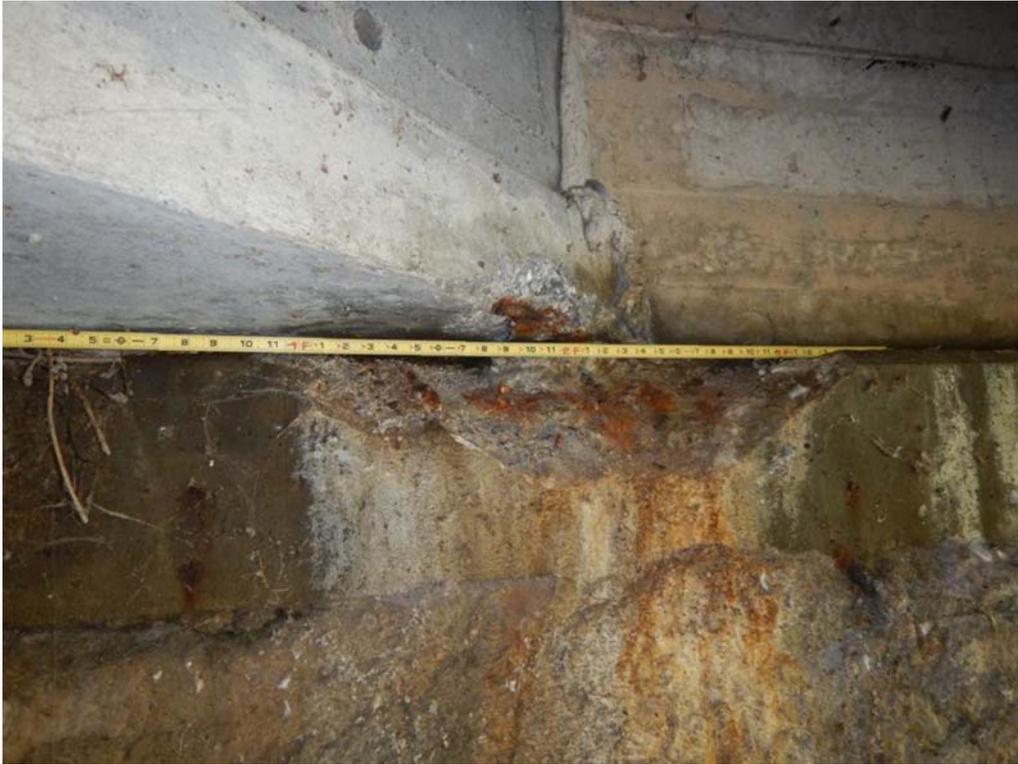
Photo 39: Pier 3, west face, Beam 5 - spall

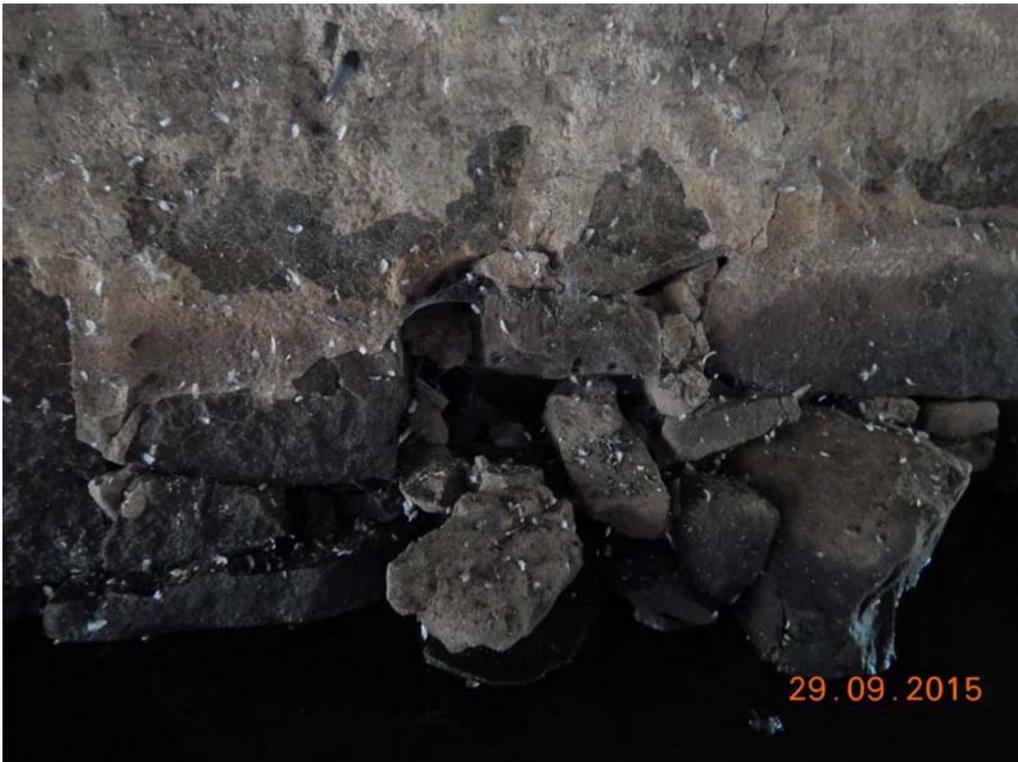
Photo 40: Pier 1, west face, Bay 9 - displaced stones at waterline

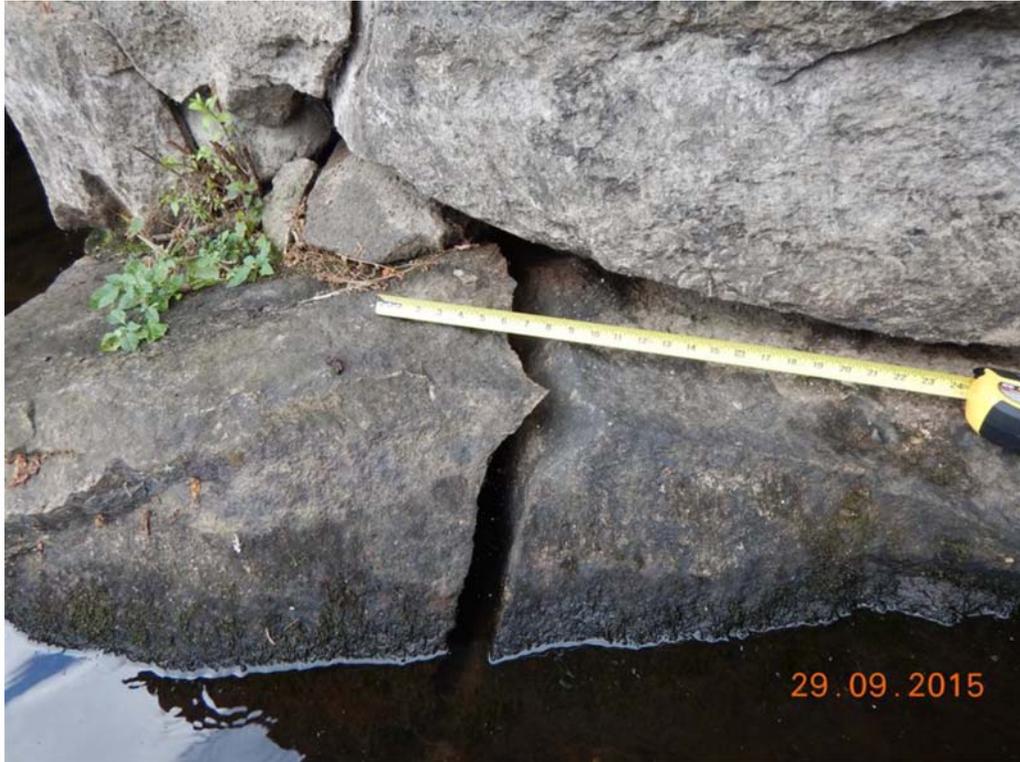
Photo 41: Pier 1, north nose - split stone

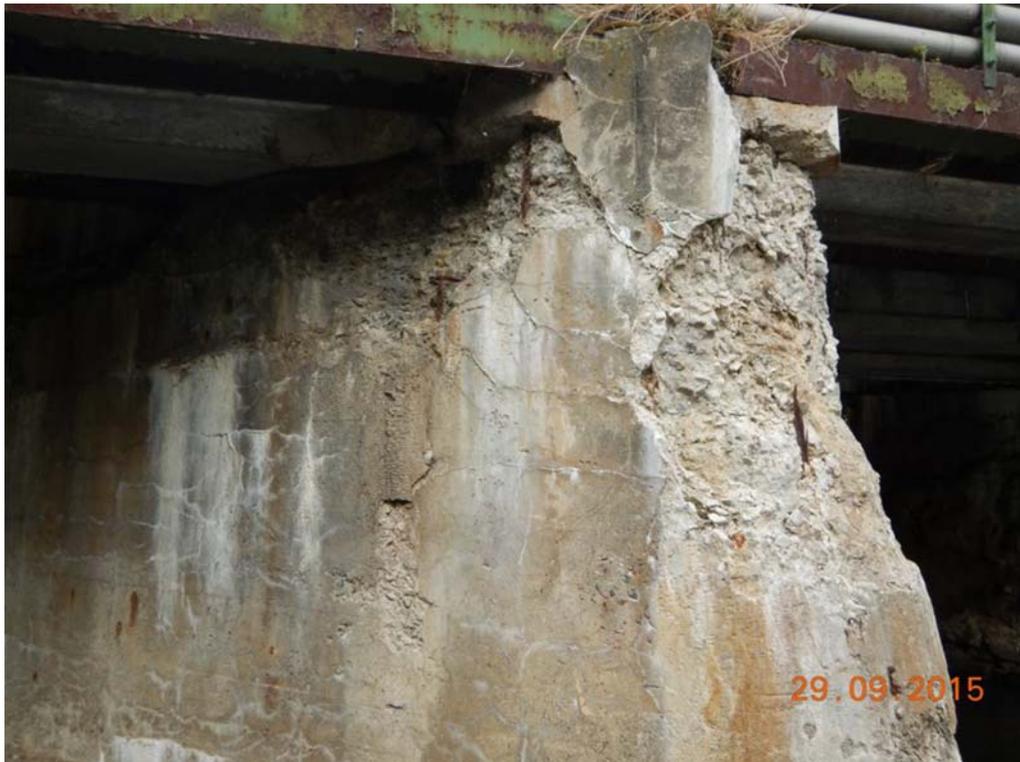
Photo 42: Pier 3, south nose - significant concrete spall/delamination

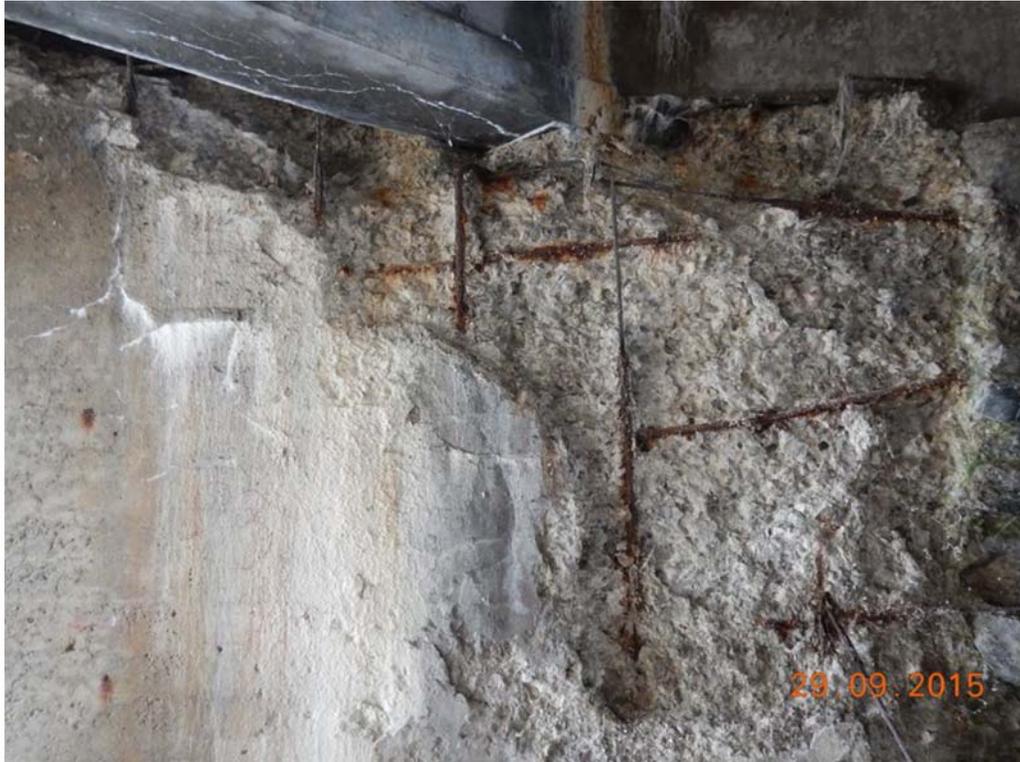
**Photo 43: Pier 3, south nose, Beam 3 - significant concrete spall/delamination with beam bearing undermining**
