# **VISUAL INSPECTION REPORT**

**LEO ROY PARKING GARAGE**

**100 MARKET STREET**

University of  
Massachusetts  
Lowell

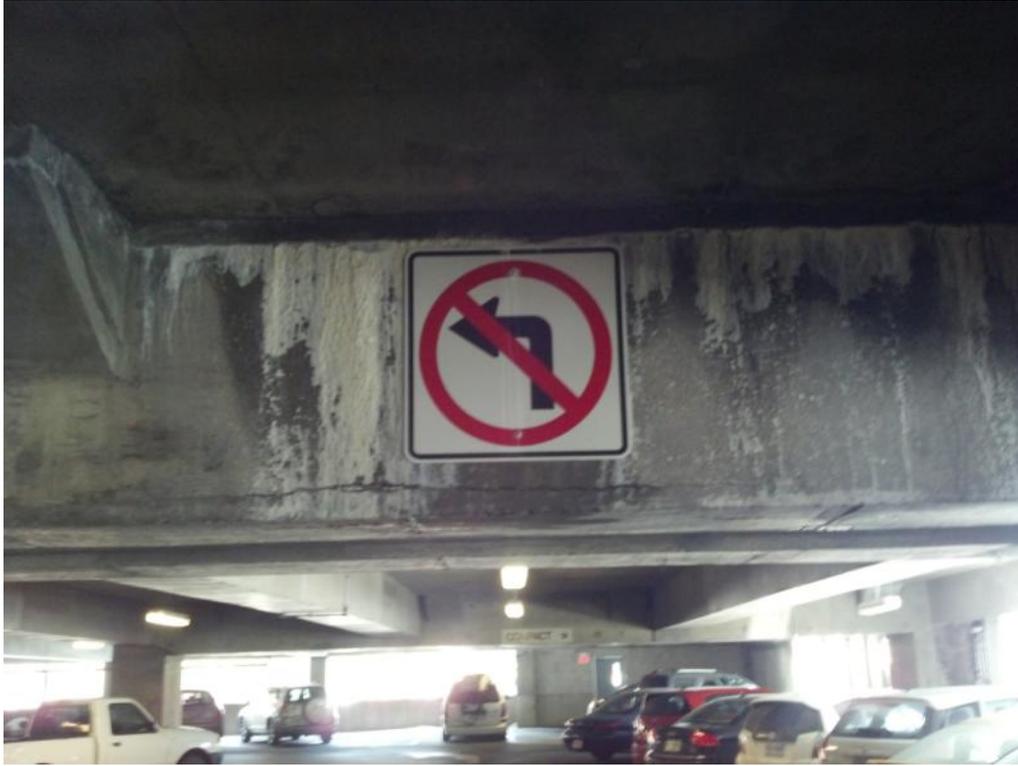
There is excessive amounts of leakage through the roof deck which causes efflorescence stain on the side surface of the beam. There are also minor longitudinal cracks on the lower side surface of the beam. **See Photo # 1.** This is typical problem on all four floors. The cross beam (column line G) between the entrance and up ramp shows a severe scaling with heavily corroded and exposed rebars at the bottom side of the beam. **See Photo #7.** The middle span (beam-10) shows excessive rust bleeding on the side surface due to the failure of the expansion joint sealant. **See typical Photo # 13.** This is a typical problem on the first four floors.

Photo 1: Efflorescence and leaching at cross beam K on 1<sup>st</sup> floor, typical

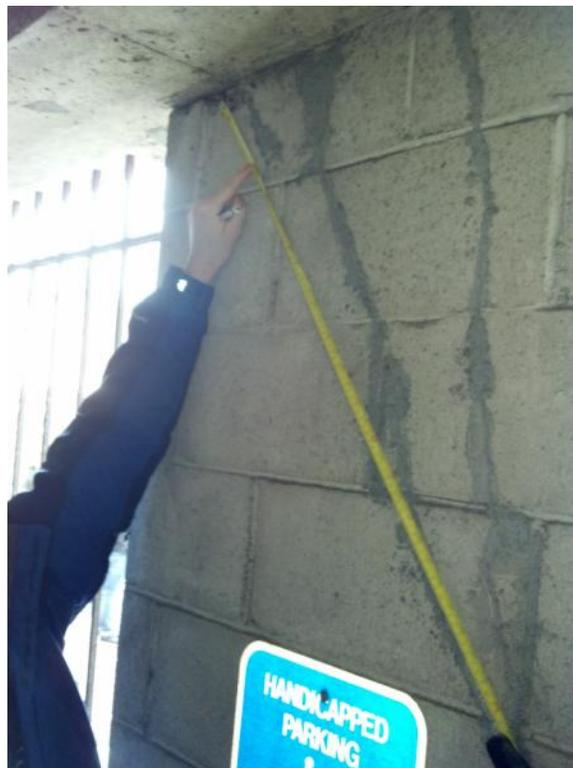
The exterior concrete masonry block wall located on the east side of the entrance facing north shows moderate diagonal 42 × 1/2" sealed cracks. This is not a structural wall and it was flagged as a minor defect. **See Photo #2.**

Photo 2: 42 inch by 1/2" sealed crack in concrete masonry block adjacent to 1<sup>st</sup> floor entrance

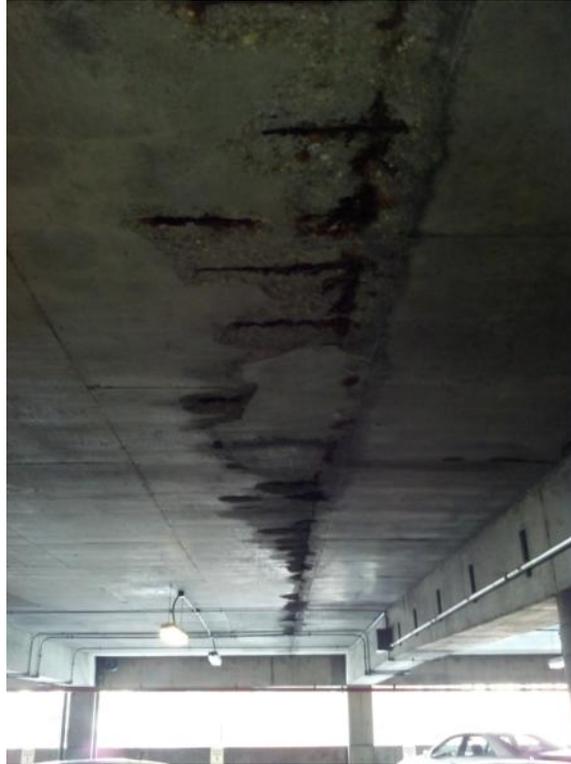
There is severe spalling with heavily corroded and exposed rebars between beam- 7 and beam-8. **See Photo #3.** This is a typical problem on the first four floors. There is also 10"× 10" severe spalling, with heavily corroded exposed rebars, and exposed electric cable between column R-8 and R-9. It also shows a saturated concrete surface on the ceiling which can be an indicator of first stage of concrete deterioration. **See Photo #4 and #12.** This is typical problem on the first four floors.

**Photo 3: Failed patch with spalling and exposed rebar, full width of structure between beams 7 and 8 on first floor, typical all floors.**

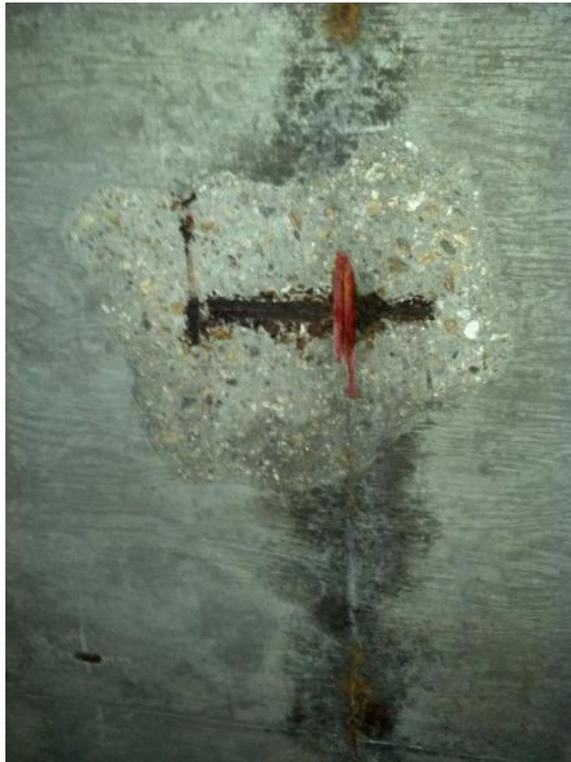
**Photo 4: 10" x 10" spall with exposed rebar and electrical cable in ceiling on 1<sup>st</sup> floor between columns R-8 and R-9.**

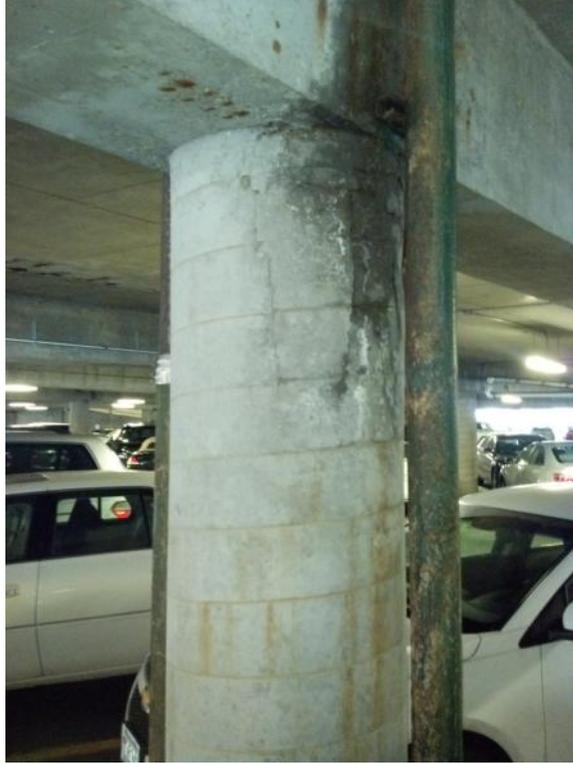
There are minor vertical cracks and minor efflorescence stains on the surface of column R-7 and G-3 due to the water leakage of the adjacent drain pipe. It also shows moderate rust bleeding on its surface. **See Photo #5 and #6.** Column E-10 shows an extensive ½" by full beam height diagonal crack right at the beam support. **See Photo #8.** There is also a spalling surface area with severely corroded and exposed joint rebars at the beam support of column E-10. This was flagged as a critical issue and should be repaired as soon as possible before conditions deteriorate further. **See Photo # 9**

**Photo 5: Deterioration of column R-7 adjacent to leaking drain pipe on 1<sup>st</sup> floor.**

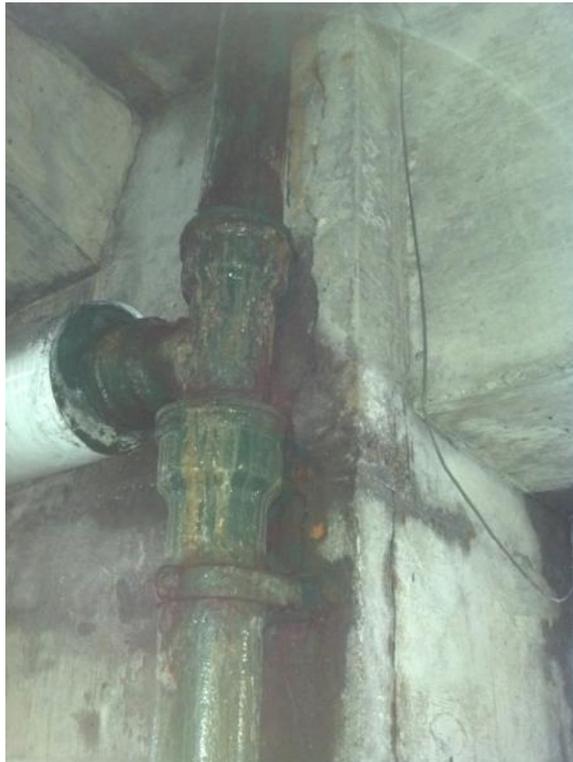
**Photo 6: Cracking of concrete adjacent to leaking drain pipe at column G-3 on 1<sup>st</sup> floor**

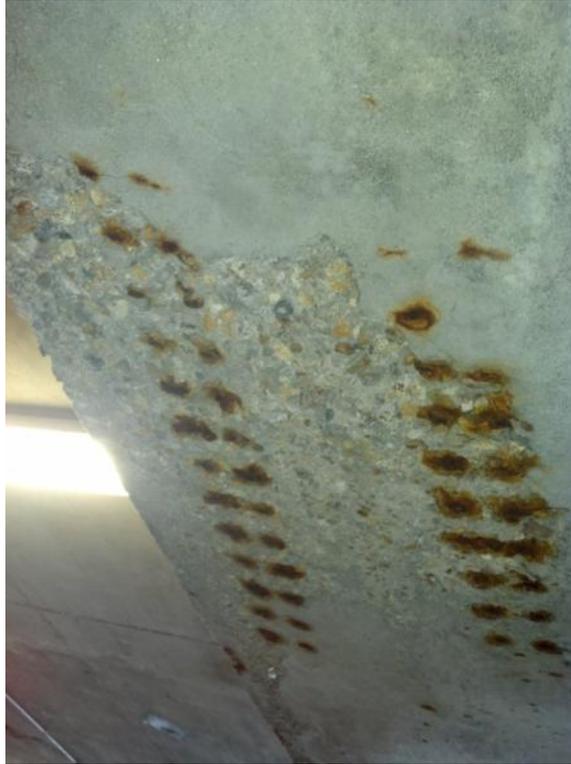
**Photo 7: Severe scaling with exposed reinforcement in cross beam (column line G) between entrance and up ramp on 1<sup>st</sup> floor.**

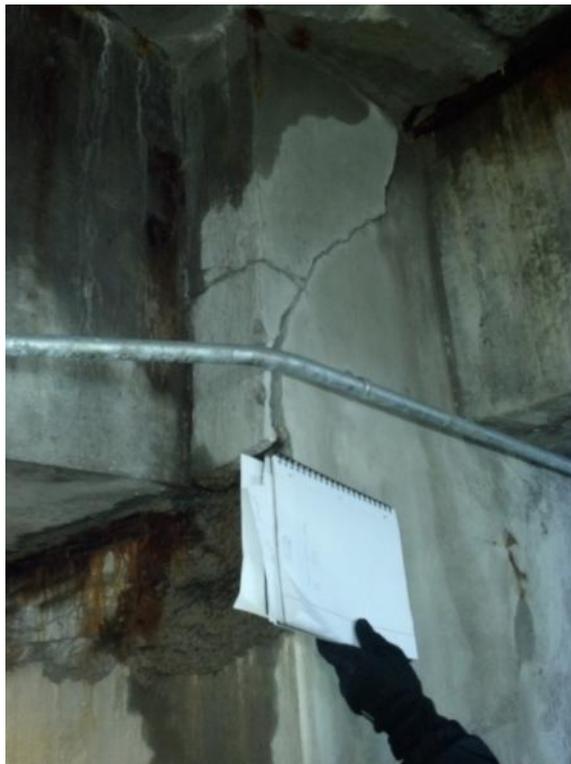
**Photo 8: ½" by full beam height crack with spalling of beam support at column E-10, 1<sup>st</sup> floor.**

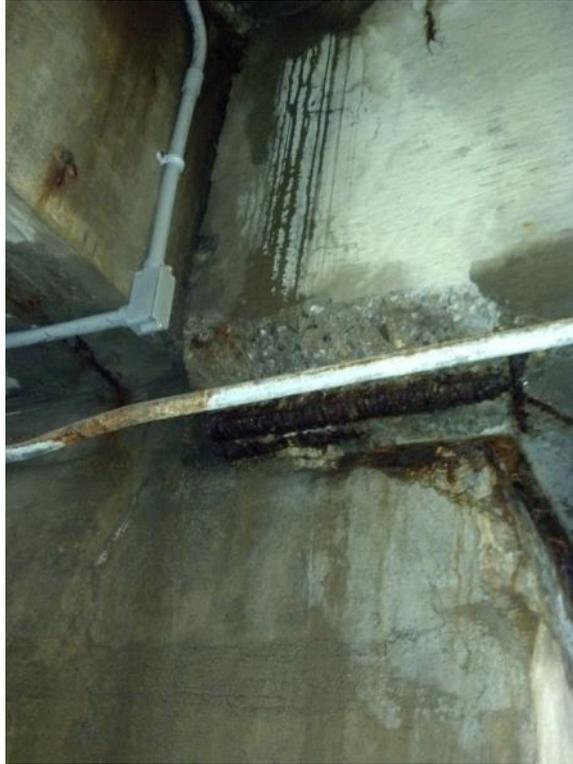
Photo 9: Spalling with exposed rebar at beam support at column E-10, 1<sup>st</sup> floor.

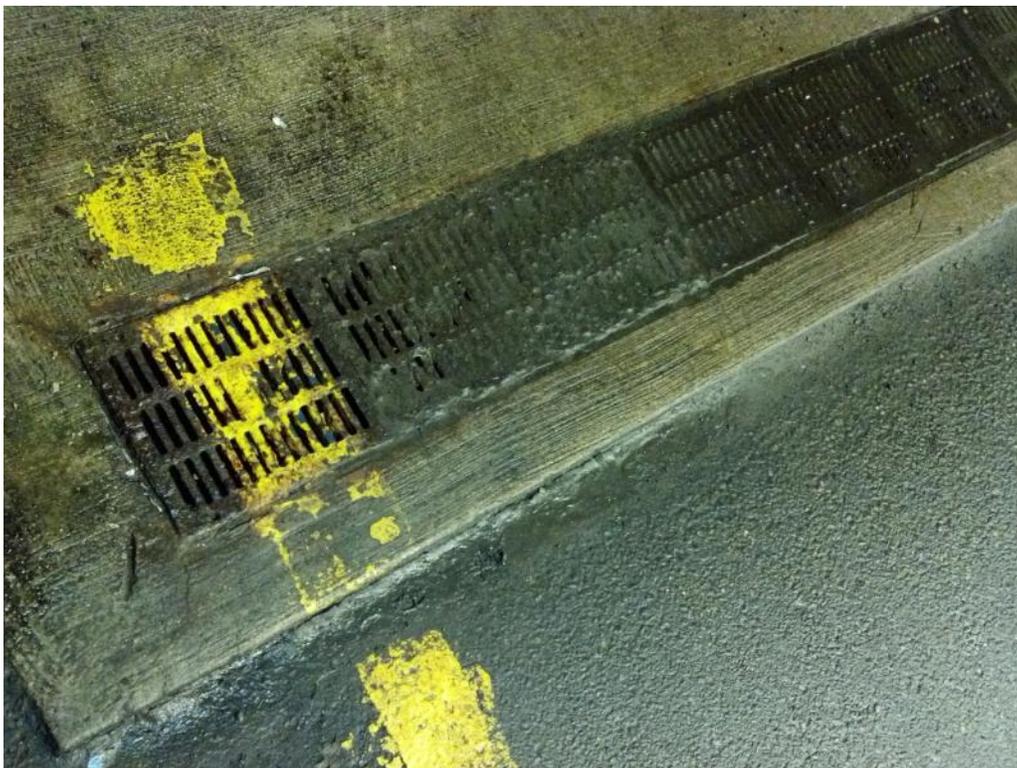
The existing drainage at the bottom of the up ramp is partially clogged by concrete thus limiting its full functionality. This problem can cause puddle of water. This is typical of all drains throughout the structure. **See Photo # 10.** There is large area of heavy leakage through the joint around the drainage pipe and the slab decks. The joints also show moderate to extensive rust. **See photo #5, #6 and #19.**

Photo 10: Clogged drain at bottom of 1<sup>st</sup> floor up ramp. Typical all drains on all floors.

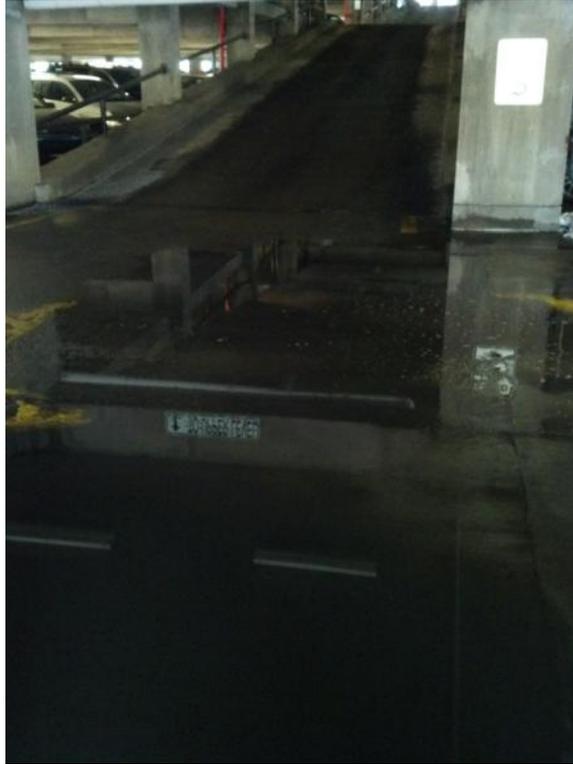
At the bottom of the down ramp, which is the expansion joint of the floor deck, there is heavy ponding of water; this puddle can cause water leakage and consequently may lead to corrosion of rebars and also deterioration of concrete. **See Photo # 11.** This is a typical problem on 3<sup>rd</sup> and 4<sup>th</sup> floor.

Photo 11: Standing puddle at bottom of down ramp on 2<sup>nd</sup> floor

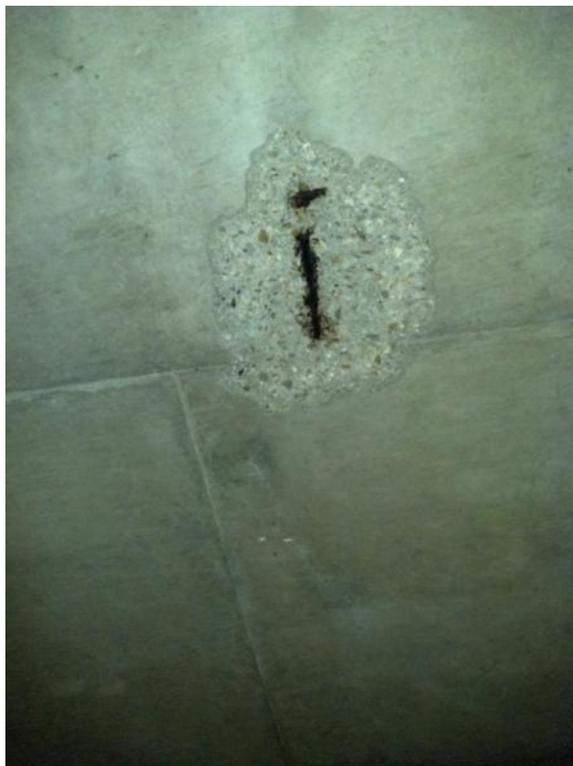
The ceiling adjacent to column K-10 shows a 12" × 15" deep spalling surface area with heavily corroded and exposed rebars on the ceiling. **See Photo 12.** . There is extensive rust bleeding through the expansion joint of the deck to the side face of the middle span beam. There is also part of the expansion joint sealant, or the water proof membrane, hanging out on the side of the middle span beam. **See Photo #13.** This is a typical problem on 3rd and 4th floor. For additional remarks see ceiling remarks of first floor.

Photo 12: 12"x15" spall with exposed rebar on 2<sup>nd</sup> floor adjacent to column K-10, typical on floors 1-4

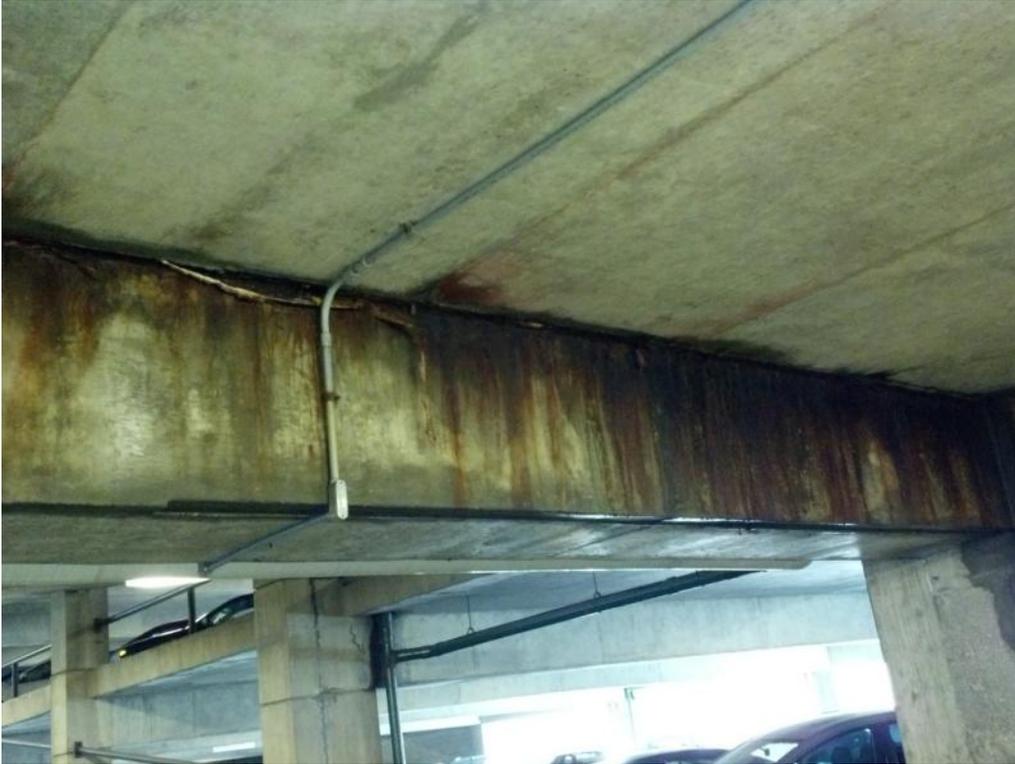
Photo 13: Failure of expansion joint and leaking at beam 10 on 2<sup>nd</sup> floor, typical all floors.

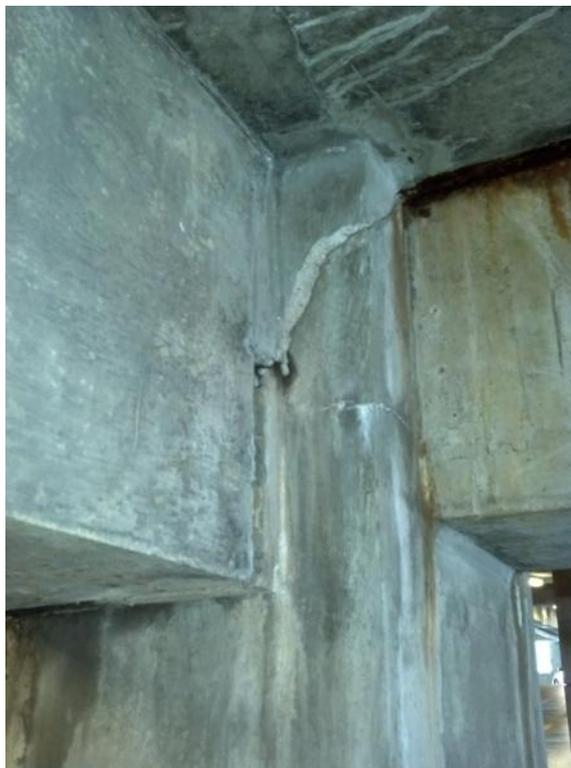
Column E-10 shows an extensive 1" width by half beam height diagonal crack on the beam support. **See Photo # 14.**

Photo 14: Half beam height x 1" W crack at beam support at column E-10, 2<sup>nd</sup> floor.

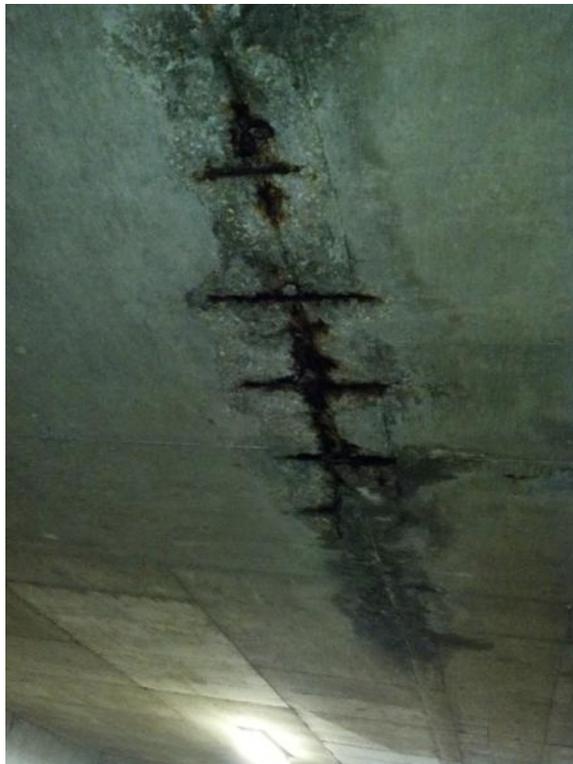
The ceiling between column K-5 and K-6 shows 18"×10" deep spalling with heavily corroded and exposed rebars. It also shows a saturated concrete surface on the ceiling which can be an indicator of concrete deterioration. **See Photo #15.** For additional remarks see ceiling remarks of first floor.

Photo 15: 18" W x ~10' L spall with exposed rebar in ceiling between columns K-5 and K-6, 3<sup>rd</sup> floor.

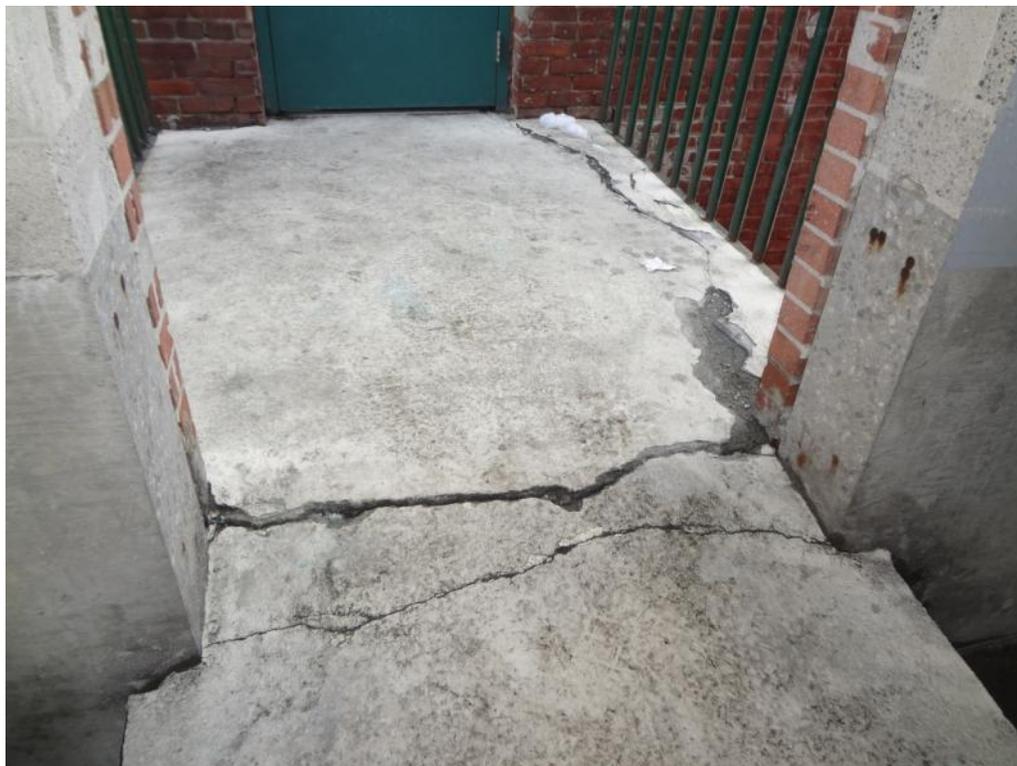
There are severe cracks at the connection of the pedestrian bridge to the parking garage. Cracking in the concrete surface of the bridge should be monitored and/or repaired. **See photo #16.** For additional remarks see floor slab remarks of second floor.

Photo 16: Full width by 1" cracking in 4<sup>th</sup> floor pedestrian foot bridge

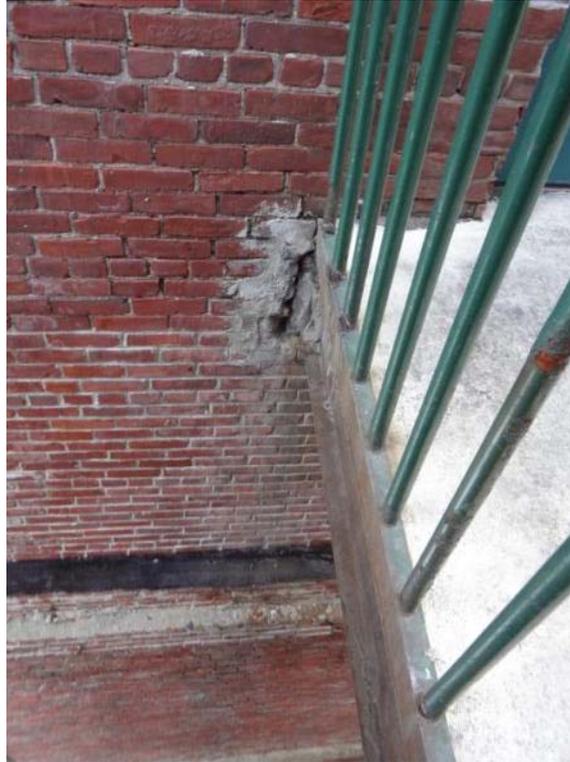
There is a severe deterioration on the steel beam support of the pedestrian bridge. There is also a wide gap between the connection of the steel beam support and the brick wall. **See Photo #17.** For additional remarks see beam remarks of first floor.

Photo 17: Deterioration of steel beam support connection on 4<sup>th</sup> floor pedestrian bridge

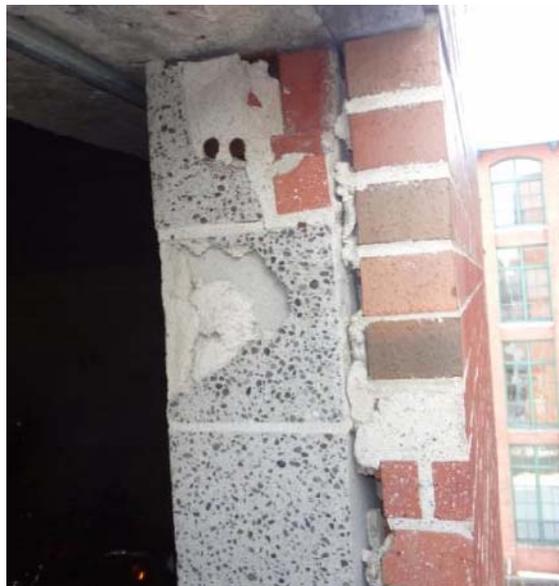
Photo 18: Incomplete connection of brick facing to concrete masonry blocks at 4<sup>th</sup> floor pedestrian bridge.

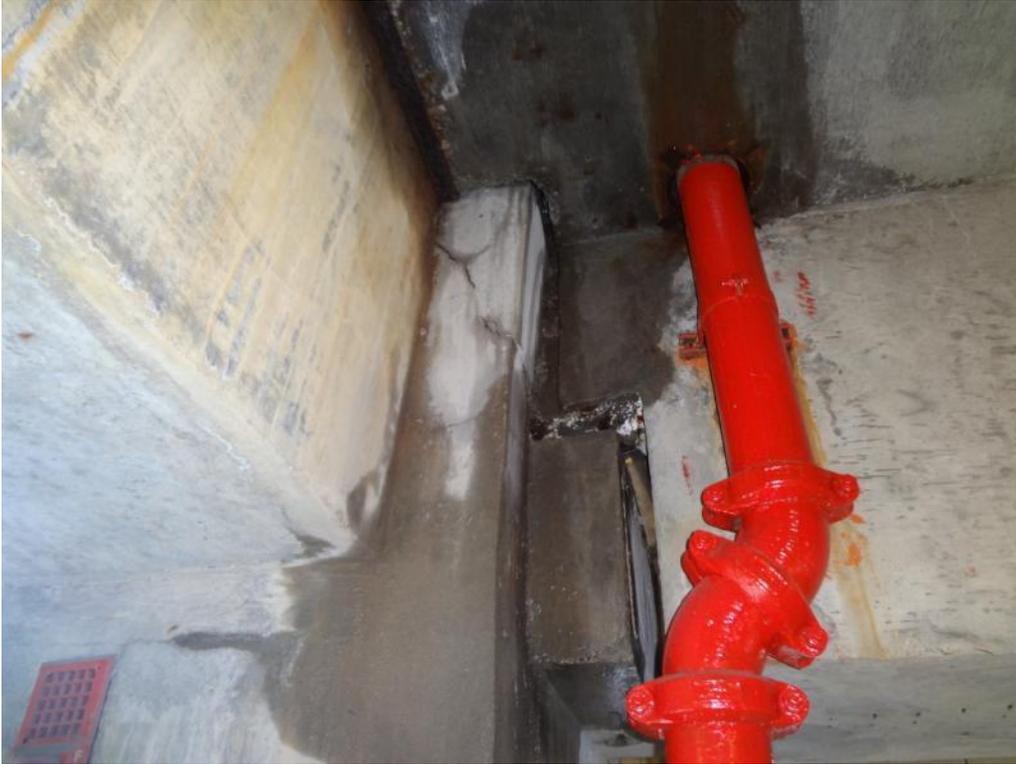
Column G-10 shows an extensive crack right on the beam support and a wet surface due to the extensive leakage from the drainage pipe adjacent to it. **See Photo #19.**

Photo 19: Cracking and spalling at beam support adjacent to leaking drain at column G-10, 4<sup>th</sup> floor.

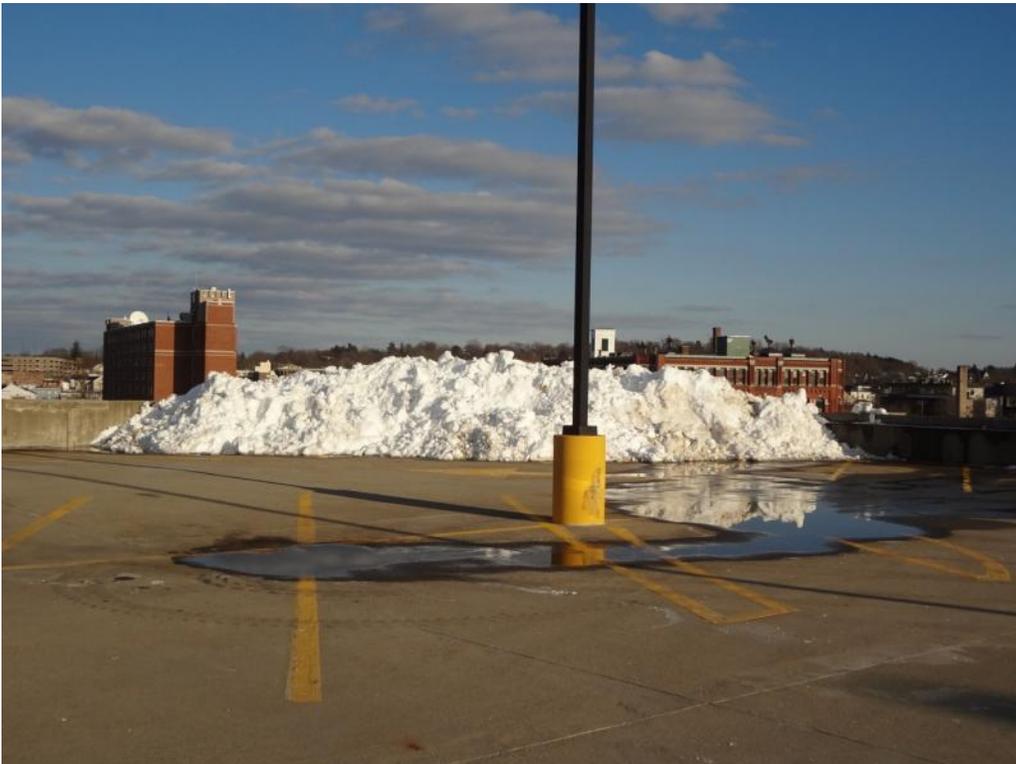
The floor slab shows some minor scaling and uneven patching. There is also a pile of snow which can cause deterioration of the reinforced concrete. The stockpiling of snow other than on the first floor should be avoided. This melting snow, often containing deicing salt, can lead to progressive chloride infiltration into the concrete surface as well as possible overload of the structure's capacity. Clogged drainage further magnifies this problem as melt water cannot drain. Snow stockpiles were also observed on other floors. **See Photo # 20.**

Photo 20: Melting snow stockpile on roof deck
