**City of Lowell**  
**Department of Public Works**  
**Lands and Building Division**

**Memorandum**

Re: Moody School  
Date: 2/12/08

## Inspection Report

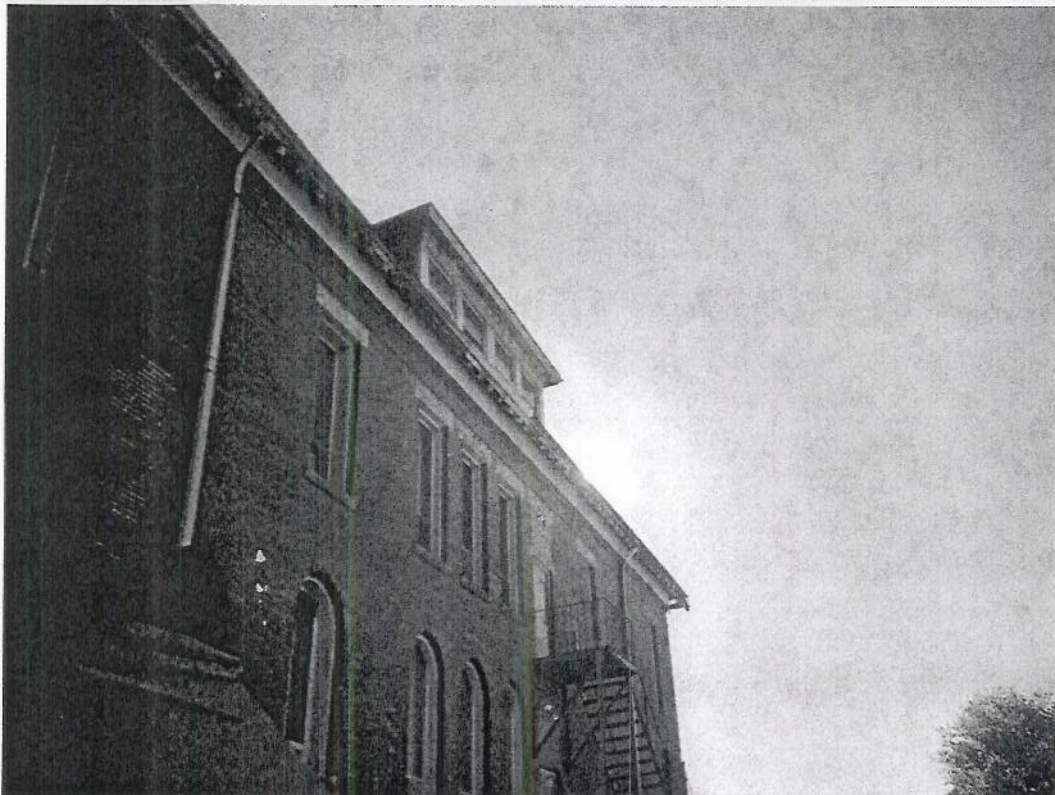
Multiple dormers and detail work make this a difficult roof to do.

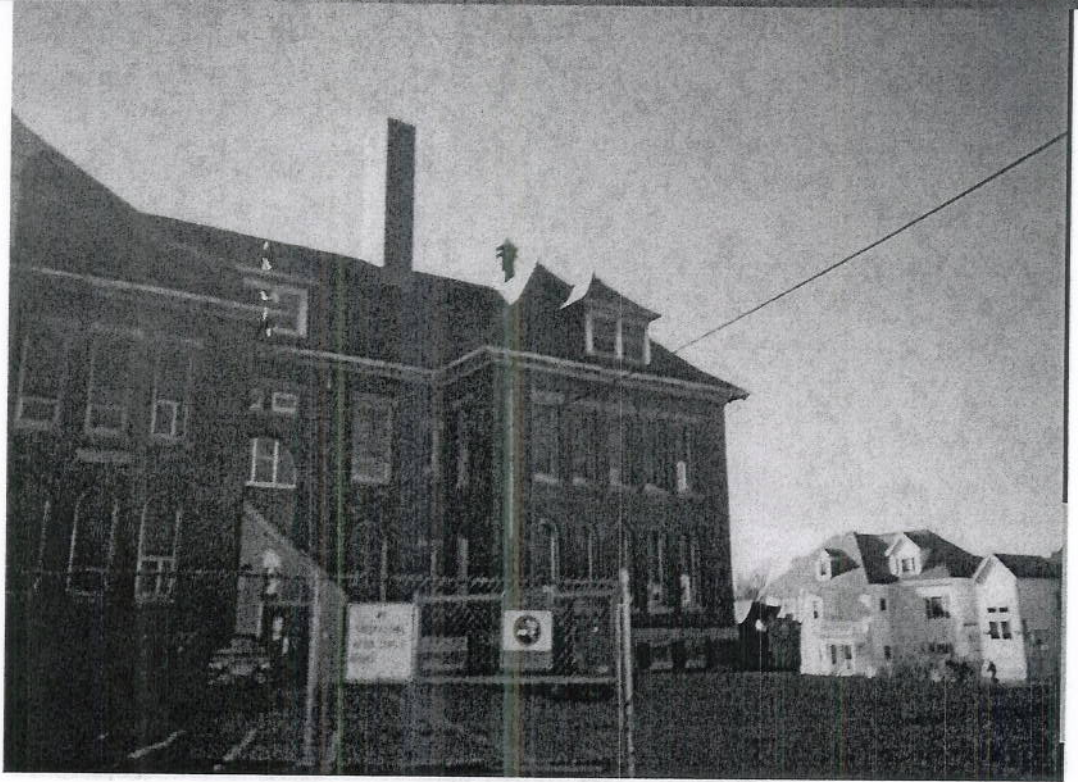
Side view.
