January 7, 2025

Re: Existing Conditions Assessment
Smith Baker Senior Center
400 Merrimack Street
Lowell, MA 01852
Gale JN 843870 P01

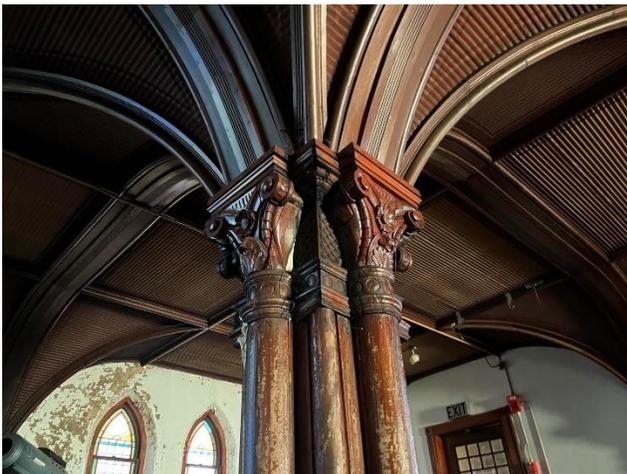
Image 2: Stained decorative woodwork at a column location.

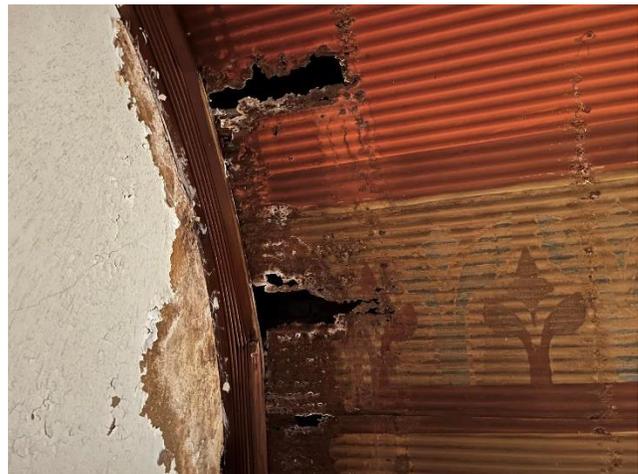
Image 3: Rust deterioration at the decorative metal ceilings and water staining on adjacent plaster finishes.

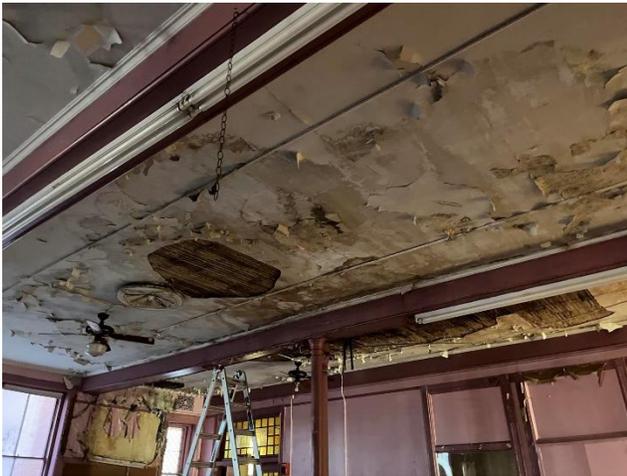
Image 4: Blistering/peeling paint, displaced plaster finishes, and water staining at the ground floor below leak location.

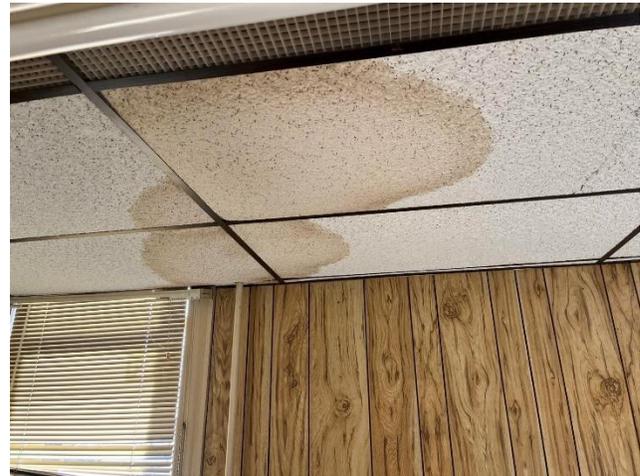
Image 5: Typical stained ceiling tiles.

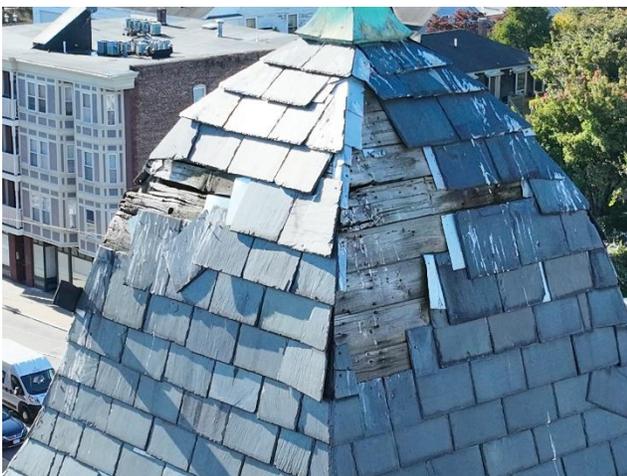
8. A cupola is located at the intersection of the roof ridges and includes wood windows and a bell-shaped roof with slate shingles and a copper finial. Several shingles are missing, exposing the wood plank decking. The windows and associated wood framing/trim at the cupola is in poor condition with broken glass, deteriorated/missing paint, and plywood installed at the interior of broken windows. The wood framing appeared to have been previously repaired/covered with aluminum sheet metal along the base of the windows.

Image 6: Missing and loose slate shingles at the roof cupola.

The steep sloped roof areas should be removed and replaced with a new slate roof system to match the existing configuration and aesthetic. Prior to the installation of underlayments and new shingles, the existing tongue and groove wood deck should be reviewed for areas of deterioration. Deteriorated wood deck should be removed and replaced. The ridges of the roof include terracotta ridge caps which were observed to be displaced in isolated locations, and should be resecured as part of the roofing replacement. The deteriorated roofing components at the cupola located at the ridge of the steep-sloped roof should also be removed and replaced to match the adjacent slate roofing. Restoration or replacement of the associated windows at the cupola should be included as part of the roof replacement; *please refer to the window section below*.

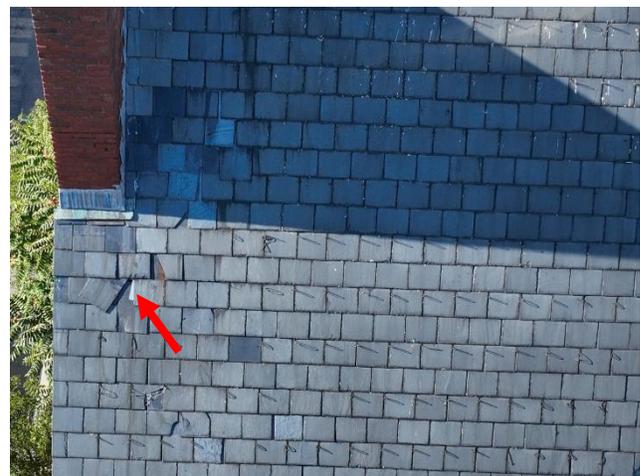
1. The main steep-sloped roofing system (Roof Area A) appears to consist of slate shingles over a wood plank deck, with decorative terracotta pieces constructed along the ridges, eaves, and rake edges. Several shingles were observed to be missing, broken, or displaced. Areas of previous repairs appear to be located along the lower limits of the slate shingle roof. Parking along the east side of the building on Cardinal O'Connell Parkway has been closed due to reported falling slate shingles and roof shedding.

Image 7: Loose, cracked, and missing slate shingles.

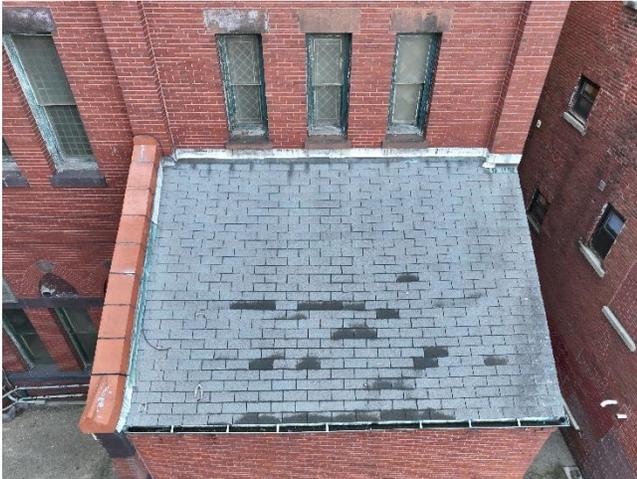
9. A small steep-sloped roof at the west side of the building (Roof Area D) includes asphalt shingles. The asphalt shingles appear to be aged with granule loss and several holes from previous penetrations. The roof includes a gutter and terracotta capstones above the entrance. Sheet metal reglet flashing appears to be constructed at the brick masonry rising wall at the roof transition.

Image 8: Asphalt shingled roof above the west elevation entrance with missing and deteriorated shingles.

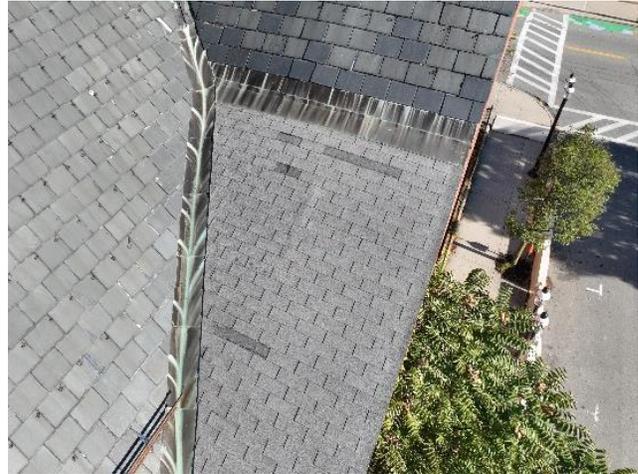
6. A portion of the roof at the east side of the building appears to be constructed with asphalt shingle roofing. Several asphalt shingles appear to be missing.

Image 9: Asphalt shingle roof at the east elevation with missing shingles.

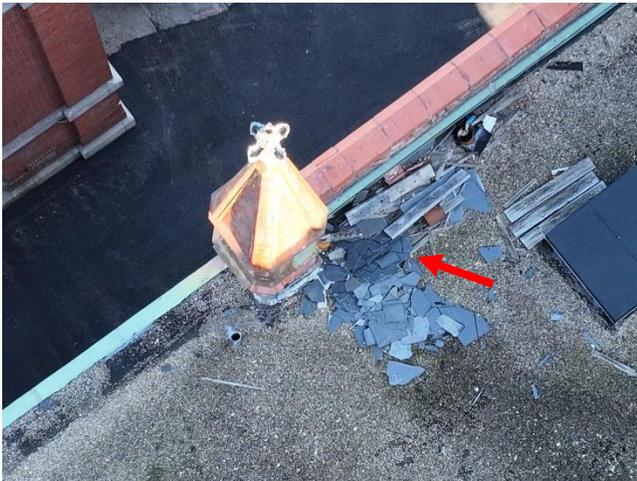
2. Materials and debris were observed at the low-sloped roof areas, including broken slate shingles from the adjacent roofs, wood, and miscellaneous debris.

Image 10: Material and debris in various locations on the low sloped roofs.

It is Gale's opinion that the existing gravel surfaced built-up roofing and rolled asphalt roofing systems should be removed and replaced with new single-ply roof membrane systems consisting of an air/vapor barrier (AVB), polyisocyanurate insulation, coverboard, and a roof membrane such as EPDM or PVC. Additional walkway pads should be installed adjacent to the steep-sloped roofing areas to mitigate potential damage to the membrane from falling ice and/or snow.

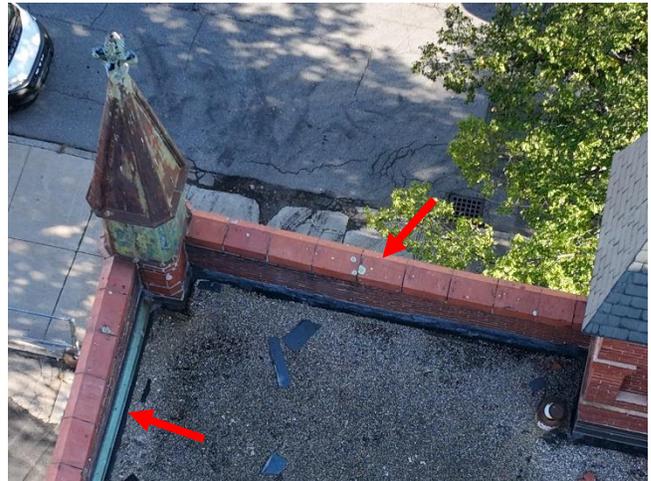
4. A portion of Roof Area B includes a brick masonry parapet with terracotta capstones. Copper flashing is constructed along the roof to masonry wall transition. Parapet caps do not appear to be constructed with cap flashing. Mortar joints between the capstones are typically deteriorated, and isolated capstones are cracked and/or displaced.

Image 11: Brick masonry parapet with terracotta capstone and copper flashing at roof to wall transition.

The existing terracotta coping caps at the brick masonry parapet walls adjacent to the low-slope roofs should be removed and reinstalled as required to install new sheet metal cap flashing. Additionally, the inside face of the parapet walls can be clad with plywood and membrane flashing to mitigate excess moisture through the exterior wall and into the new roof system.

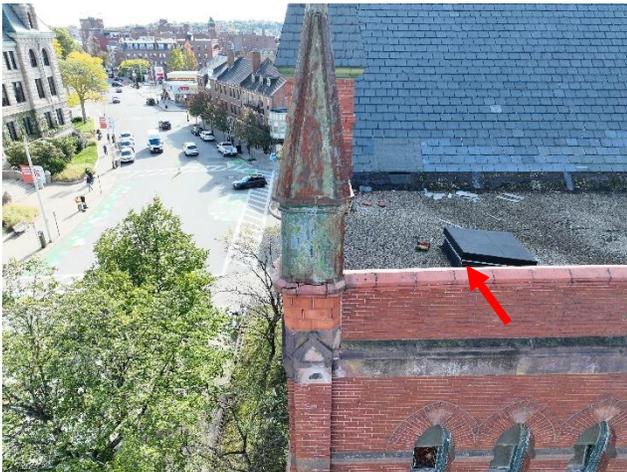
Image 12: Displaced roof access hatch.

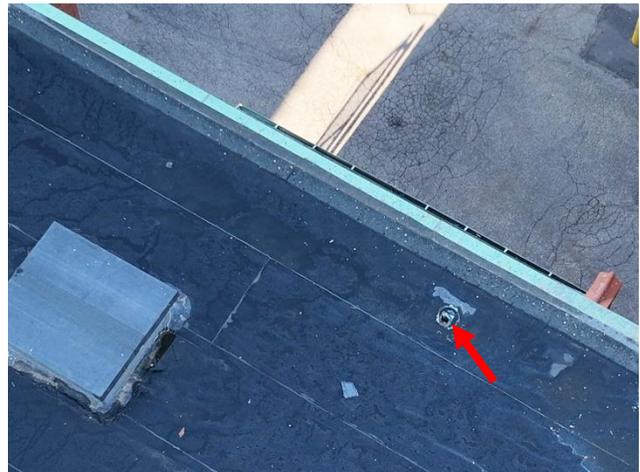
Image 13: Roof drain with missing drain strainer.

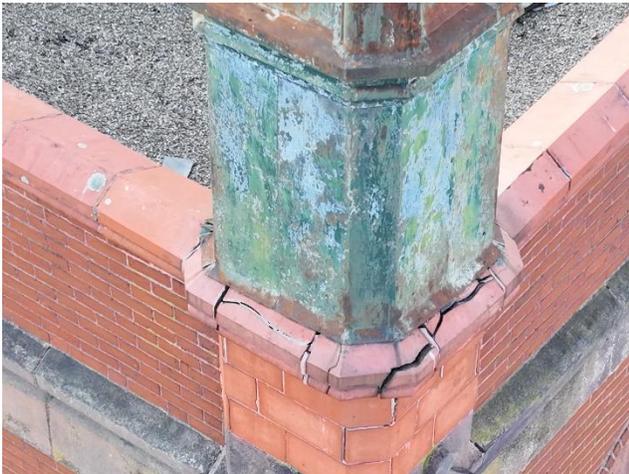
Image 14: Cracked and displaced terracotta accents along roof parapet.

Terracotta coping caps are also installed along the roof rake, and several caps were observed to be cracked, spalled, and with deteriorated mortar joints. These areas are located adjacent to pedestrian walkways, and Gale informed Lowell of these locations as they are potential fall hazards. As a temporary repair, it is Gale’s opinion that debris containment netting be installed at the terracotta caps to reduce the potential of fall hazards from displaced, cracked, or spalled components. Please note, the installation of netting may require structural augmentation that is not included within the cost estimate. The installation of debris netting is a remedial repair to reduce the potential for fall hazards associated with the terracotta. To address the deterioration of the terracotta, it is Gale’s opinion that the cracked terracotta be removed and replaced, and mortar joints be repointed.

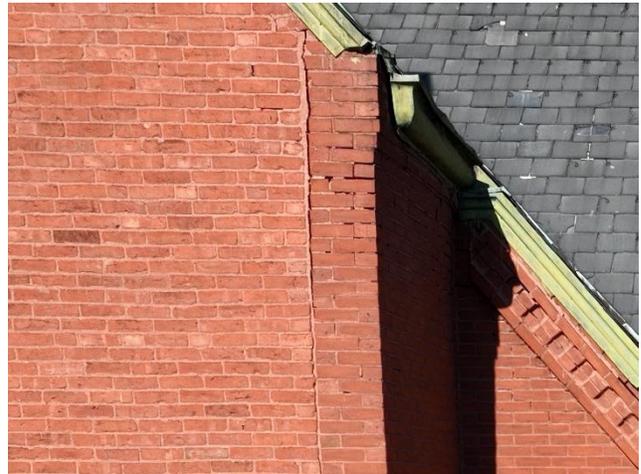
Image 15: Separation at the vertical mortar joint at the east elevation.

It is Gale's opinion that the deteriorated mortar joints be repointed in accordance with the Brick Industry Association's (BIA) recommendations which require removal of existing mortar to a predetermined depth and replacement with a mortar mix appropriate for the masonry units and the surrounding environment. Buttered joint repairs such as those observed on this building, are not preferred, and will delaminate prematurely. Buttering is the application of mortar over the surface of the deteriorated mortar. The industry standard procedure includes cutting existing joints back to at least three-quarters of an inch ($\frac{3}{4}$ ") in depth and applying new mortar of an appropriate strength and composition in lifts (thin applications) until the full depth of the cut is solidly packed. At locations of displaced masonry or heavily deteriorated mortar, it is Gale's opinion that the brick masonry be removed and salvaged if possible to rebuild deteriorated brick masonry sections.

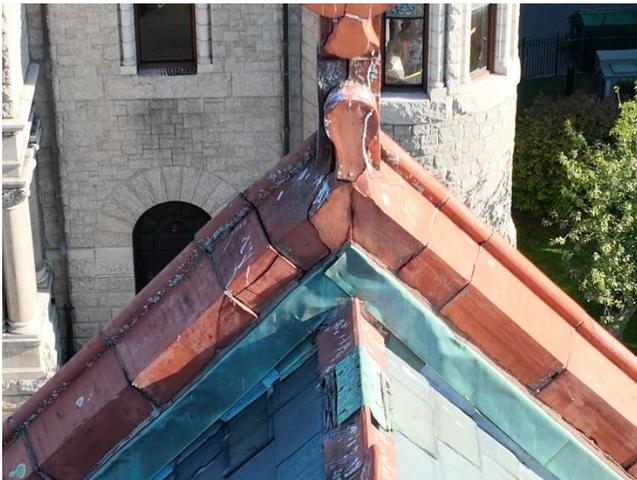
8. Several locations of terracotta coping along the roof edge were observed to be cracked and/or displaced, and several mortar joints between the terracotta pieces are deteriorated or previously repaired with sealant.

Image 16: Terracotta roof edge observed to be cracked and displaced, with deteriorated mortar joints in various locations.

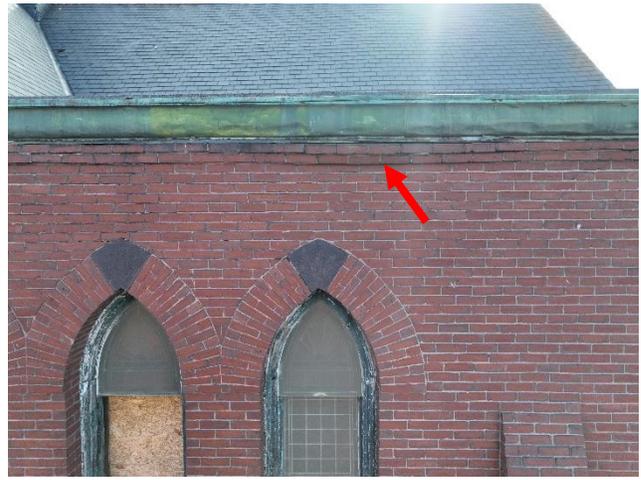
4. Isolated locations of brick masonry were observed to be bowing/displaced. Additionally, isolated areas of mortar joints at the brick masonry were observed to be heavily deteriorated and/or missing.

Image 17: Brick masonry observed to be bowing or displaced and deteriorated or missing mortar joints in various locations.

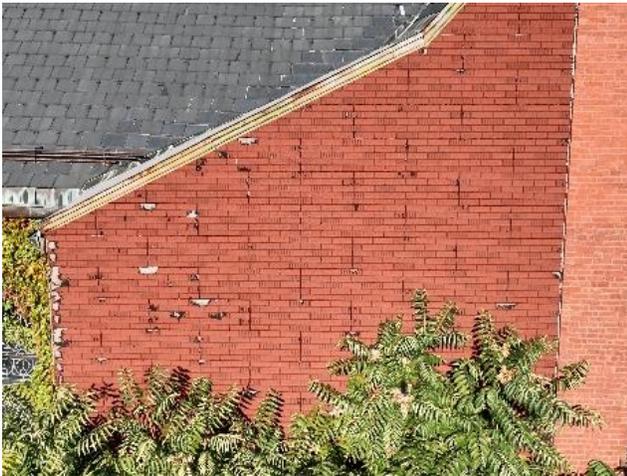
10. At the south elevation, a portion of the building façade appears to be constructed with wood framing with wood plank sheathing and faux brick asphaltic siding. The siding is in poor condition with several areas deteriorated or missing, exposing the wood sheathing. At one (1) location, there is a hole in the siding that is open to the interior. An adjacent tree is growing into the siding.

Image 18: Asphaltic siding at the east elevation in poor condition. Heavy vegetative growth.

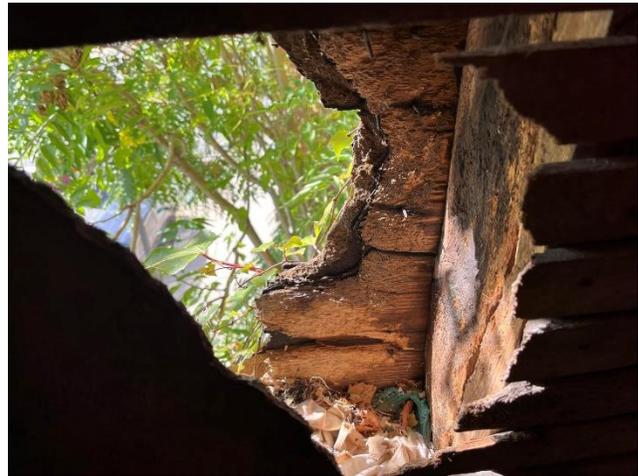
Image 19: Opening to the interior through the asphaltic siding at the east elevation.

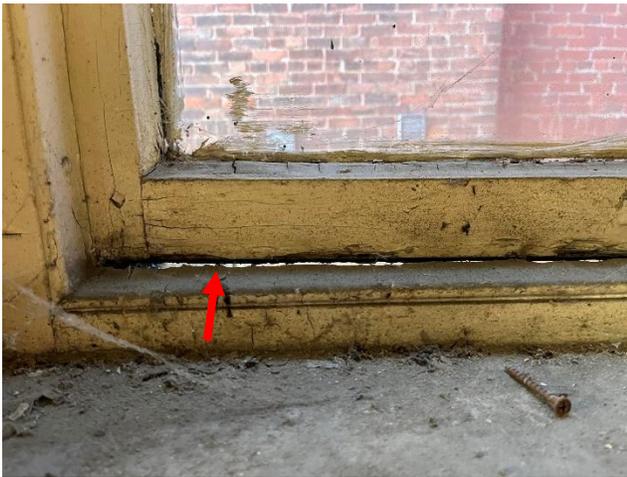
Image 20: Displaced lower sash open to the exterior with no weatherstripping.

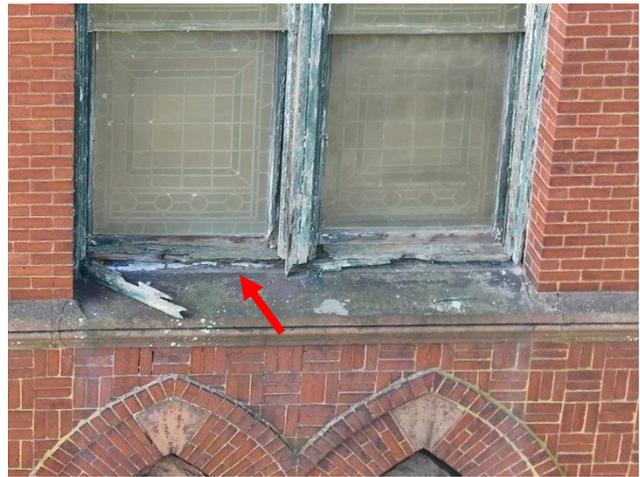
Image 21: Deteriorated wood window frames and components.

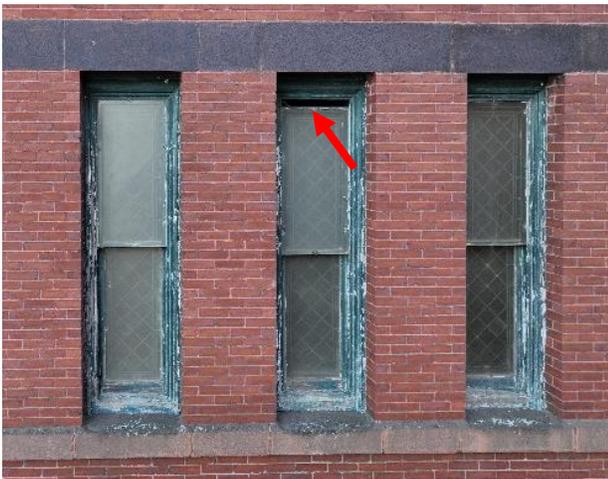
Image 22: Typical displaced window sash.

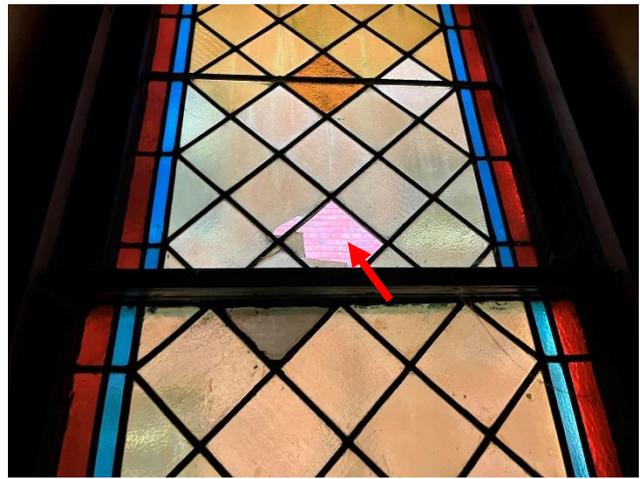
Image 23: Cracked/missing glazing at the stained glass.

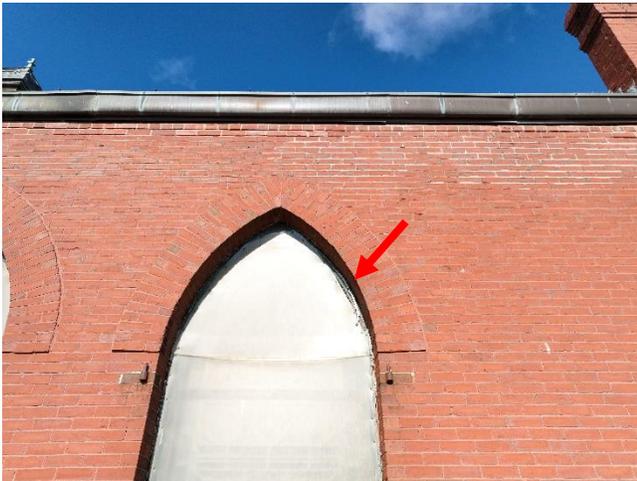
Image 24: Plexiglass bowing and displaced with missing sealant.

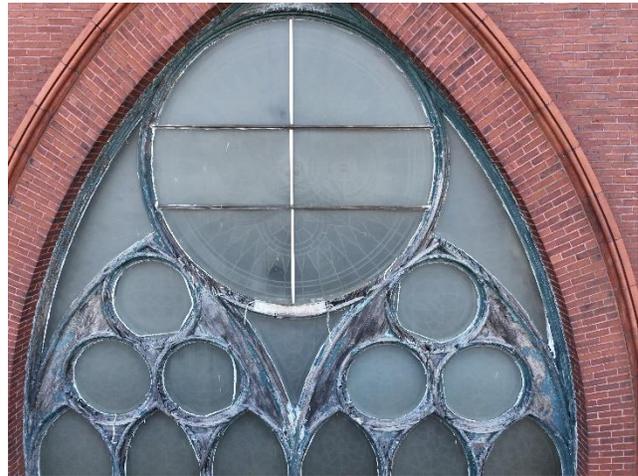
Image 25: Deteriorated wood frames, peeling paint, failed perimeter sealant, and aged plexiglass at the stained glass windows.

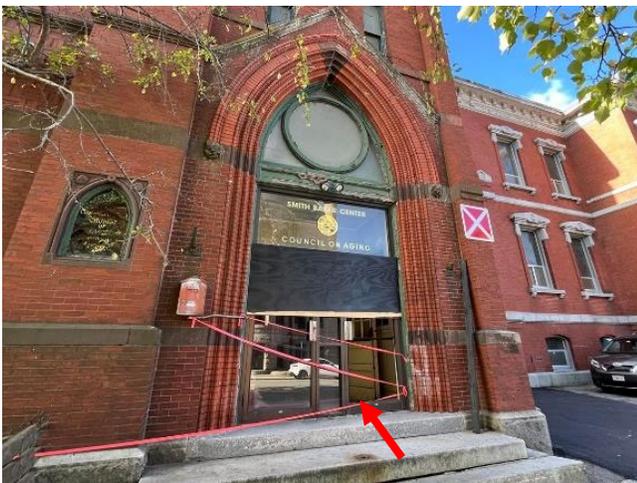
Image 26: Front door aluminum storefront with missing glazing.

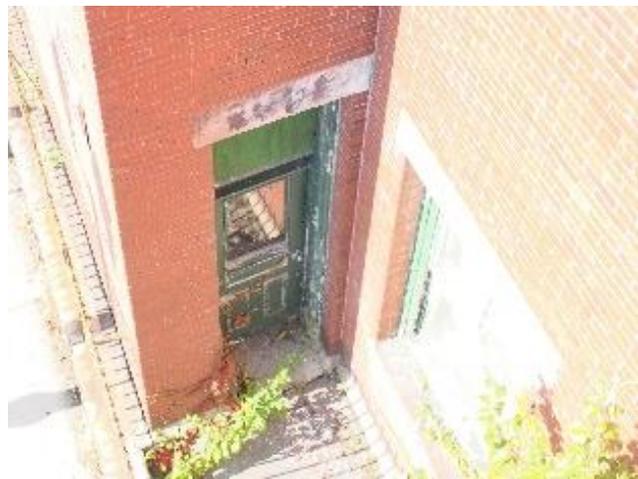
Image 27: Original wood door at the east elevation.

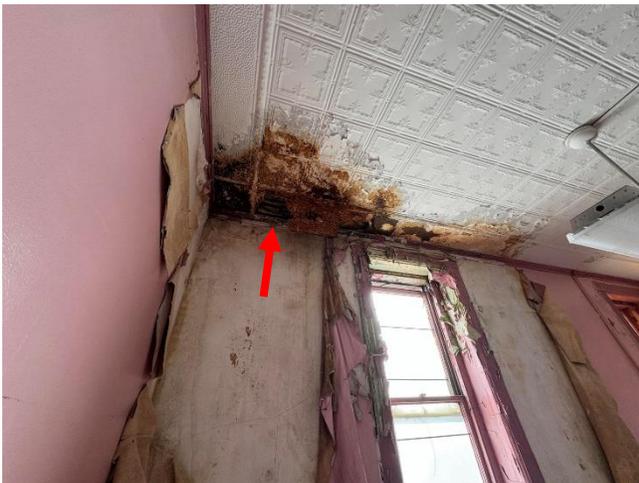
Image 28: View of an area of rotted ceiling supporting the clerestory level, located at the northeast corner of the building.

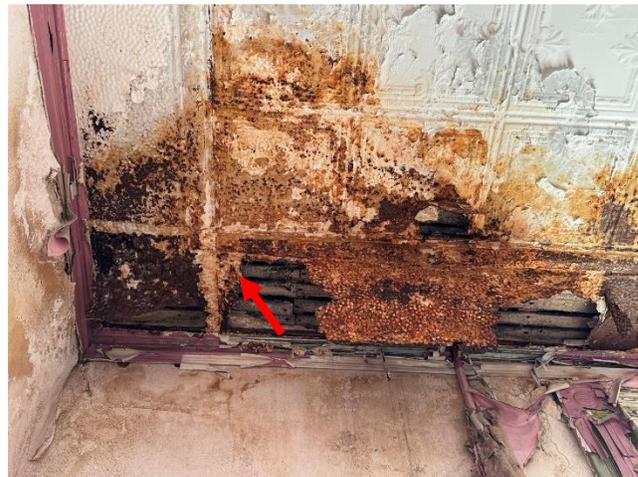
Image 29: Close-up view of an area of rotted ceiling supporting the clerestory level, located at the northeast corner of the building.

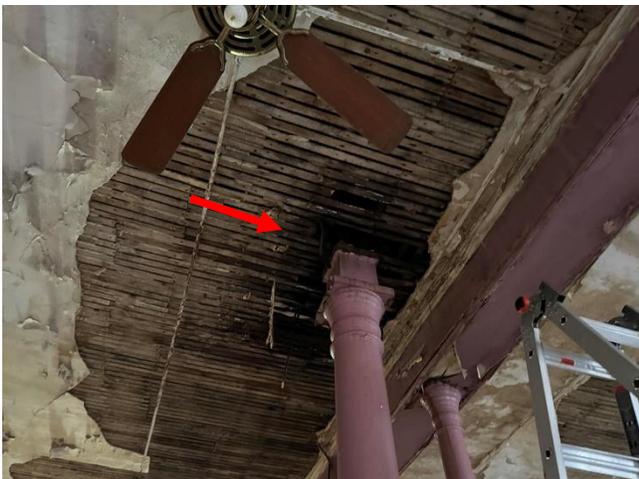
Image 30: View of ceiling area below the clerestory level that exhibits signs of past water infiltration and rot.

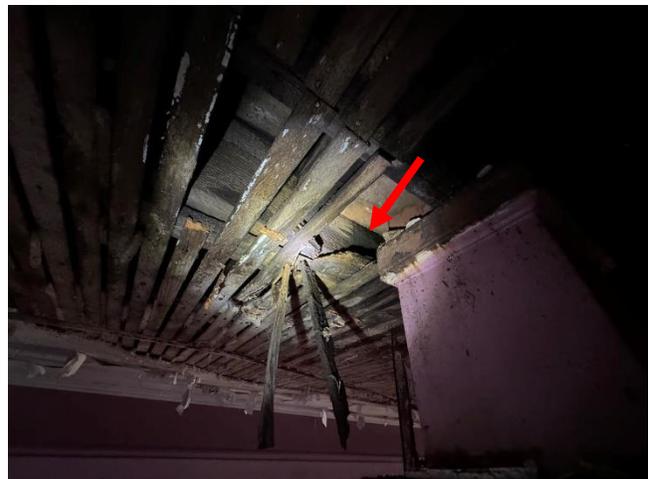
Image 31: View of a rotted wood joist supporting the clerestory level.

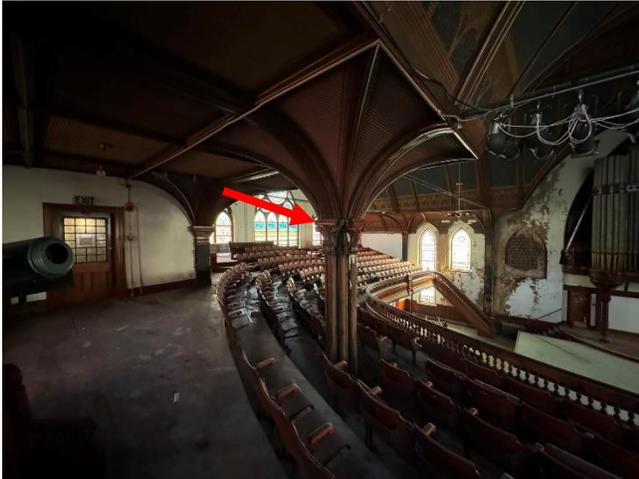
Image 32: View of the deteriorated wood column supporting the roof and clerestory level at the north side of the building.

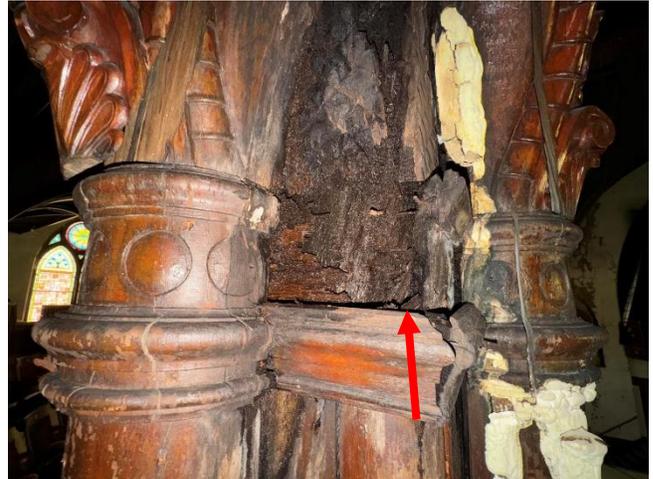
Image 33: Close-up view of the deteriorated wood column supporting the roof and clerestory level at the north side of the building.

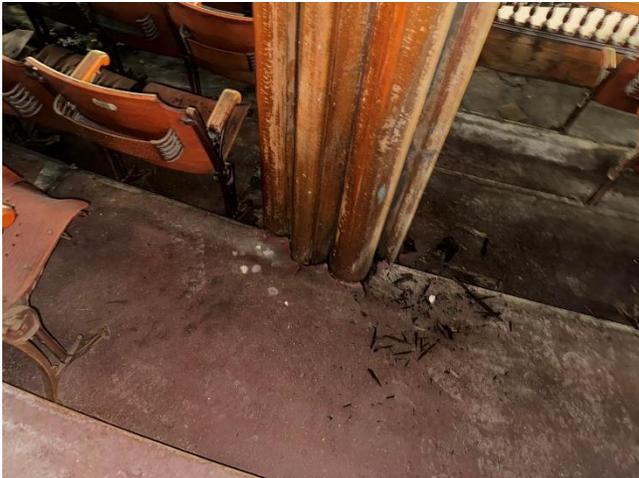
Image 34: View of rot and deterioration observed at clerestory floor surrounding the deteriorated large wood column at the north side of the building.

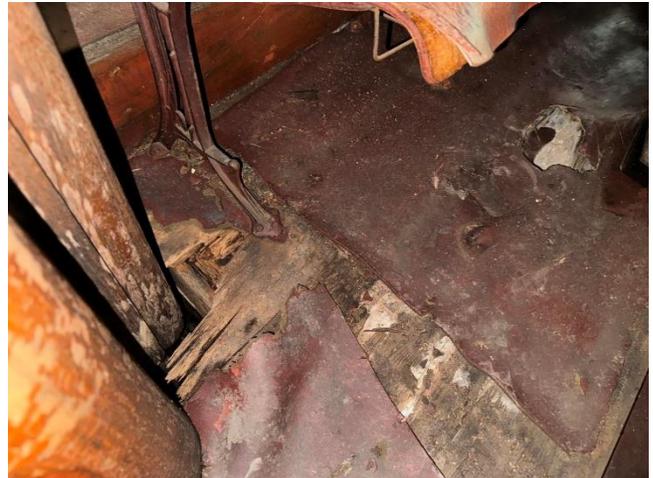
Image 35: Close-up view of an area of rot and deterioration observed at clerestory floor surrounding the deteriorated large wood column at the north side of the building.

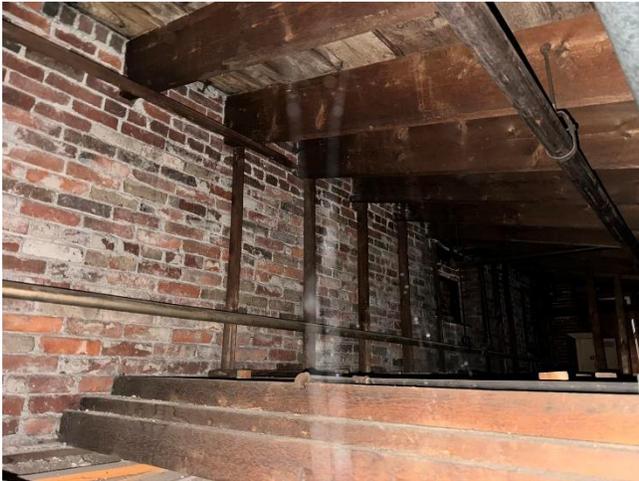
Image 36: View of brick wall supporting the clerestory level framing at the southeast corner of the building, which appeared to be in good condition.

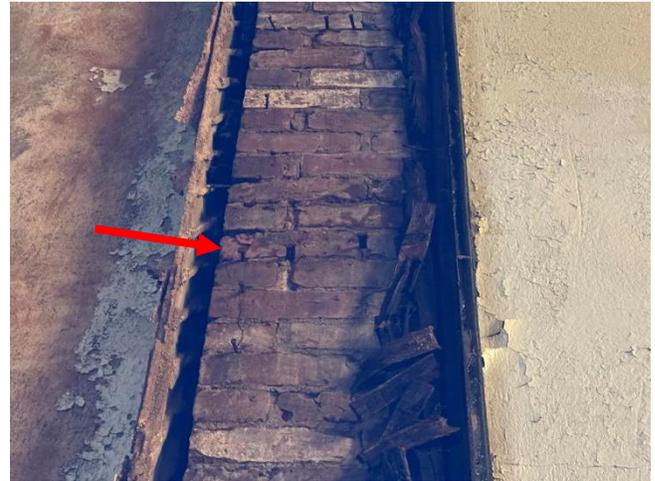
Image 37: Close-up view of an isolated area of deteriorated brick at a column at the east wall.

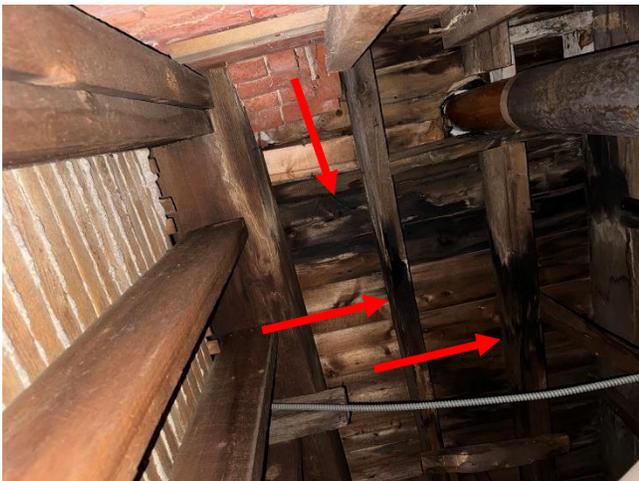
Image 38: View of roof framing at the northeast corner of the building, which appeared to exhibit signs of past water infiltration and rot at scattered locations.

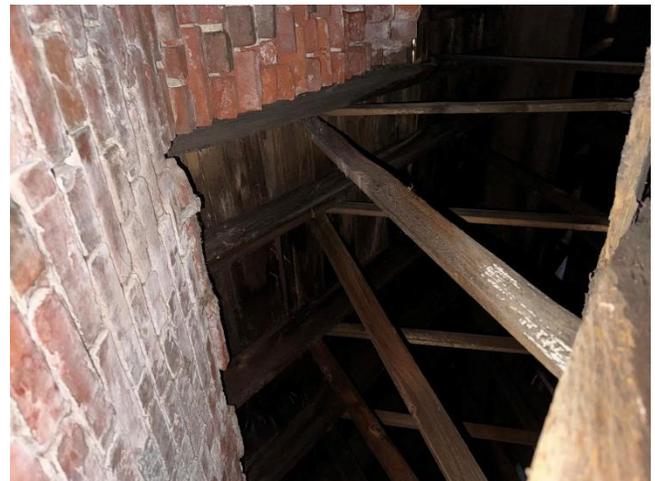
Image 39: View of roof framing at the northwest corner of the building, which appeared to exhibit signs of past water infiltration and rot at isolated locations.
