**STRUCTURES INSPECTION FIELD REPORT**

**ROUTINE & SPECIAL MEMBER INSPECTION**

B.I.N.  
**2BQ**

BR. DEPT. NO.  
**L-15-031**

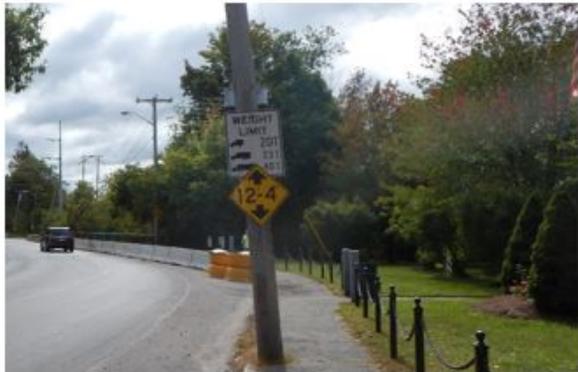
West approach load posting at bridge 20T/23T/40T

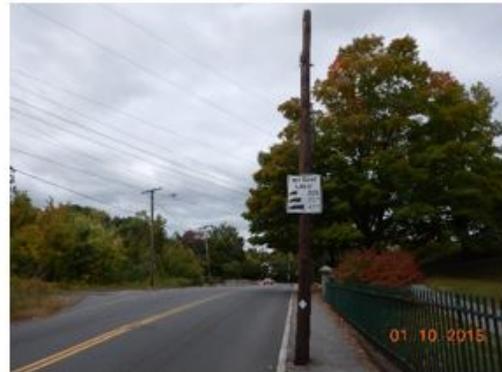
East approach load posting at bridge 20T/23T/40T

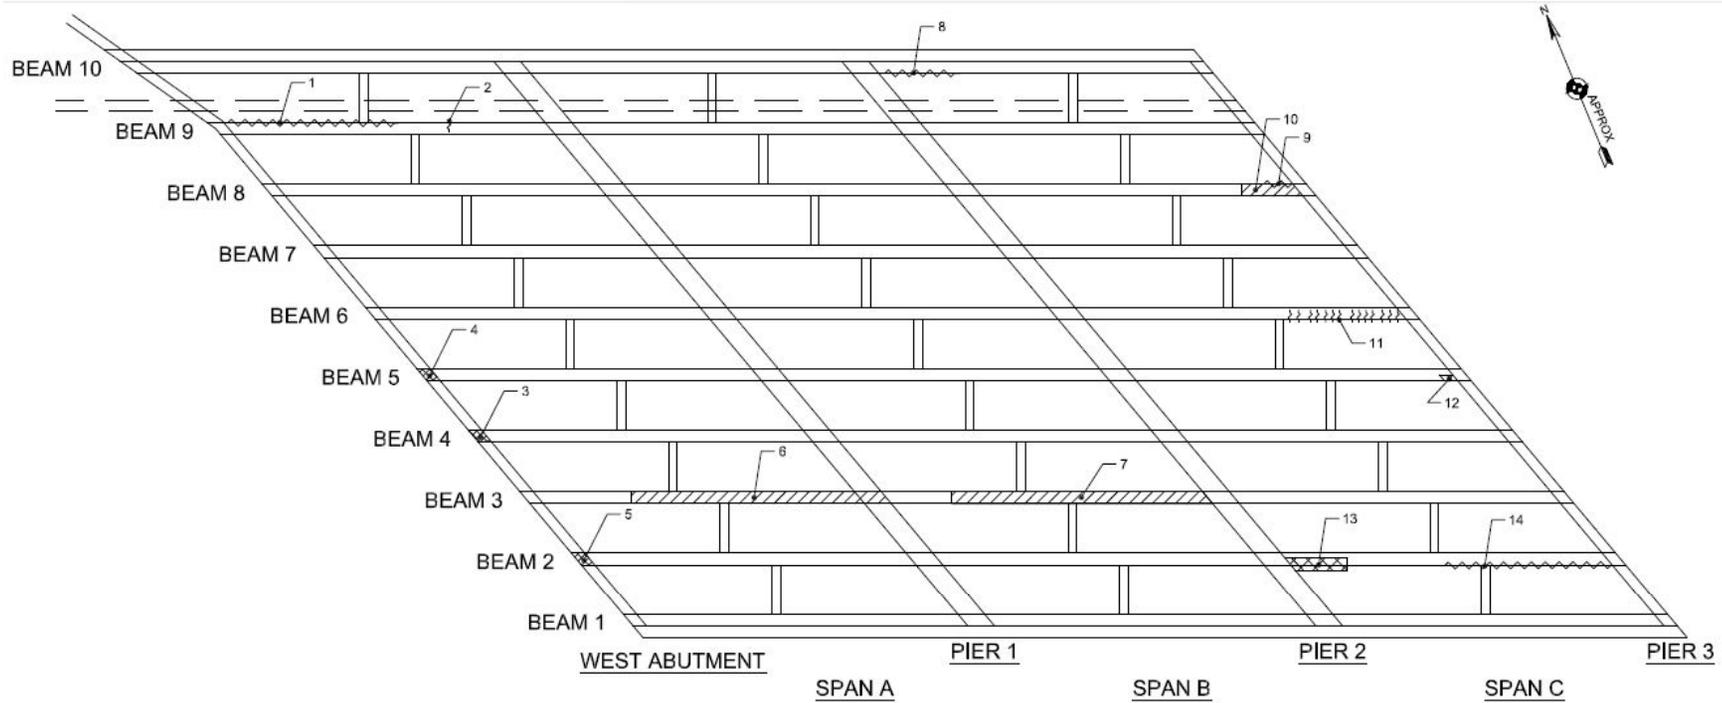
ID	Defect	Length (ft)	Width (in)	Depth (in)	# Bars	% Loss	Revisions	ID	Defect	Length (ft)	Width (in)	Depth (in)	# Bars	% Loss	Revisions
1	LCR	17	0.25				2	9	LCR	3	0.125				2
2	VCR	2.8	0.25				2	10	DELAM	6	14				2
3	SPALL	0.25	3	0.5	1		2	11	VCR	66*	0.03				2
4	SPALL	0.25	4	0.5	1		2	12	SPALL	0.5	4	1	1	50	2
5	SPALL	0.25	3	2	1		2	13	SPALL	2	6	1			2
6	DELAM	25	16				2	14	LCR	16.5	0.25				2
7	DELAM	24.5	16				2								
8	LCR	8	0.125				2

\*Defect represents series of multiple cracks; length reflects combined length of cracks

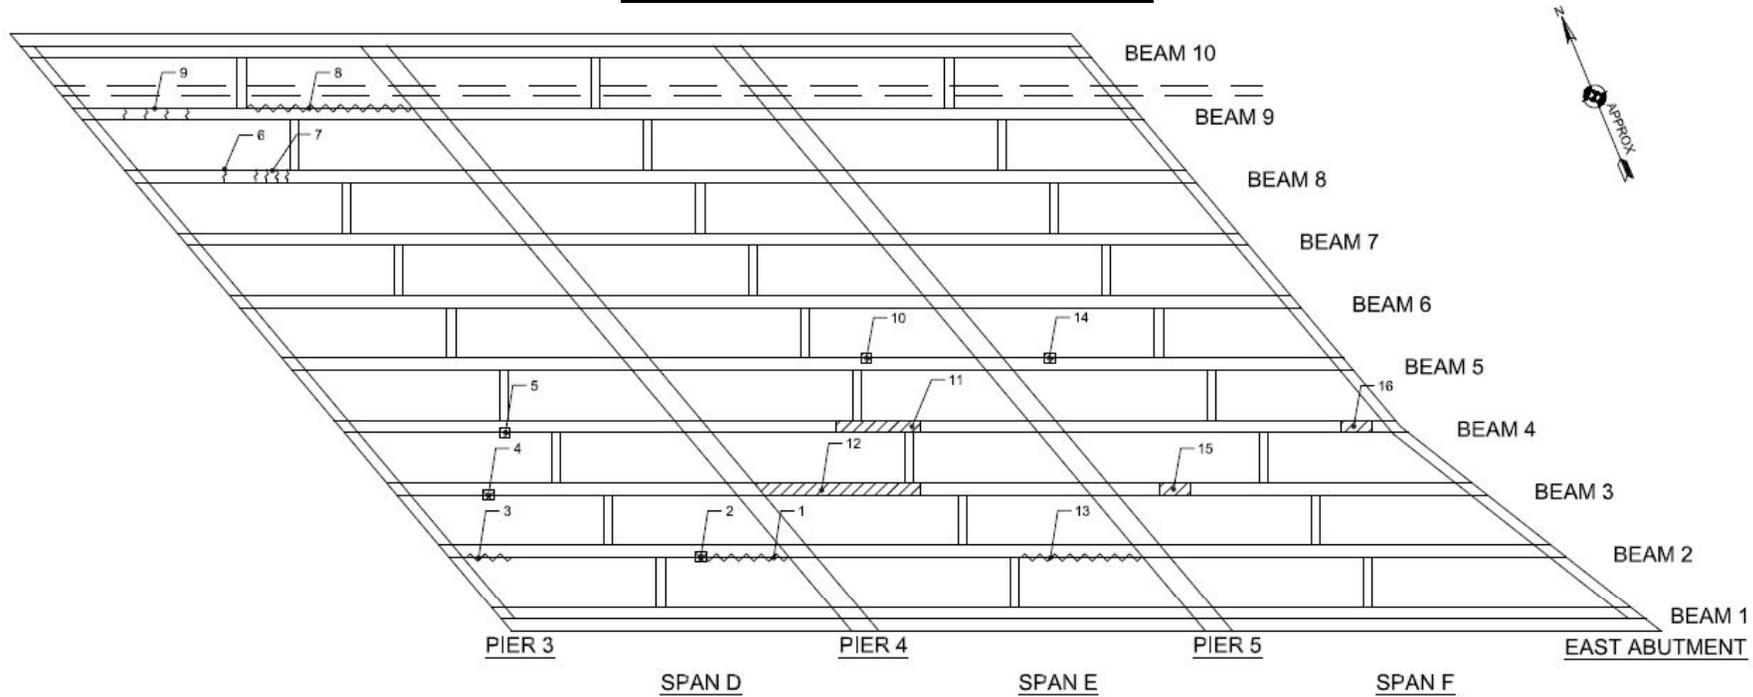
ID	Defect	Length (ft)	Width (in)	Depth (in)	# Bars	% Loss	Revisions	ID	Defect	Length (ft)	Width (in)	Depth (in)	# Bars	% Loss	Revisions
1	LCR	9	0.05				2	10	DELAM	C.25	8				2
2	SPALL	0.35	6	0.5			2	11	DELAM	8	16				2
3	LCR	5	0.06				2	12	DELAM	15	16				2
4	SPALL	1	6	2	0		2	13	LCR	34.7	0.03				2
5	DELAM	3	16				2	14	DELAM	C.67	4				2
6	VCR	2	0.03				2	15	DELAM	3	12				2
7	VCR	8*	0.03				2	16	DELAM	3	12				2
8	LCR	18.2	0.06				2								
9	VCR	10*	0.02				2

\*Defect represents series of multiple cracks; length reflects combined length of cracks  
 LCR - horizontal crack parallel to beam axis  
 VCR - vertical crack perpendicular to beam axis  
 Revisions:  
 1 - Updated information from previous inspection  
 2 - New information from current inspection  
 x - no change from previous inspection
