January 7, 2025

Re: Existing Conditions Assessment
Smith Baker Senior Center
400 Merrimack Street
Lowell, MA 01852
Gale JN 843870 P01

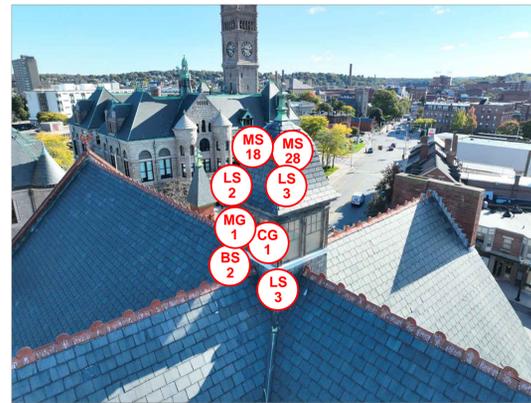
2 PARTIAL CUPOLA ELEVATION
SCALE: NOT TO SCALE

8. A cupola is located at the intersection of the roof ridges and includes wood windows and a bell-shaped roof with slate shingles and a copper finial. Several shingles are missing, exposing the wood plank decking. The windows and associated wood framing/trim at the cupola is in poor condition with broken glass, deteriorated/missing paint, and plywood installed at the interior of broken windows. The wood framing appeared to have been previously repaired/covered with aluminum sheet metal along the base of the windows.

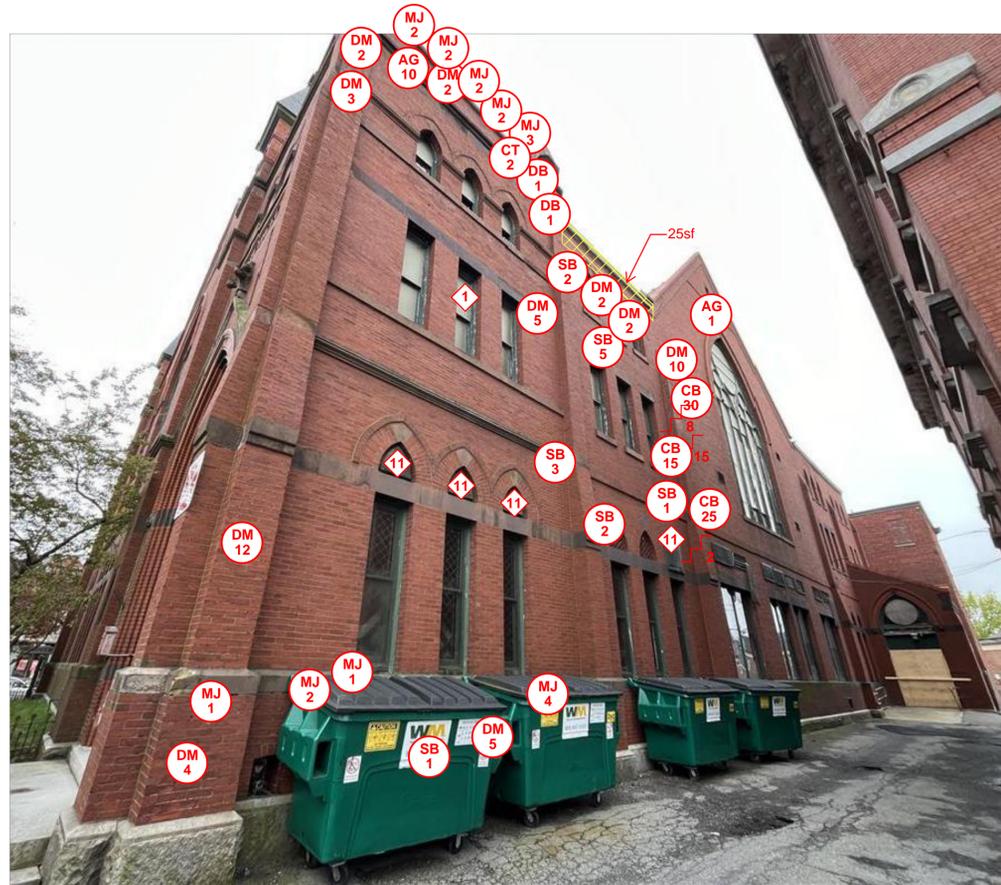
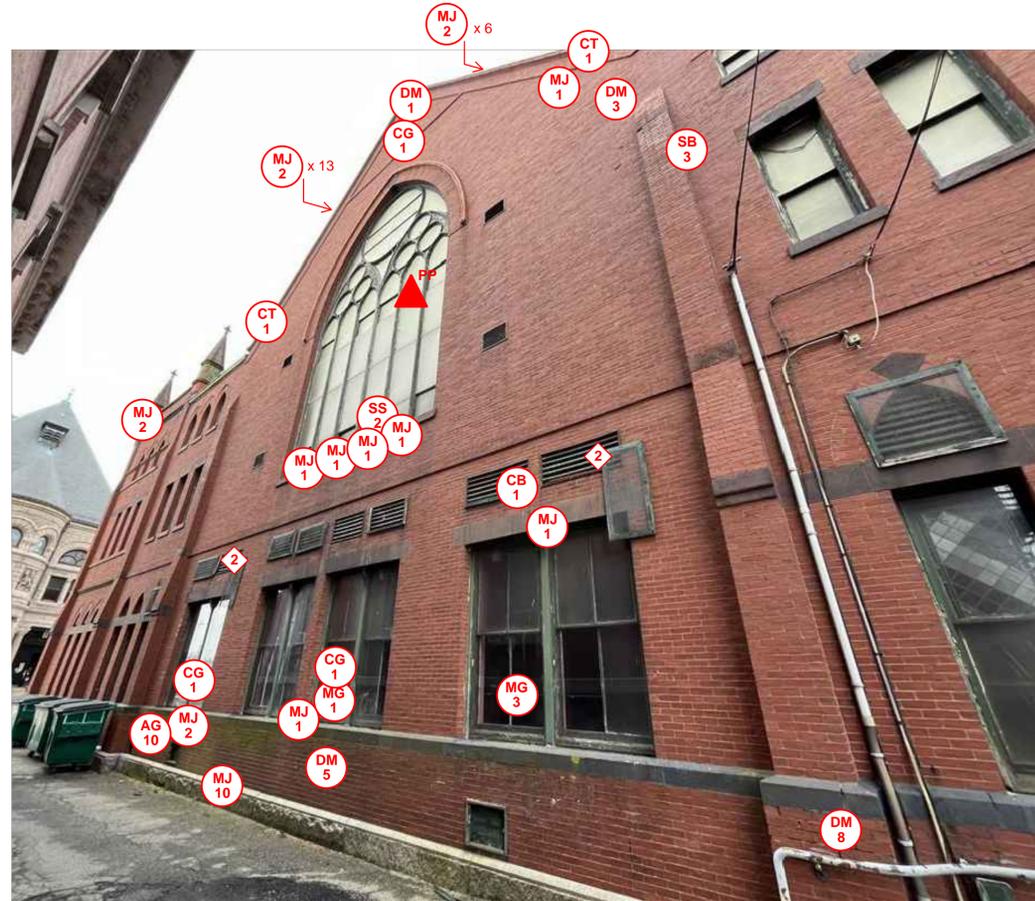
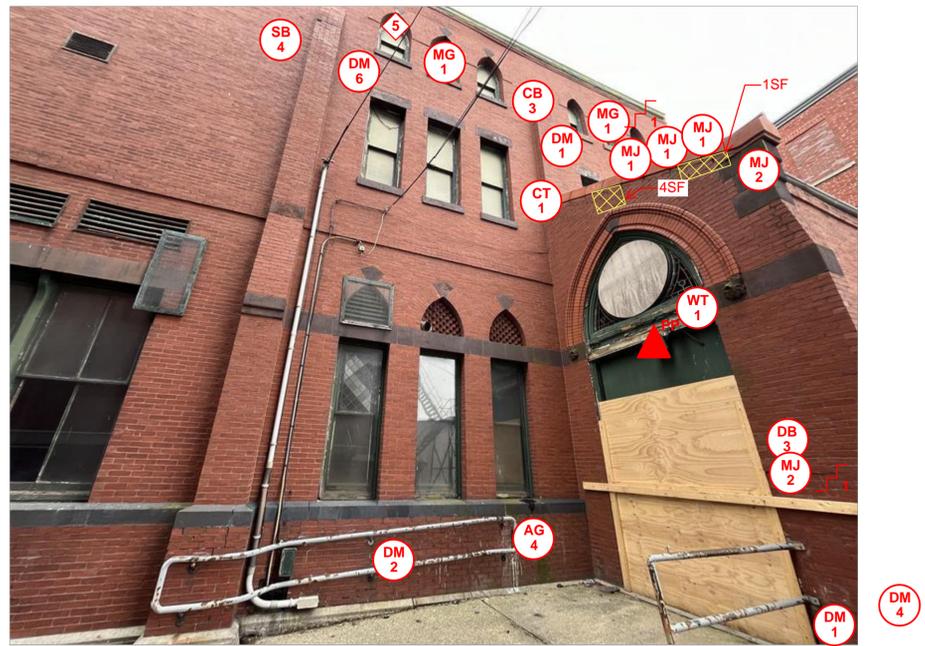
DRAWING NO.
A202

1	TOP SASH OF WINDOW IS DISPLACED.
2	LOUVER AND/OR WOOD FRAMED BIRD NETTING DAMAGED/DISPLACED.
3	BROKEN LOUVER.
4	MISSING GLAZING AT WINDOW INFILLED WITH PLYWOOD.
5	WINDOW DISPLACED WITHIN MASONRY OPENING.
6	BRICK MASONRY APPEARS TO HAVE BEEN PREVIOUSLY PAINTED/COATED AT FIRST FLOOR.
7	LOOSE PIECE OF WOOD SASH.
8	VEGETATIVE GROWTH AT INTERIOR.
9	ASPHALT SHINGLE SIDING IS IN POOR CONDITION WITH DETERIORATED/MISSING SHINGLES AND OPENINGS TO THE INTERIOR. ADJACENT TREE APPEARS TO BE GROWING INTO THE WALL.
10	EXTERIOR MOUNTED PLEXIGLASS IS DISPLACED/BOWED WITH MISSING SEALANT.
11	STONE APPEARED TO HAVE BEEN PREVIOUSLY COATED/PAINTED; COATING IS PEELING.

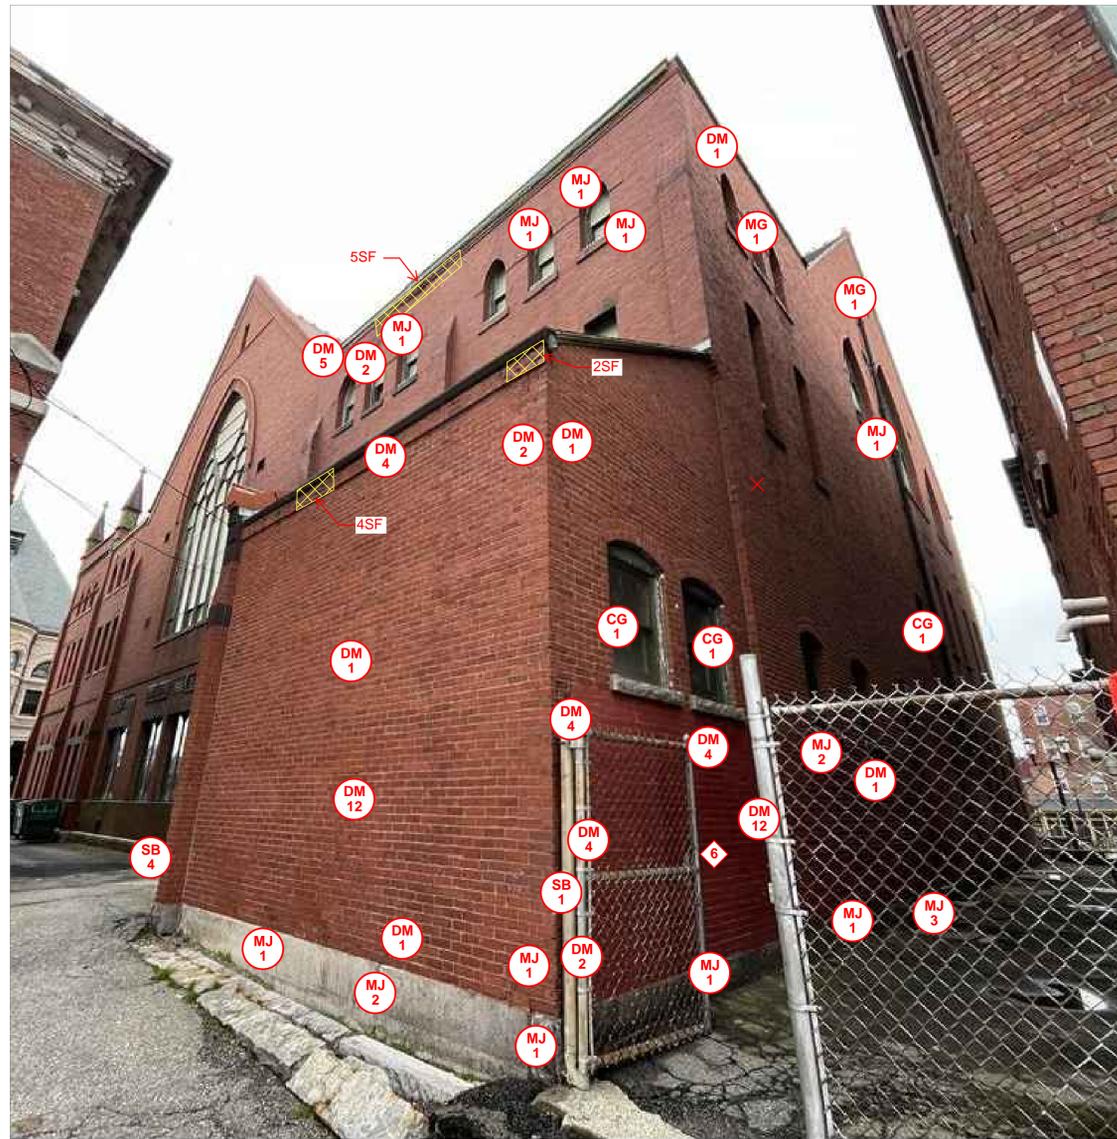
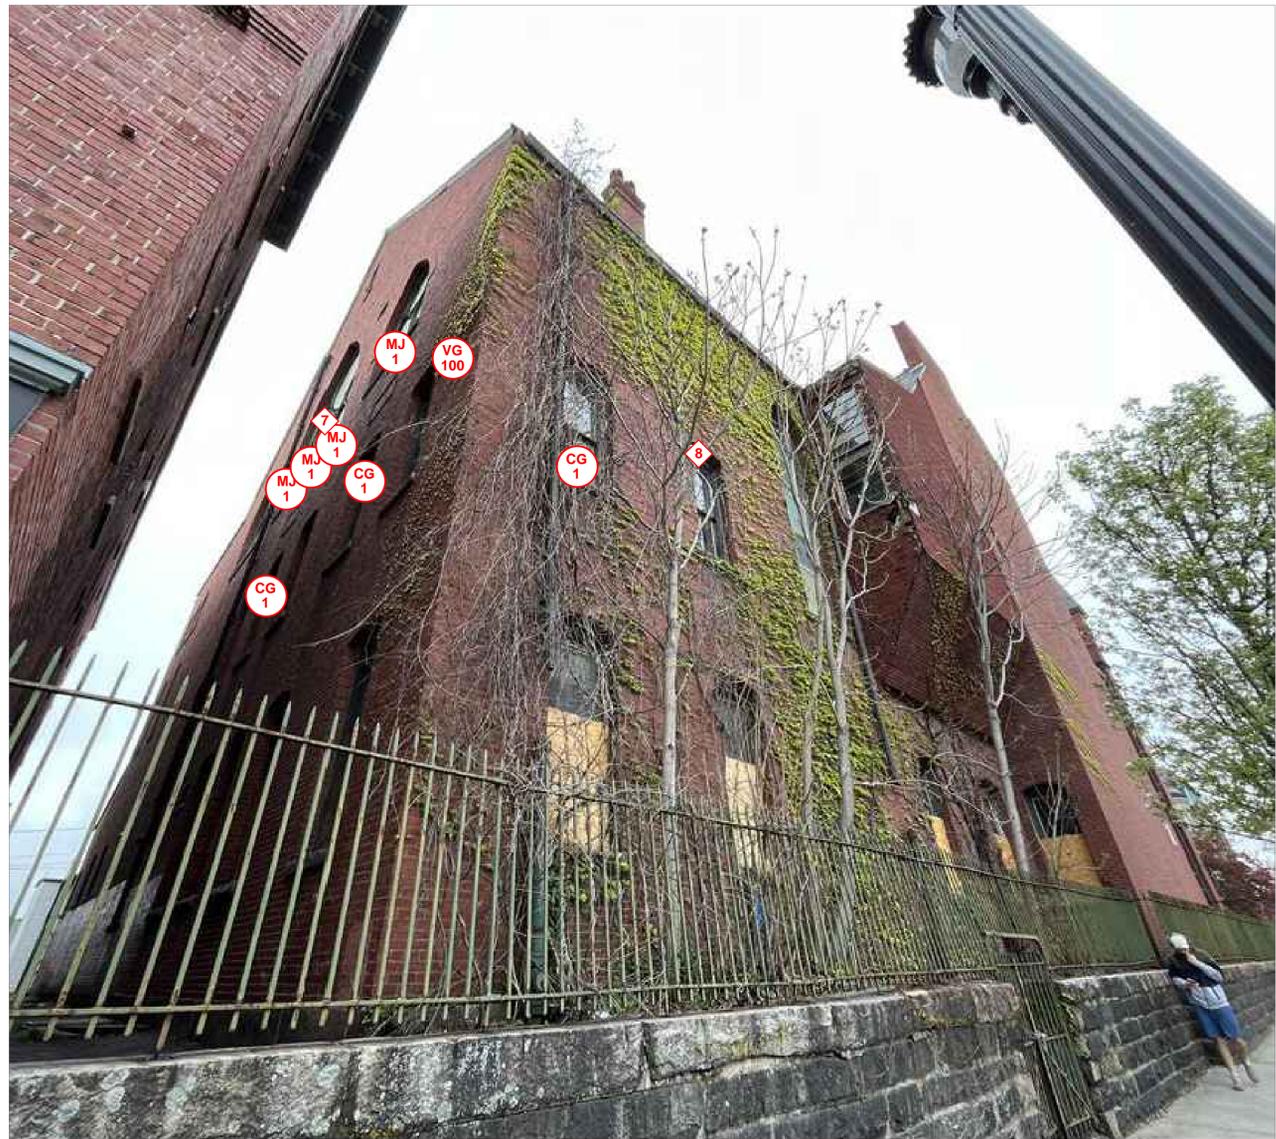
- TOP SASH OF WINDOW IS DISPLACED.
- LOUVER AND/OR WOOD FRAMED BIRD NETTING DAMAGED/DISPLACED.
- BROKEN LOUVER.
- MISSING GLAZING AT WINDOW INFILLED WITH PLYWOOD.
- WINDOW DISPLACED WITHIN MASONRY OPENING.
- BRICK MASONRY APPEARS TO HAVE BEEN PREVIOUSLY PAINTED/COATED AT FIRST FLOOR.
- LOOSE PIECE OF WOOD SASH.
- VEGETATIVE GROWTH AT INTERIOR.
- ASPHALT SHINGLE SIDING IS IN POOR CONDITION WITH DETERIORATED/MISSING SHINGLES AND OPENINGS TO THE INTERIOR. ADJACENT TREE APPEARS TO BE GROWING INTO THE WALL.
- EXTERIOR MOUNTED PLEXIGLASS IS DISPLACED/BOWED WITH MISSING SEALANT.
- STONE APPEARED TO HAVE BEEN PREVIOUSLY COATED/PAINTED; COATING IS PEELING.
