**Residential Project Description -
The City of Lowell Green Building Excellence Award**

Name & Location of Building: Chris Gleba and Kris Erikson Residence, 48 Epping St., Lowell, MA.

Project Architect and Builder: Mark Yanowitz, Verdeco Design, LLC

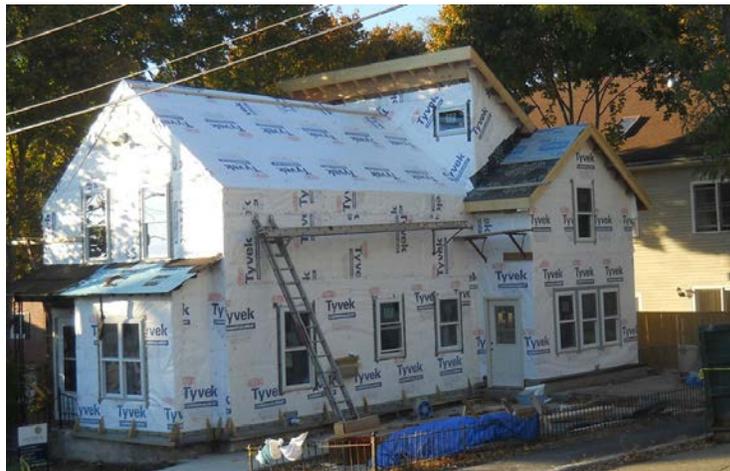
The structure was wrapped with Tyvek Commercial Wrap. Tyvek was selected because it was both an air and water barrier and it had the high permeability that we desired for the “vapor-out” assembly.

To achieve the DER program goal of R-60 at the roof, we over-framed the existing roof framing with new 16” TJI framing and filled the cavities with rock wool insulation by overlapping (3) layers of materials. Both wall and ceiling assemblies virtually eliminated all thermal bridging concerns.
